Re: **Requested Modification to the Mitigation and Monitoring Plan of the Sierrita Gas Pipeline by Kinder Morgan through the Altar Valley**

Sierrita Pipeline Project

Long-Term Monitoring Plan

Pima County Revisions: May 20, 2014

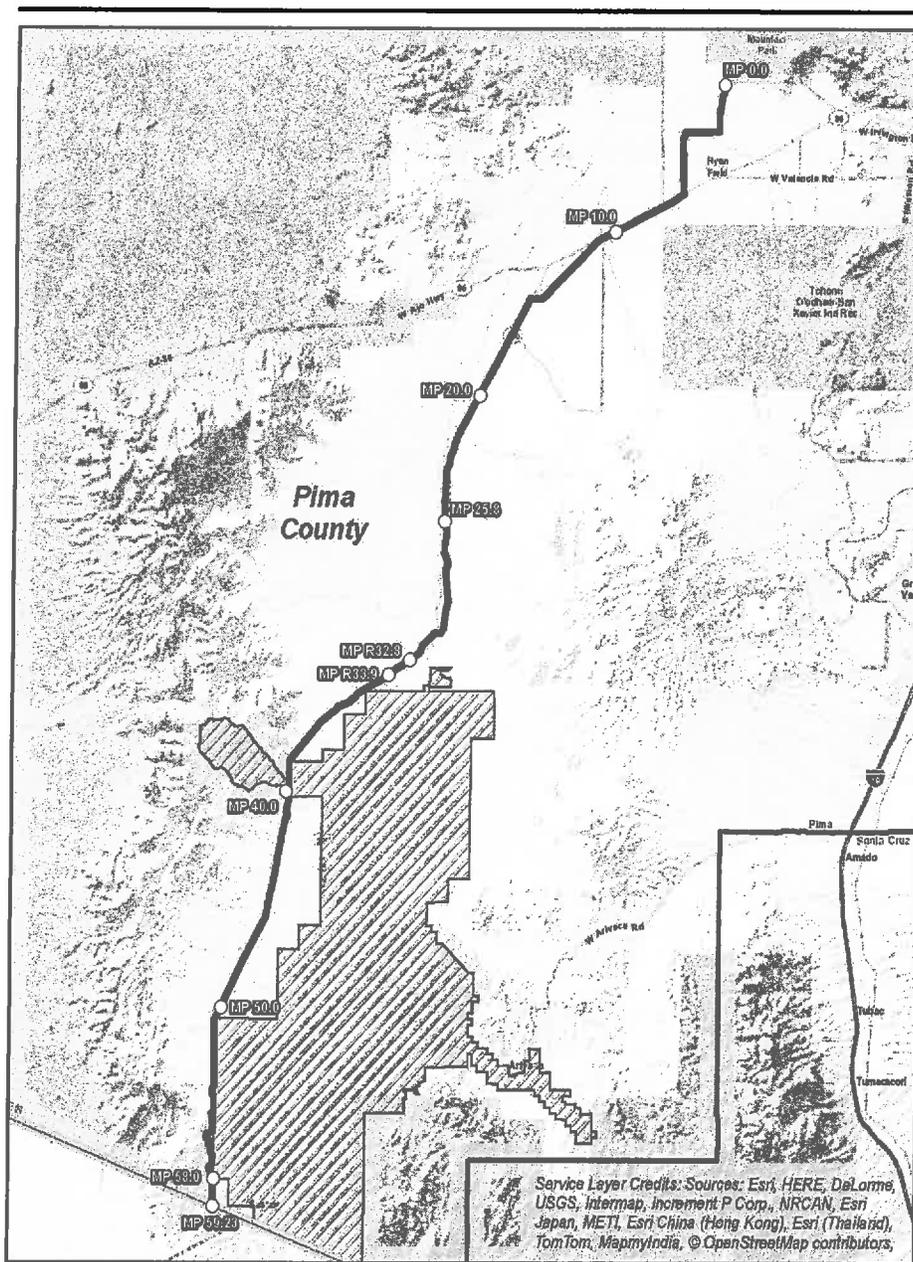
Figure 1

Sierrita Pipeline Project
Current Project Route

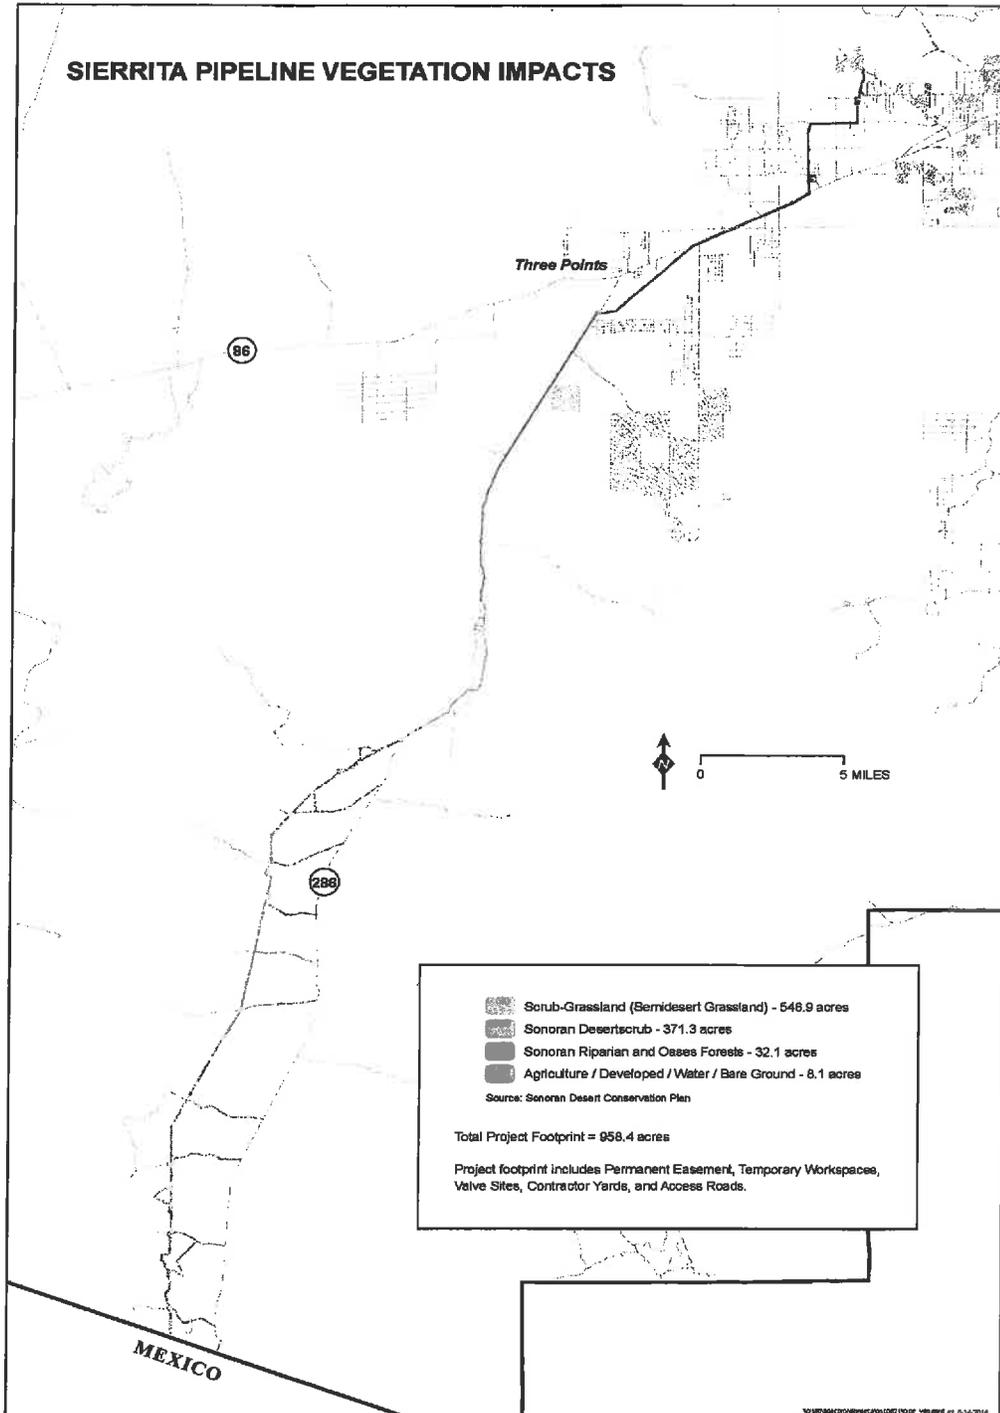
Figure 2. Dominant vegetation communities along the pipeline route.

- The number of sampling points will be established using statistically appropriate methods that account for the variation in vegetation resources over the approximately 60 mile pipeline and variation of resources within each plot. Sierrita will work with Pima County and statisticians to determine the number of plots needed. Stratification of sites will likely be appropriate and will add efficiencies to the sampling. Stratification based on dominant vegetation type (Figure 2) is an accepted and prudent approach.
