Pantano Wash Bank Protection and River Park: Fort Lowell to Tanque Verde Road

Ecosystem Restoration, Mitigation and Preservation

In addition to providing flood and erosion protection, and creating a river park, another goal of the project is to preserve, mitigate and restore the riparian ecosystem. The project uses several different techniques to enhance ecosystem preservation, mitigation and restoration as documented in the photographs and text provided below.

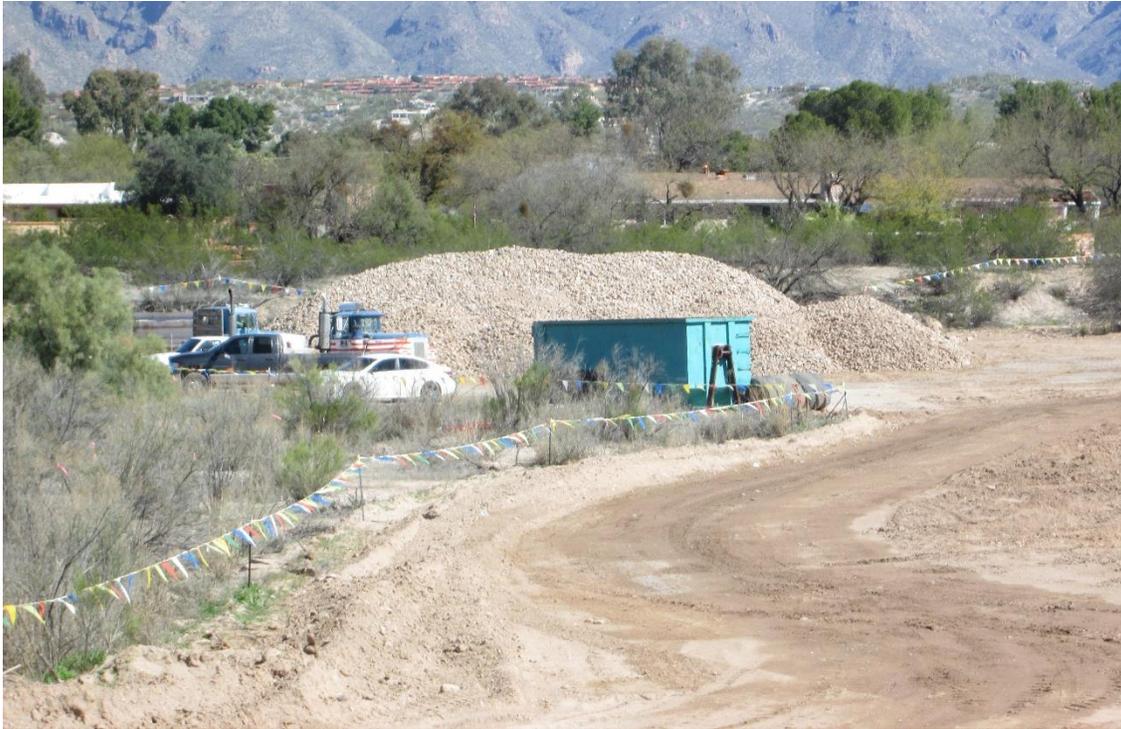
Brightly colored flagging is use to mark out large areas that the contractor is not to disturb.

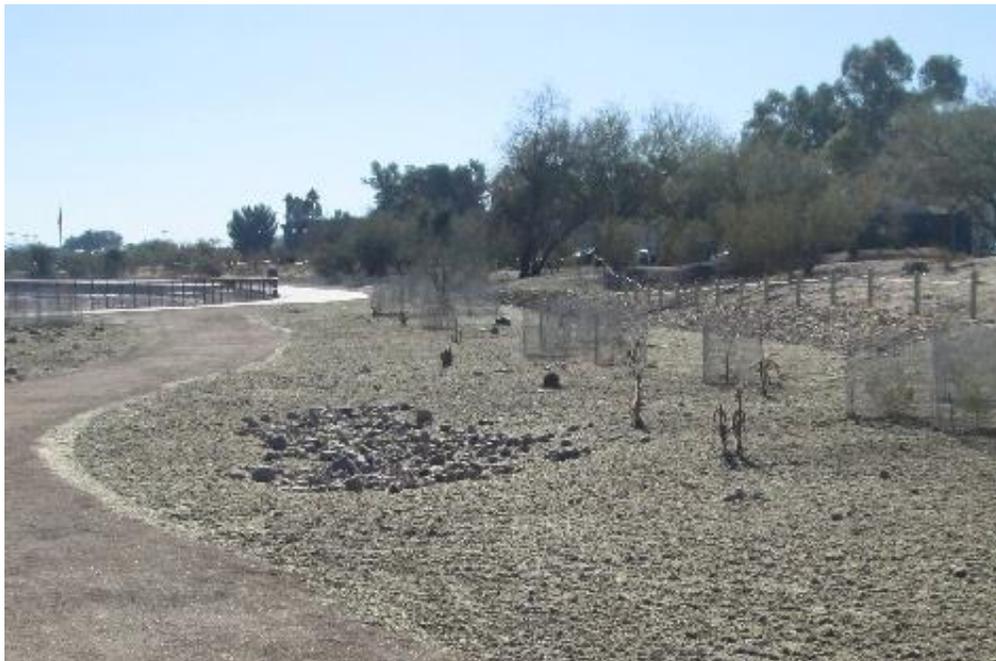
A shallow, narrow water-harvesting basin collect runoff from adjacent pavement. The water remains for only a day or two and supplement the reclaimed irrigation water that the adjacent plants receive.

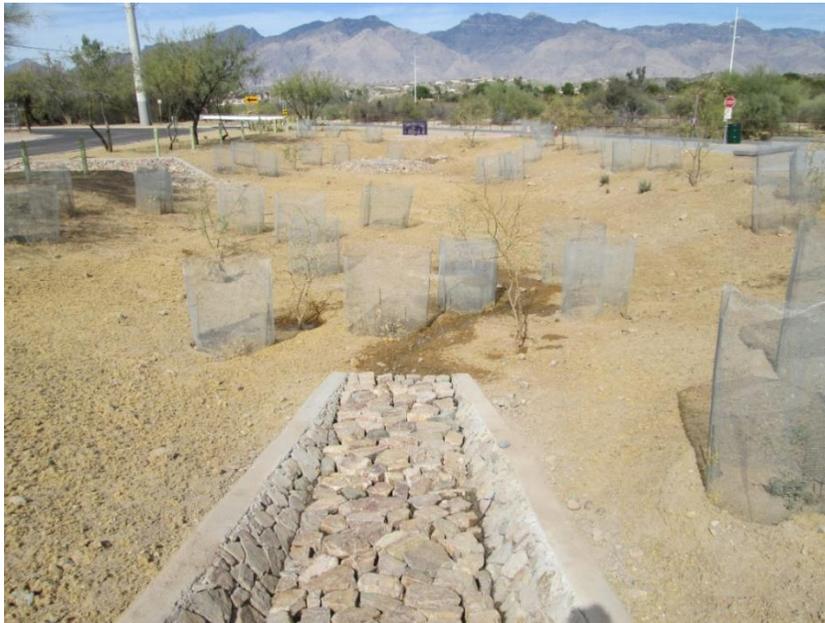
Cobbles were placed in this shallow water-harvesting basin.

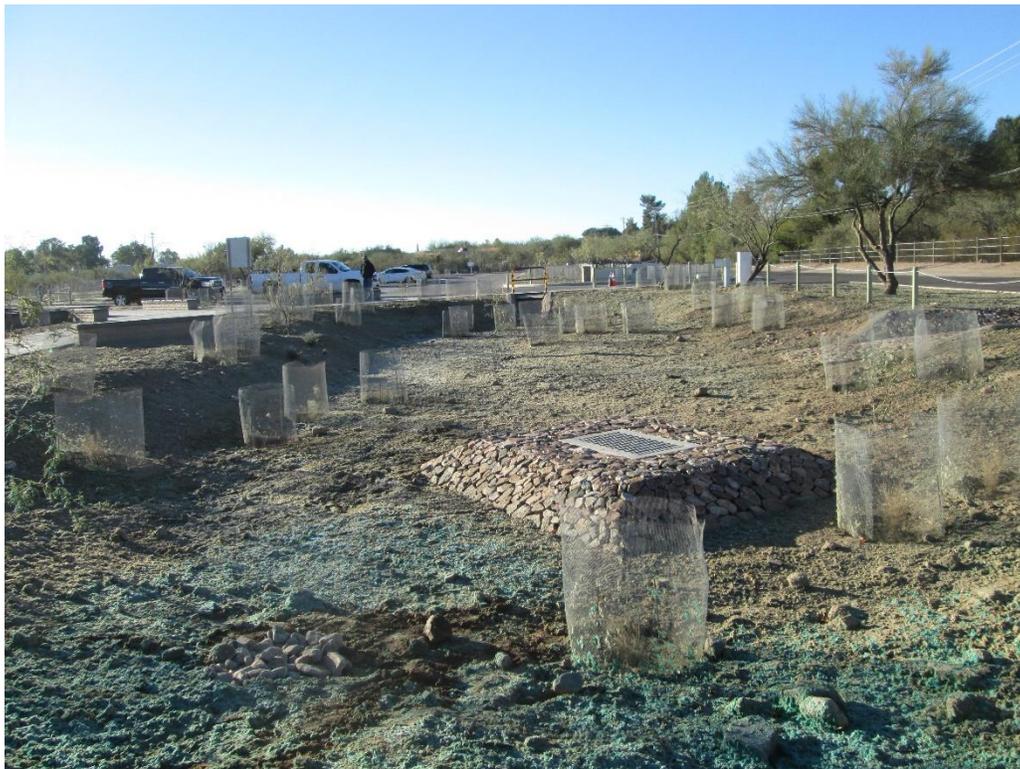
This larger storm water-harvesting basin collects more runoff. Like the smaller basin, water is only permitted to remain for a couple of days.

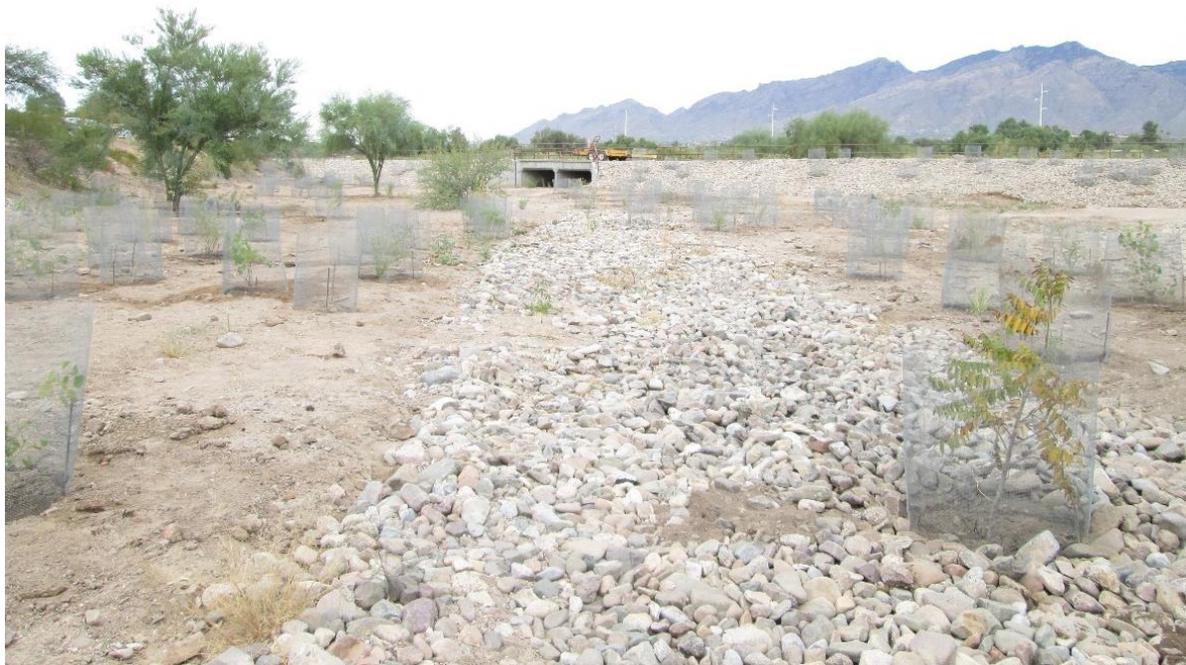
Bank protection and pathway create a berm to provide storm water harvesting.

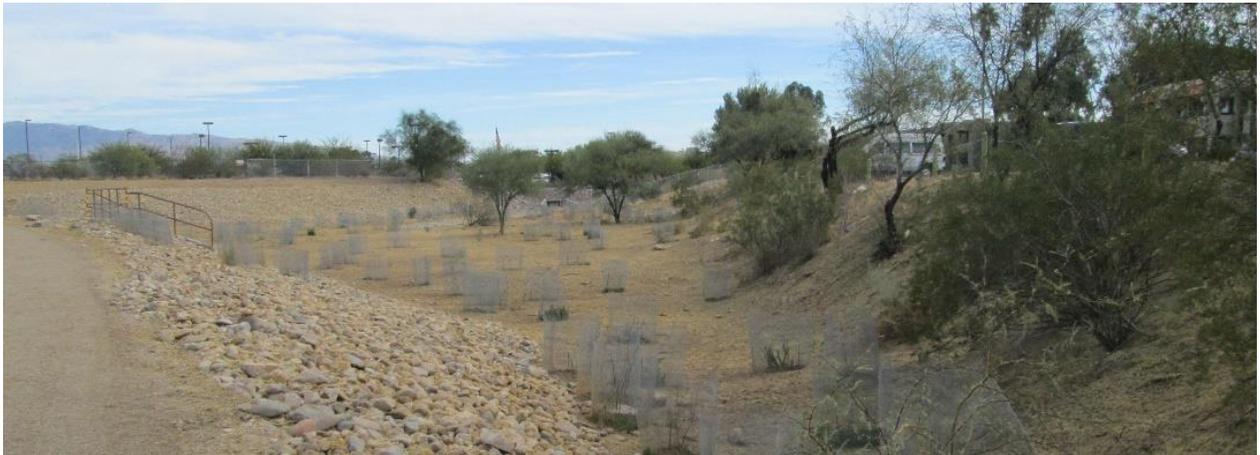
Additional native riparian trees and bushes are planted as part of the ecosystem restoration of this water rich area. Reject cobbles from the soil cement plant reduce potential for erosion by slowing the velocity of the storm-water and spreading the storm-water over a broader area of the main channel from Costco.

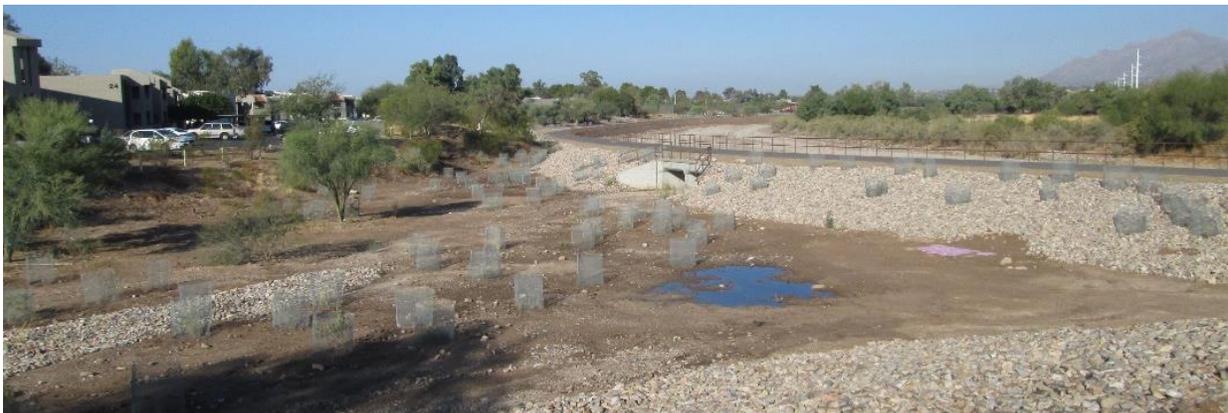
Completed basin with slope stabilization and a special hydro-seed containing selected native grasses, flowers and shrubs that grow in a wet riparian ecosystem.

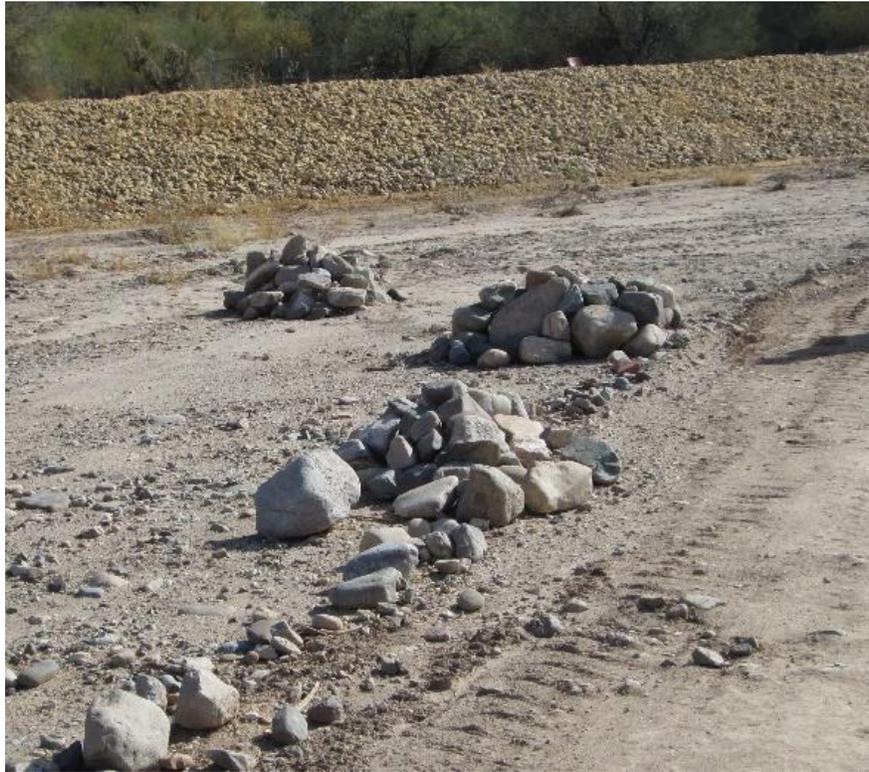
Slopes are stabilized with reject cobbles from the soil cement plant, and hydro-seed is sprayed to provide future slope stability and ecosystem plants.
