Pantano Wash Bank Protection and River Park: Craycroft Road to Tanque Verde Road Project

October 2016 to January 2017

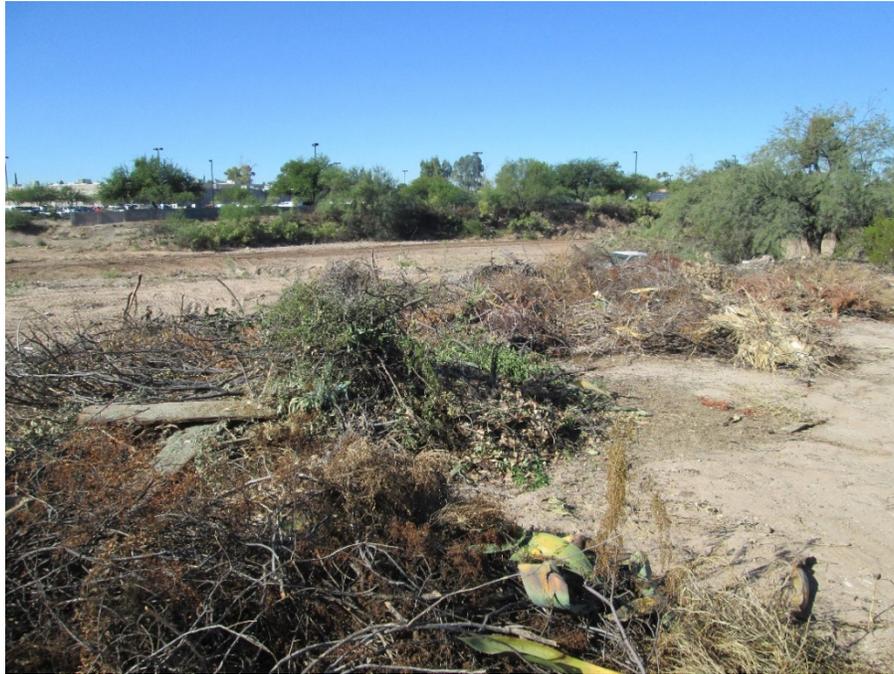
Photo 1 – Construction begins with the removal and cutting down of brush.

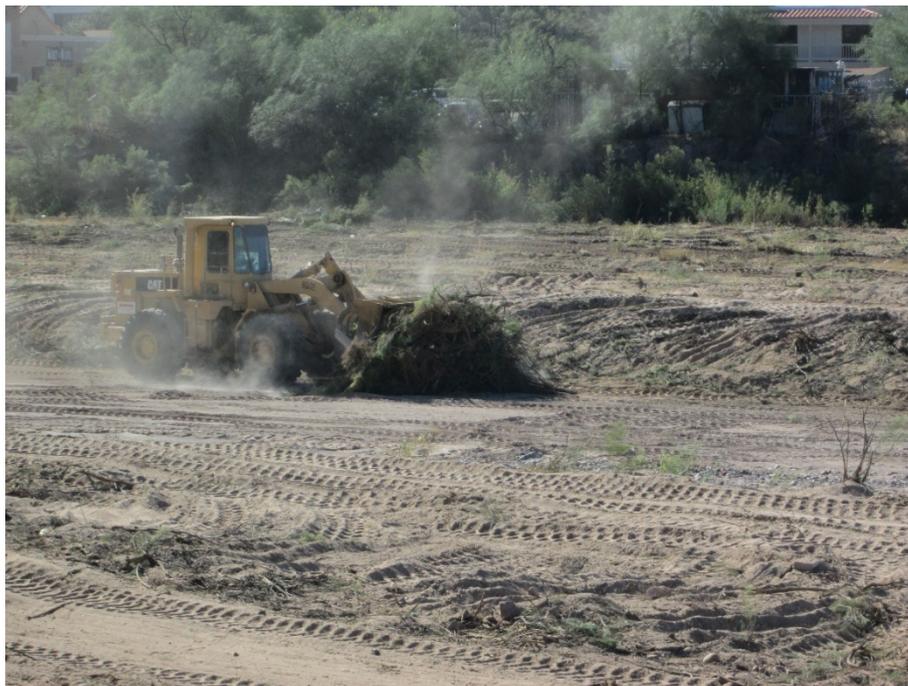
Photo 2 – The brush is then gather for disposal.

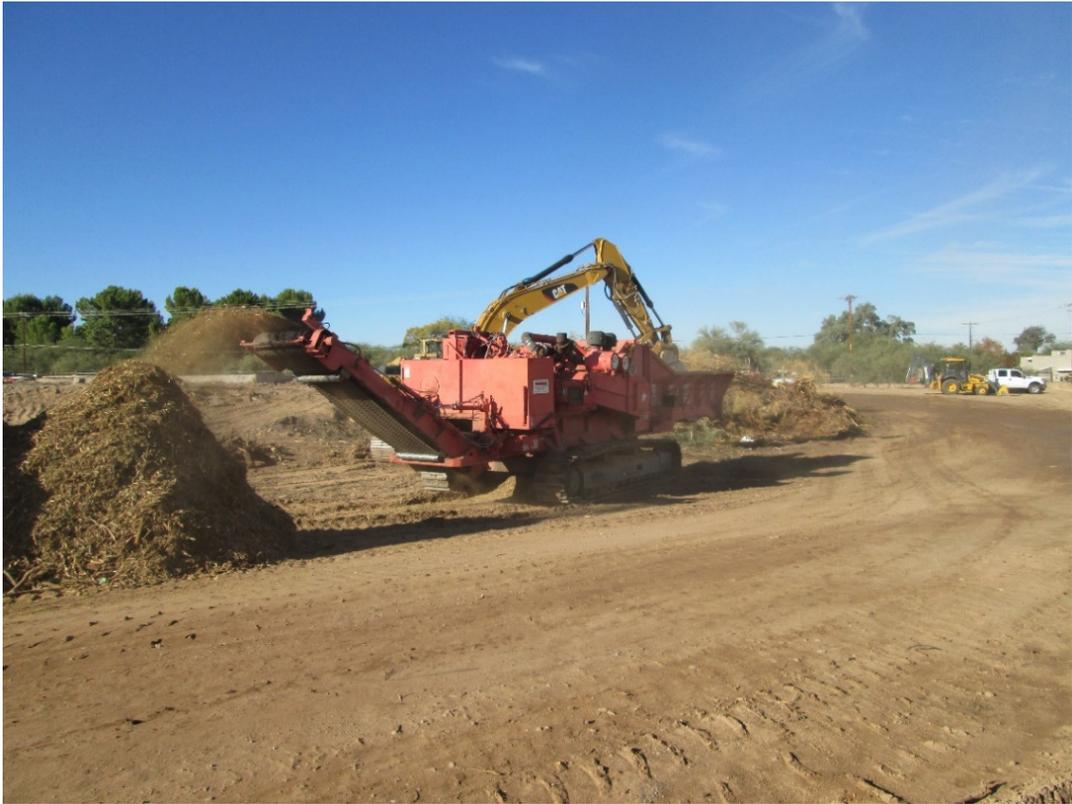
Photo 3 – The chipper grinds the brush into a mulch that maybe used as a soil cover for plants or composted.

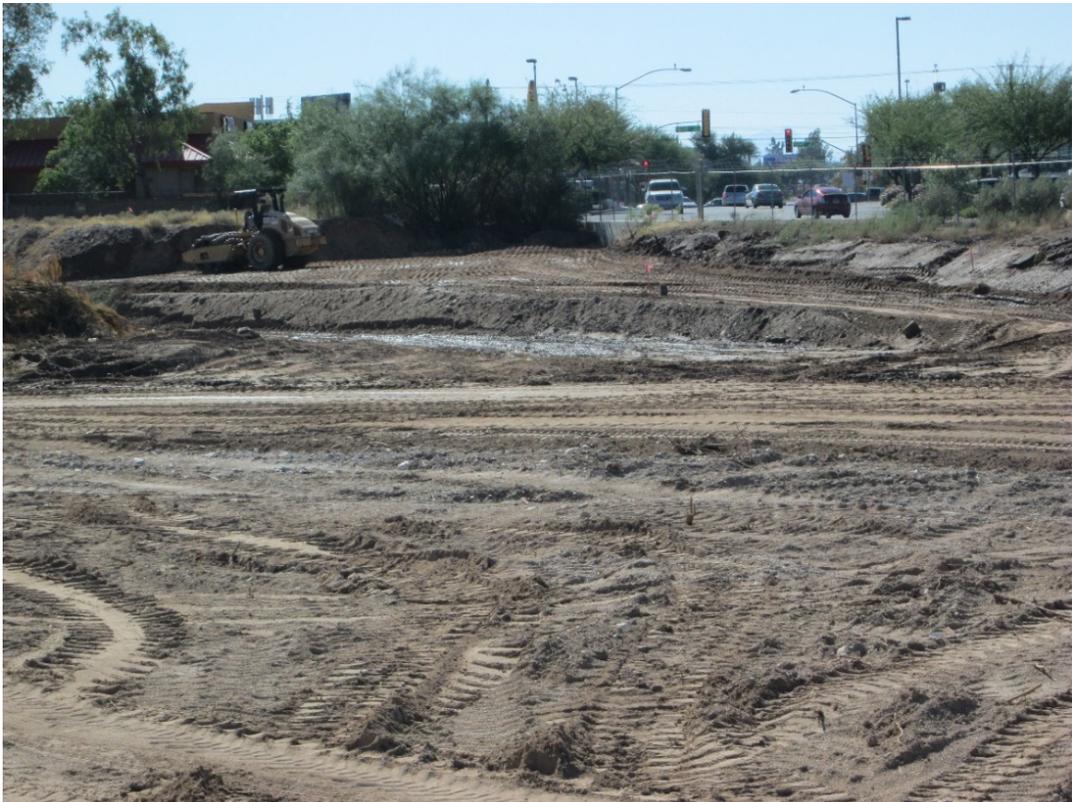
Photo 4 – The banks backfilled and shaped to create the channel.

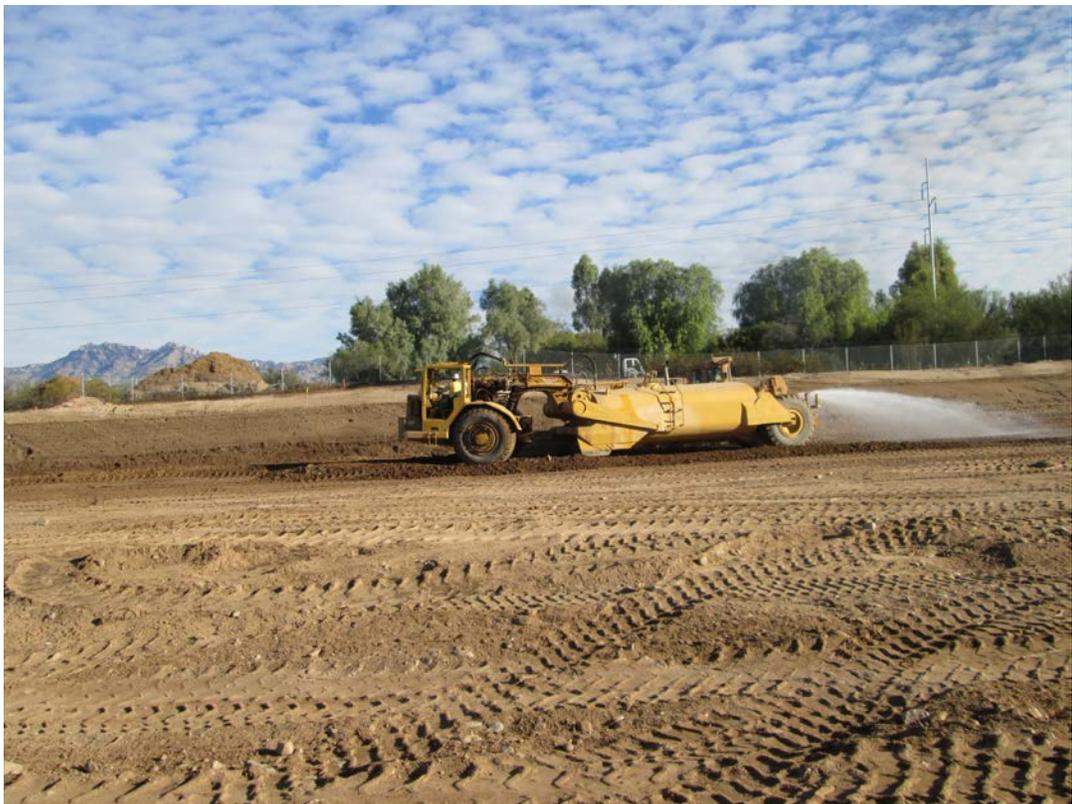
Photo 6 – Dust is control by regularly applying water to haul roads and exposed dirt surfaces.

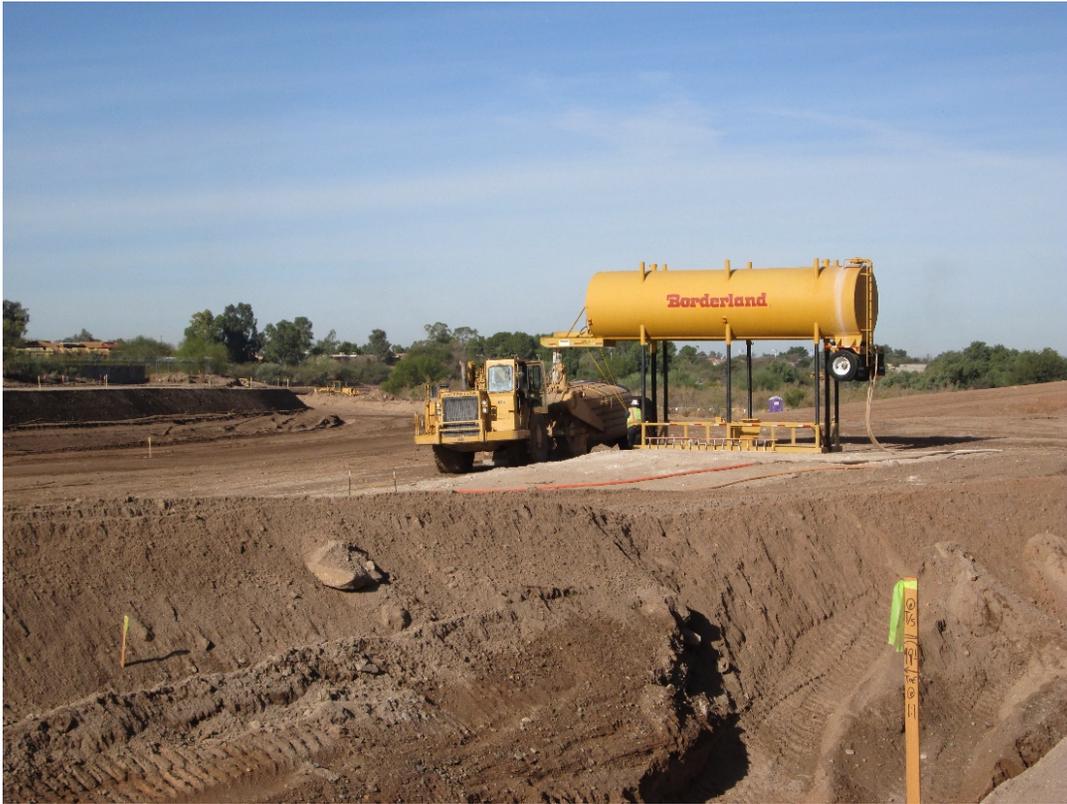
Photo 7 – Construction water storage tank.

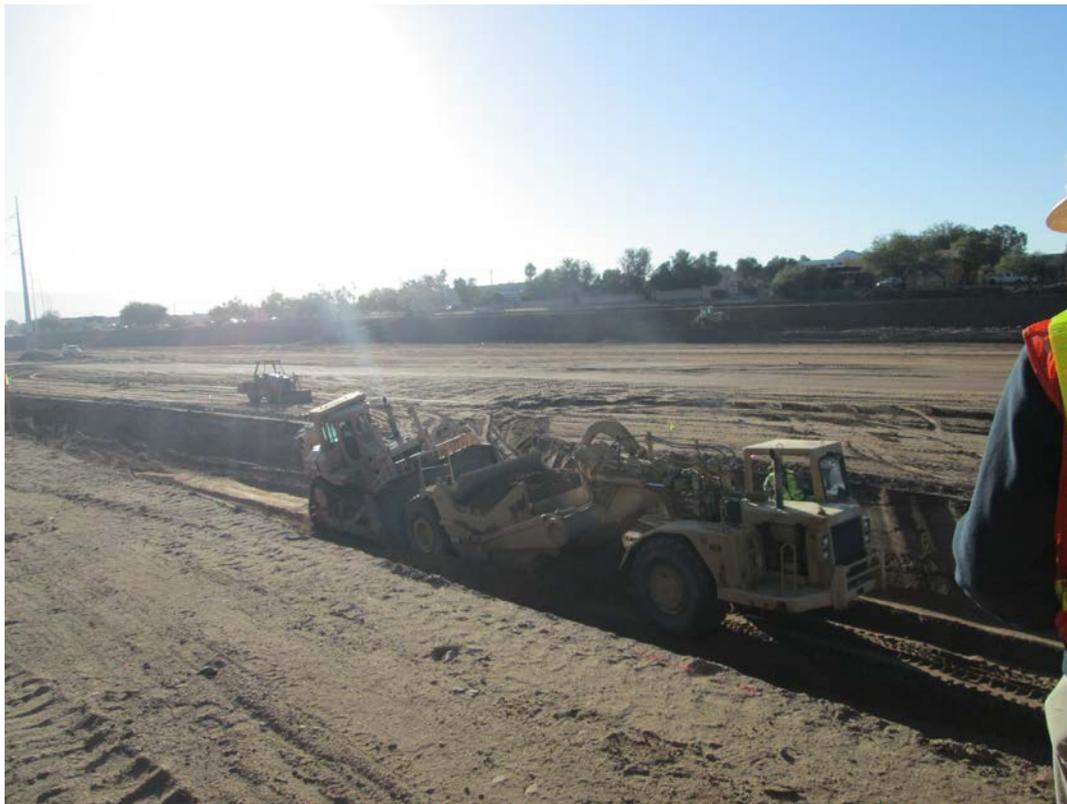
Photo 8 – Dozer assist the loading of a scraper by pushing the scraper. The scraper then haul the dirt to it final location.

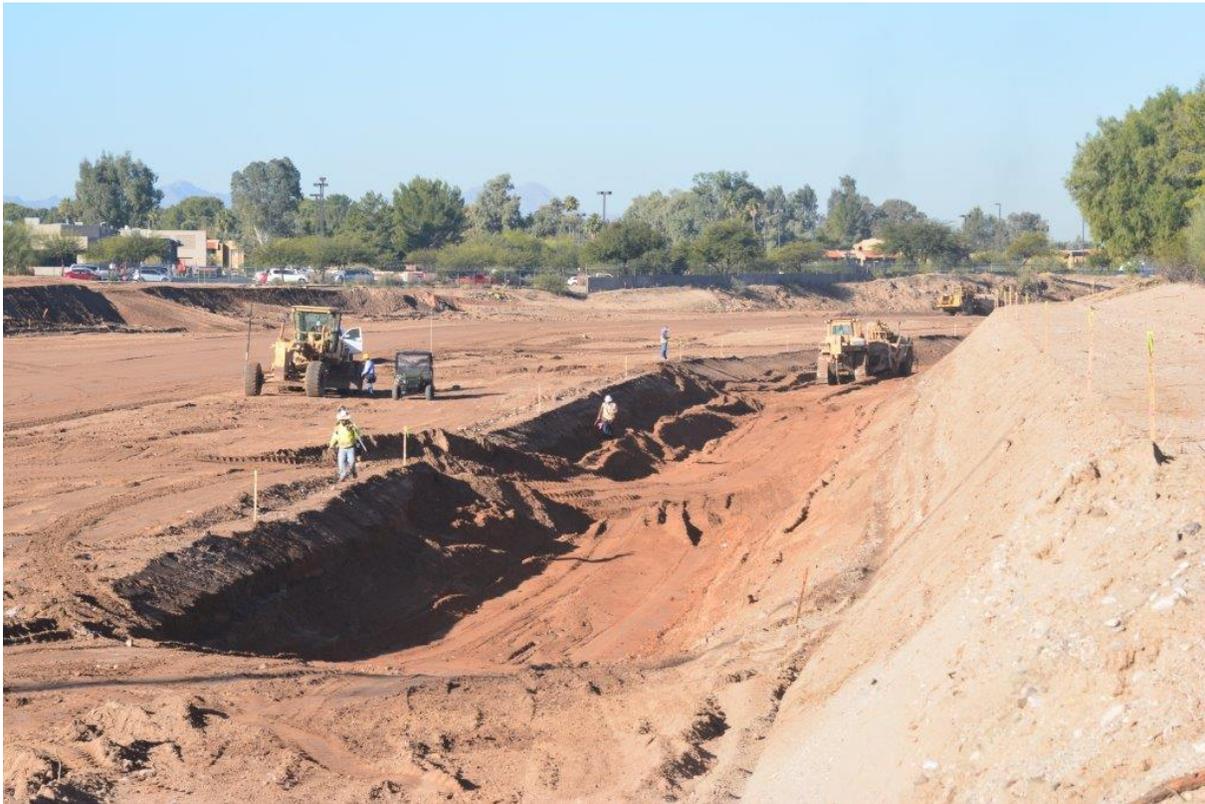
Photo 9 – Beginning the trench at the base of the bank for soil cement toedown.

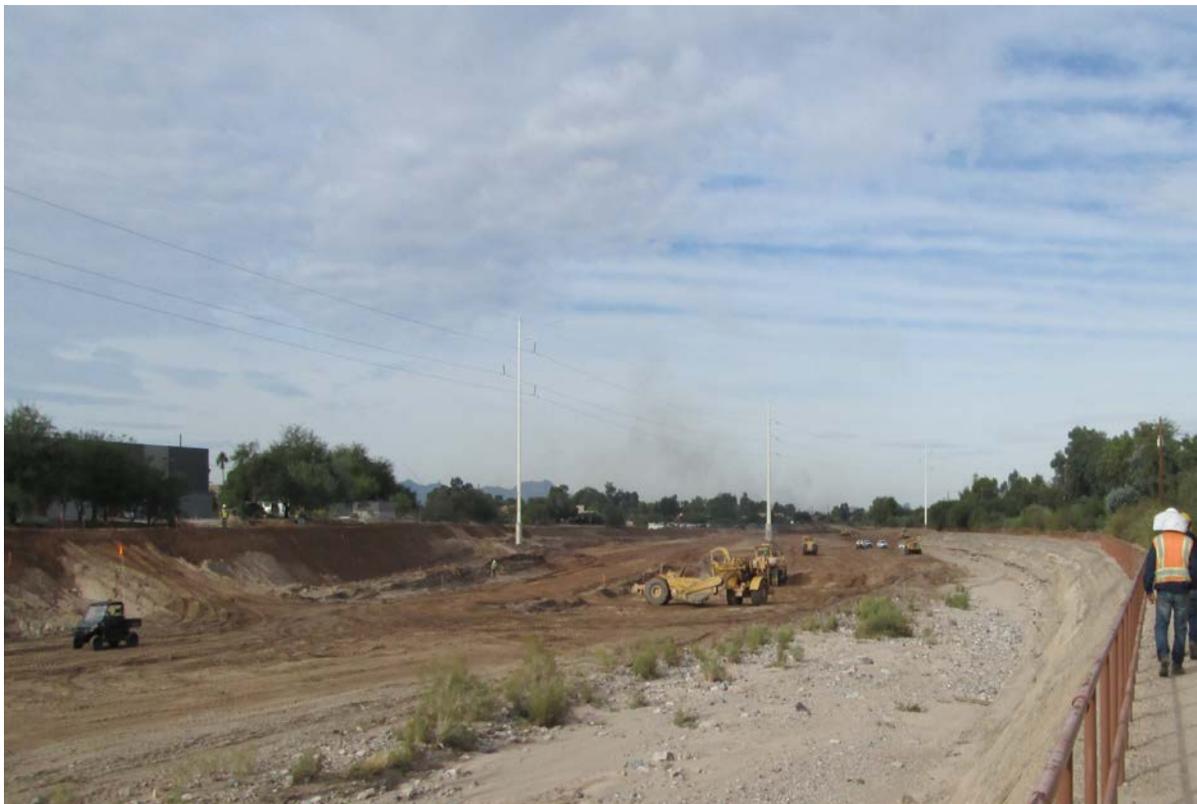
Photo 10 – Excavating the channel; sand and gravels from the channel are stockpiled for making soil cement.

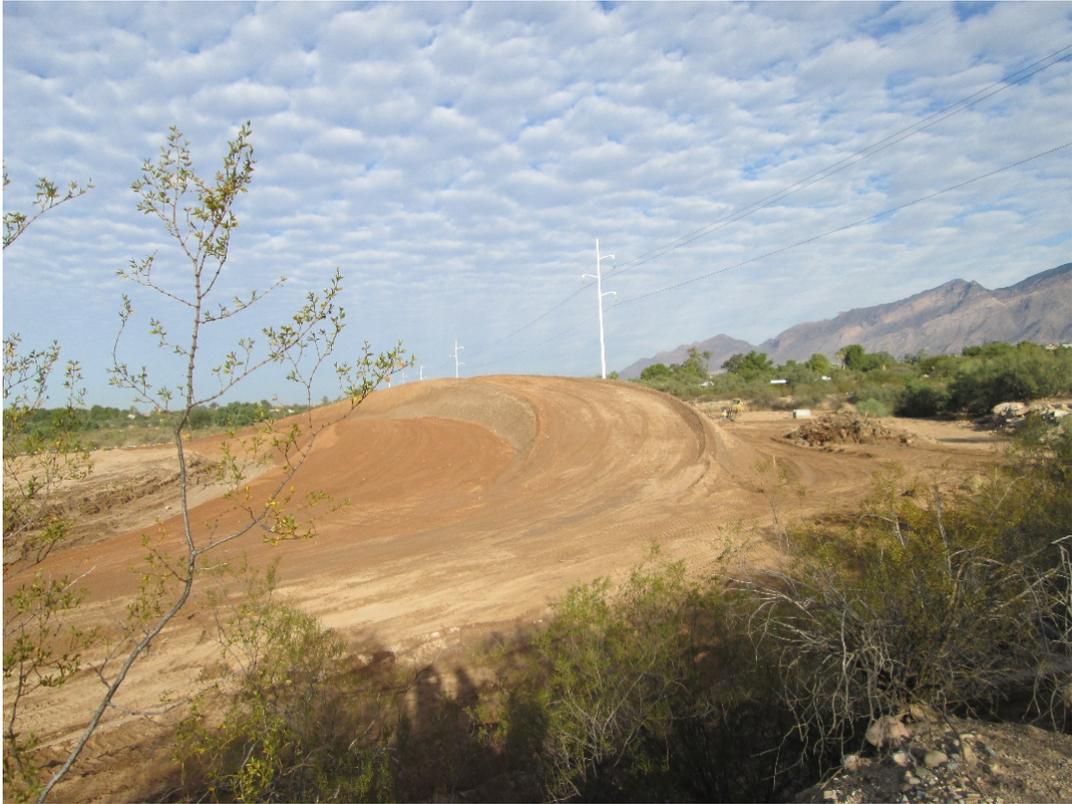
Photo 11 – Stockpile of channel material/ aggregate for soil cement

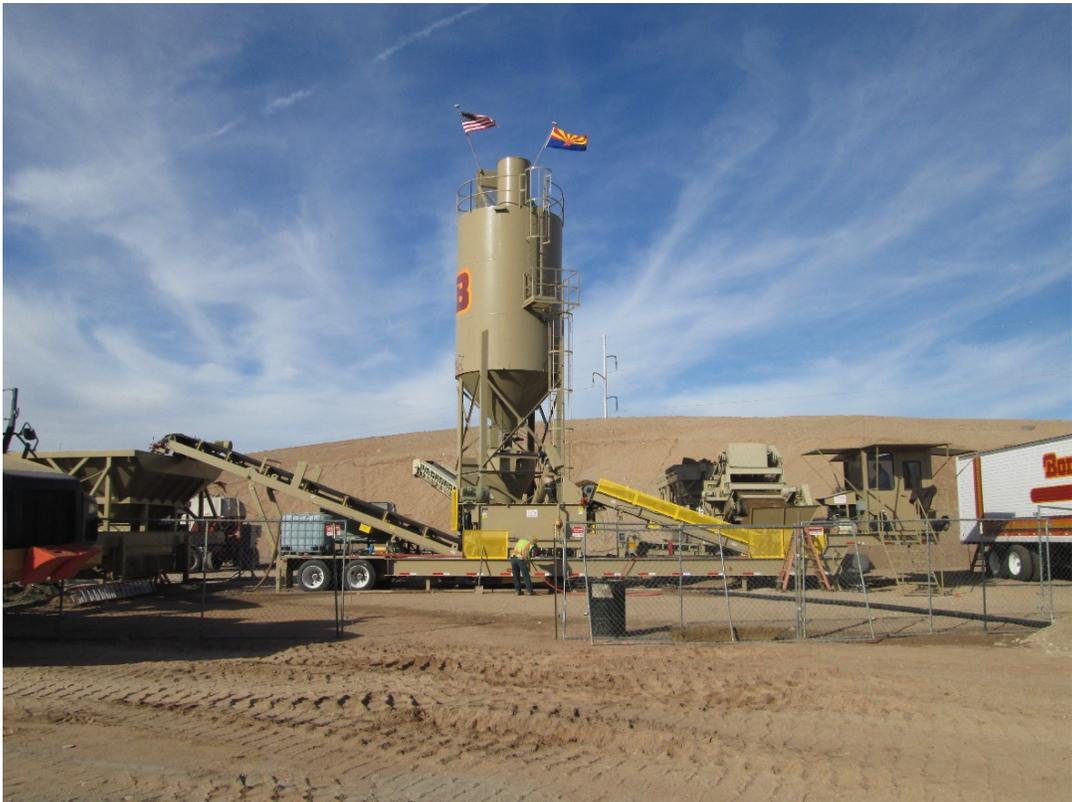
Photo 12 – Soil Cement batch plant

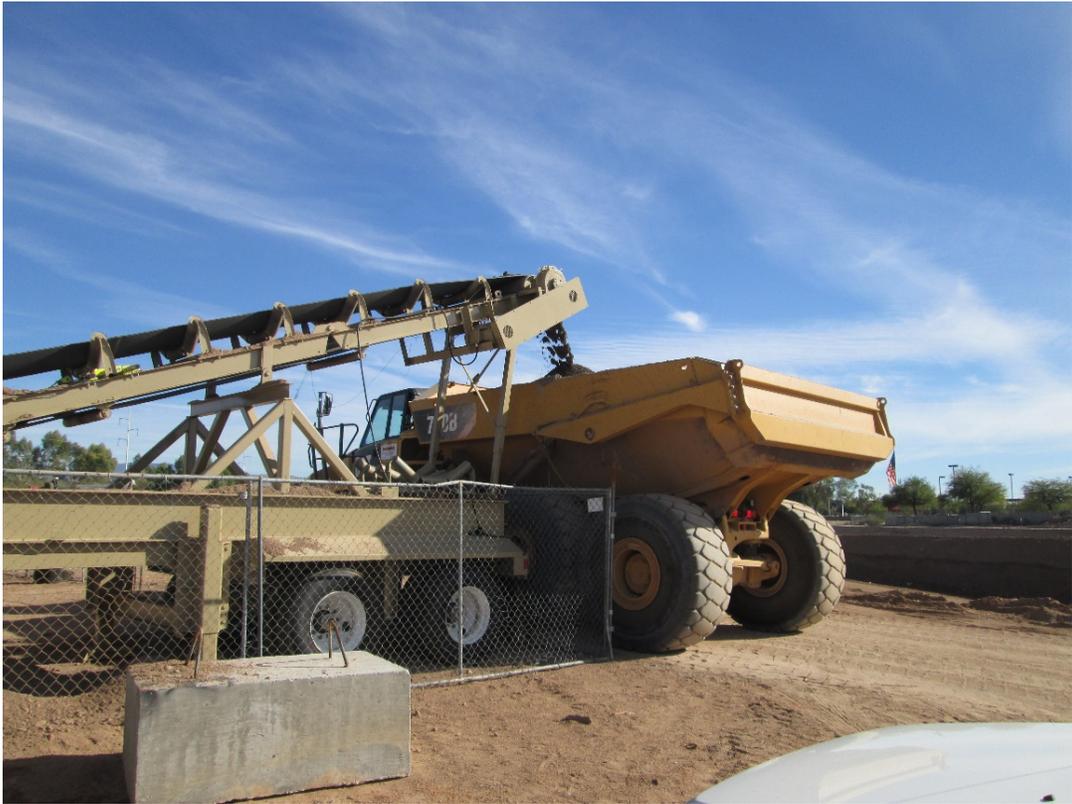
Photo 13 – Loading soil cement into a truck.

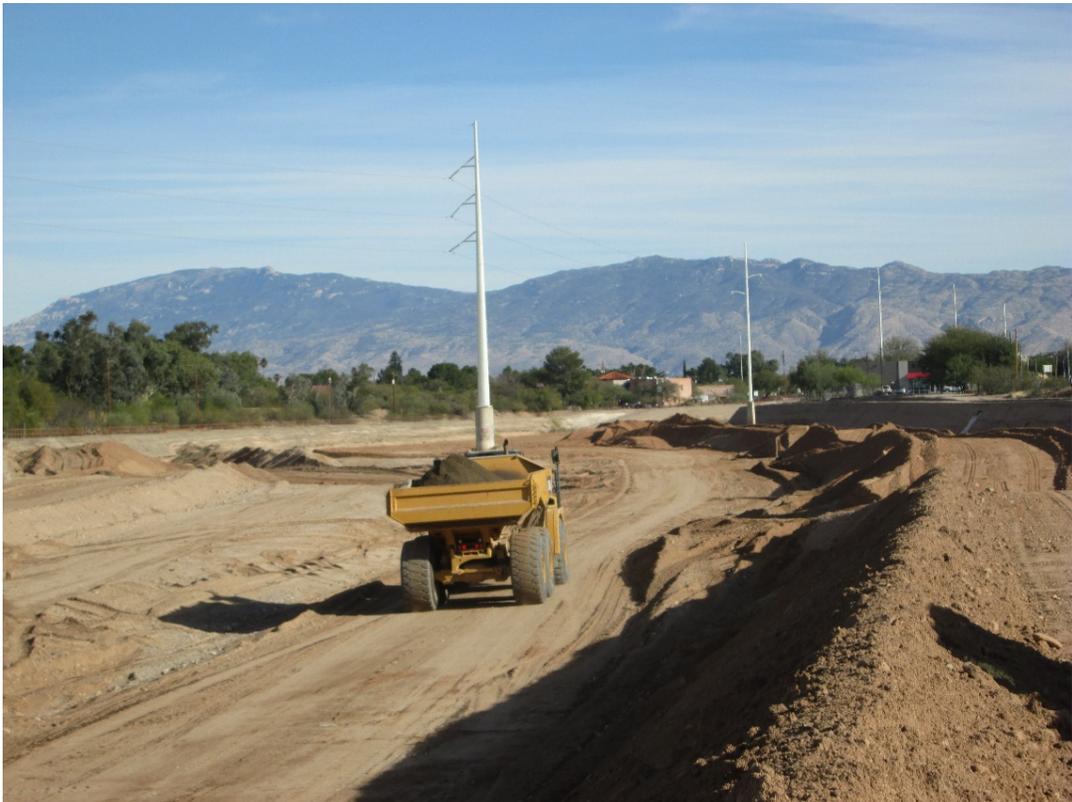
Photo 14 – Hauling soil cement to be place as bank protection.

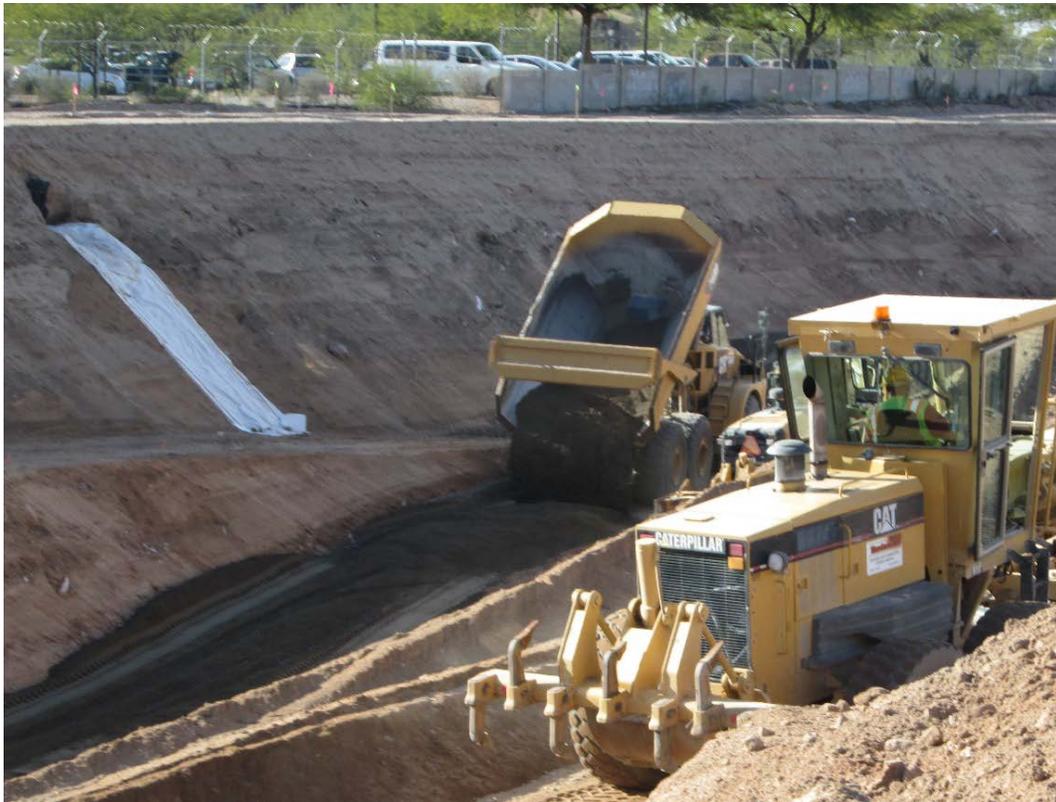
Photo 16 – Truck delivering and spreading soil cement for bank protection

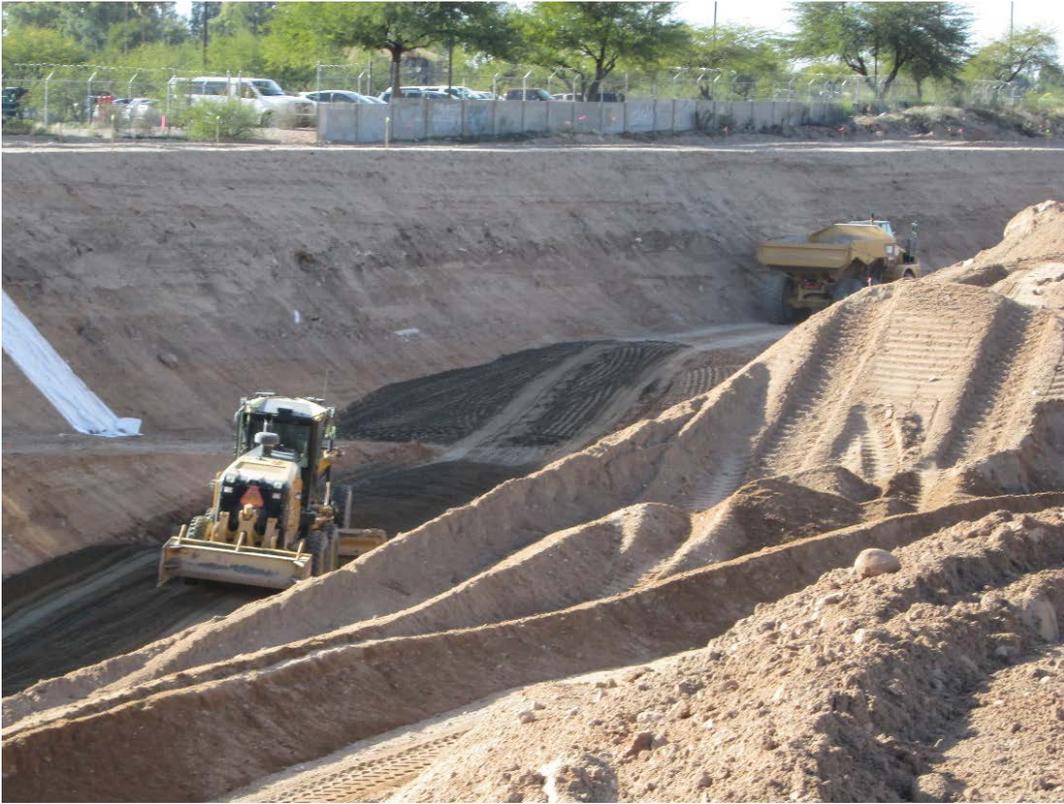
Photo 17 – Grader levels soil cement into a lift or layer.

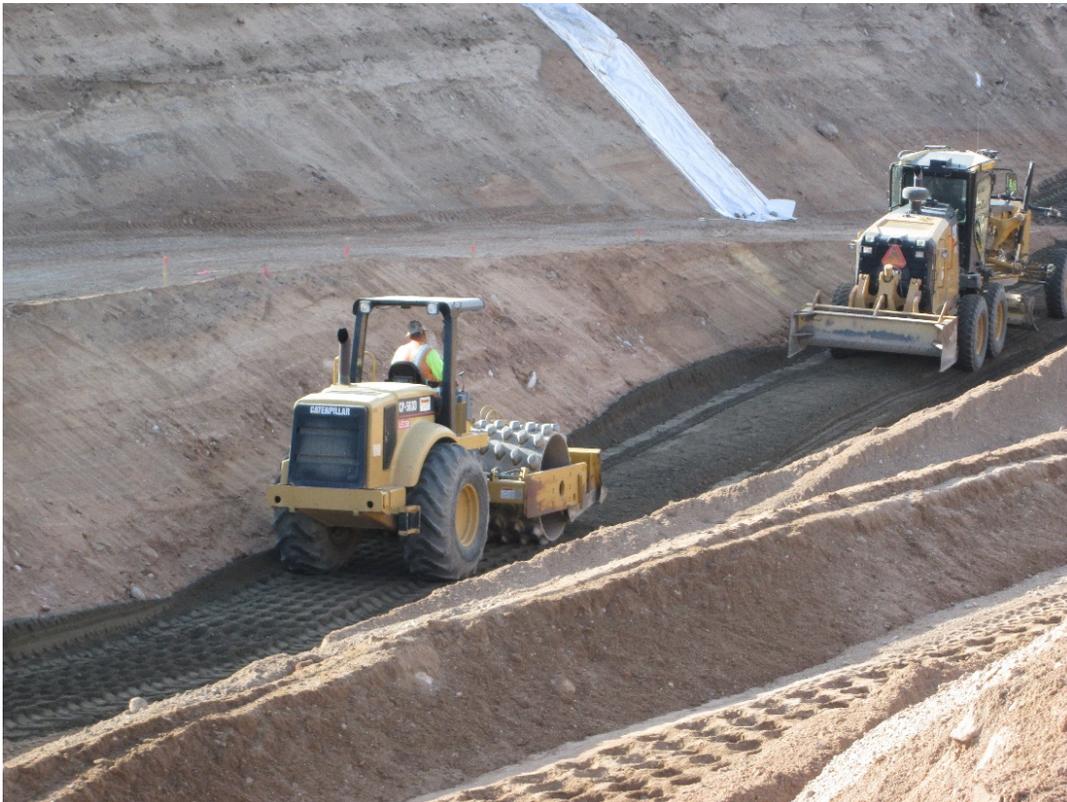
Photo 18 – Compacting of soil cement to create bank protection.

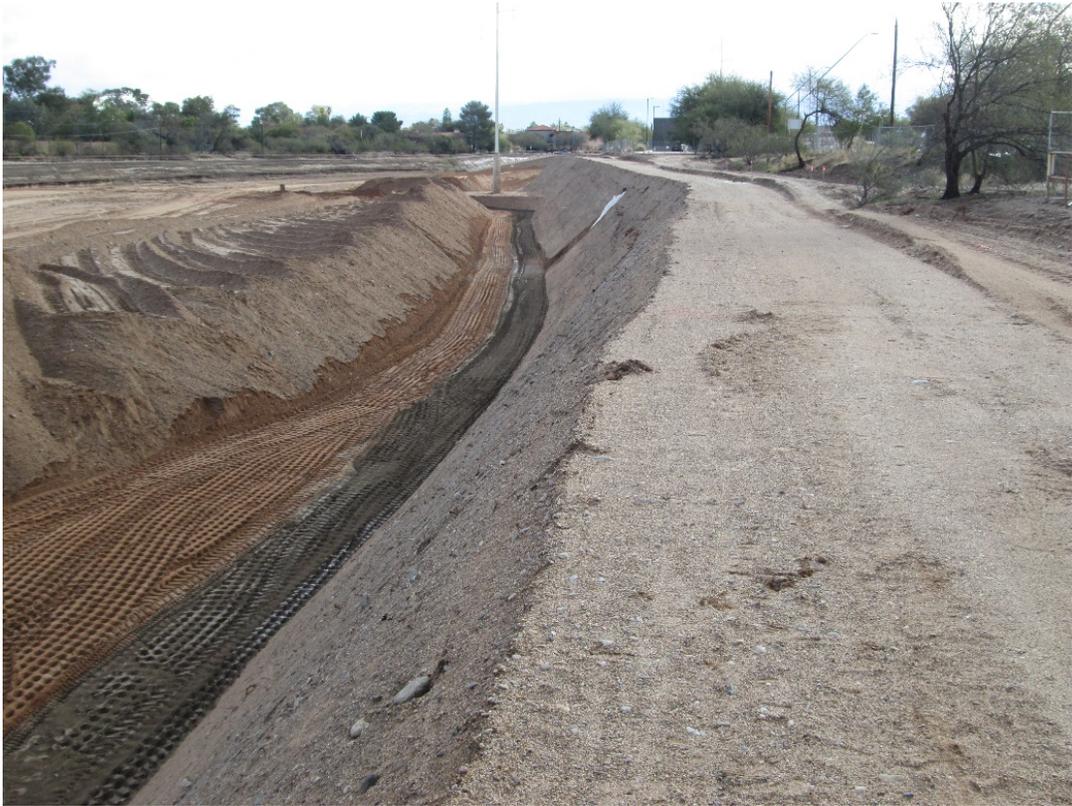
Photo 19 – Soil cement bank protection curing and hardening.
