**US Army Corps  
of Engineers  
Los Angeles District**

**Santa Cruz River, Paseo de las Iglesias  
Pima County, Arizona  
Draft Feasibility Report**

**July 2004**

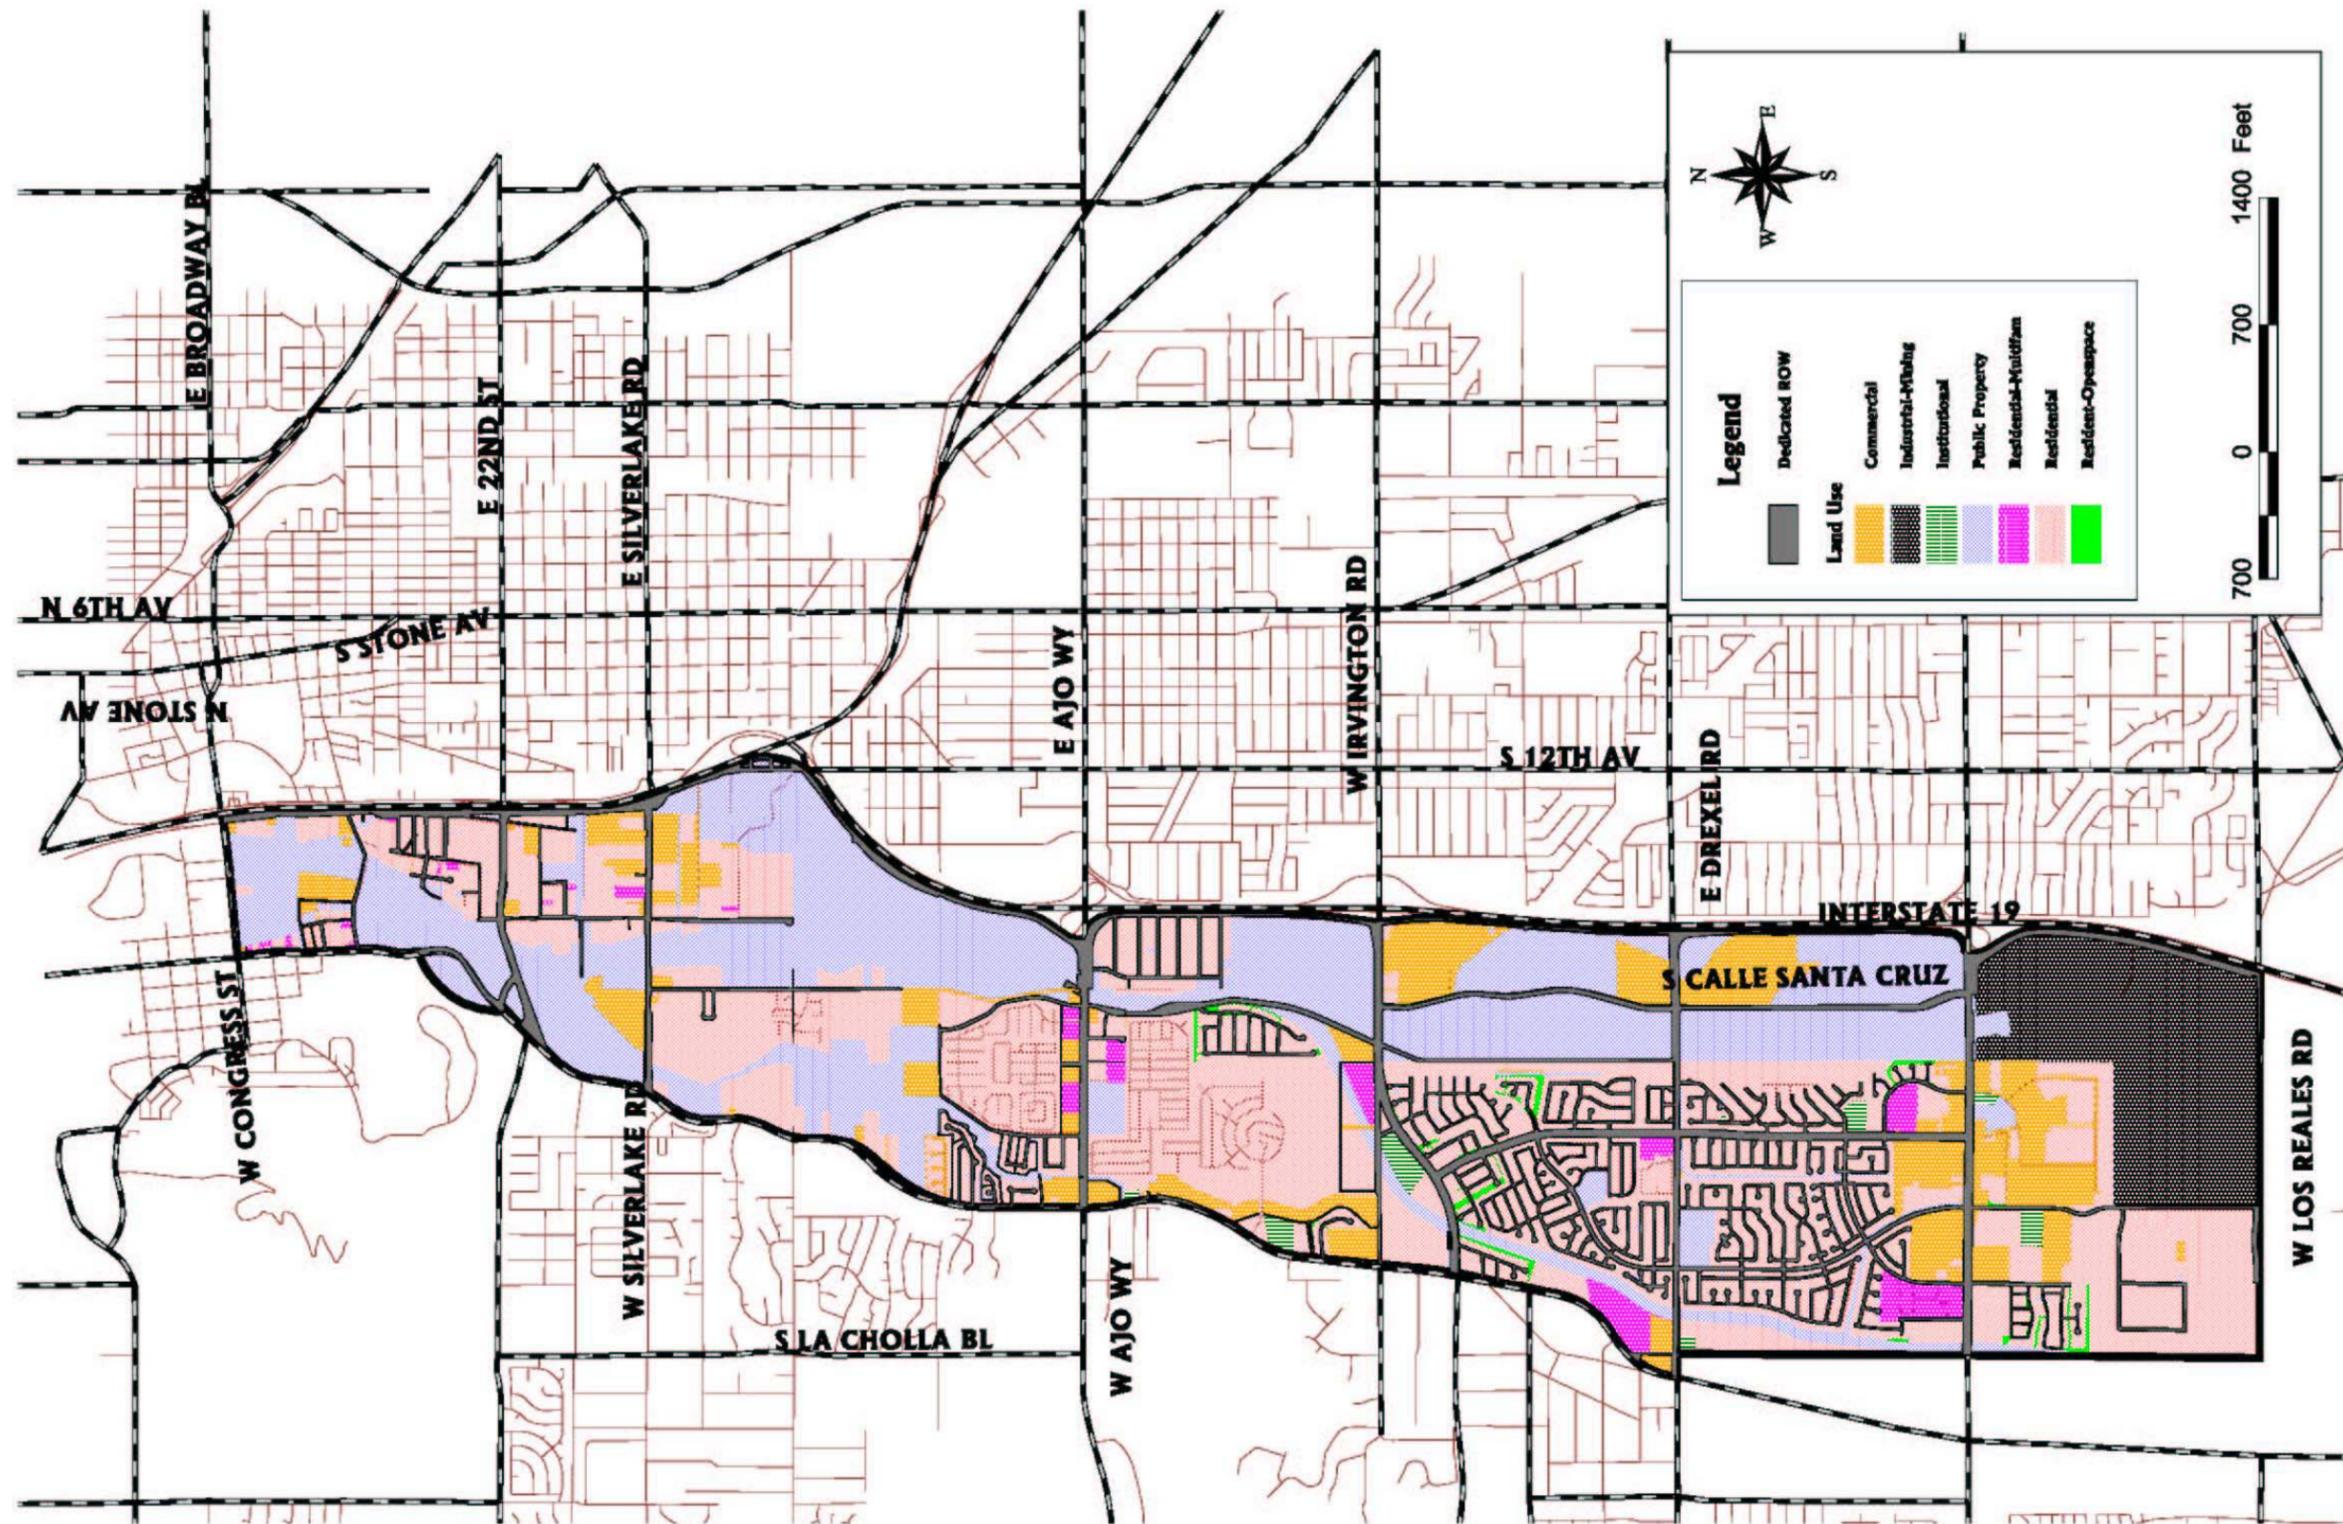
**FIGURE 2.2 Land Use**

<b>Land Use</b>	<b>Acres</b>
Residential – Single Family	1,975
Residential- Multiple Family	87
Residential – Open Space	20
Commercial	483
Industrial	385
Public	1,456
Dedicated Rights-Of-Way	567
Intitutional (Schools, Churches)	32
<b>TOTAL</b>	<b>5,005</b>

Over one-quarter of the study area (1,456 acres) is publicly owned with the majority of public acreage being held by the City of Tucson. The areas adjoining the study area have surrounding land use that is predominantly residential and commercial with some manufacturing or light industrial use. Construction activities associated with a selected alternative would occur mostly within the river floodplain and its tributary floodplains. Within the entire City of Tucson, approximately 30 percent (or 79 square miles) of the land area is vacant.

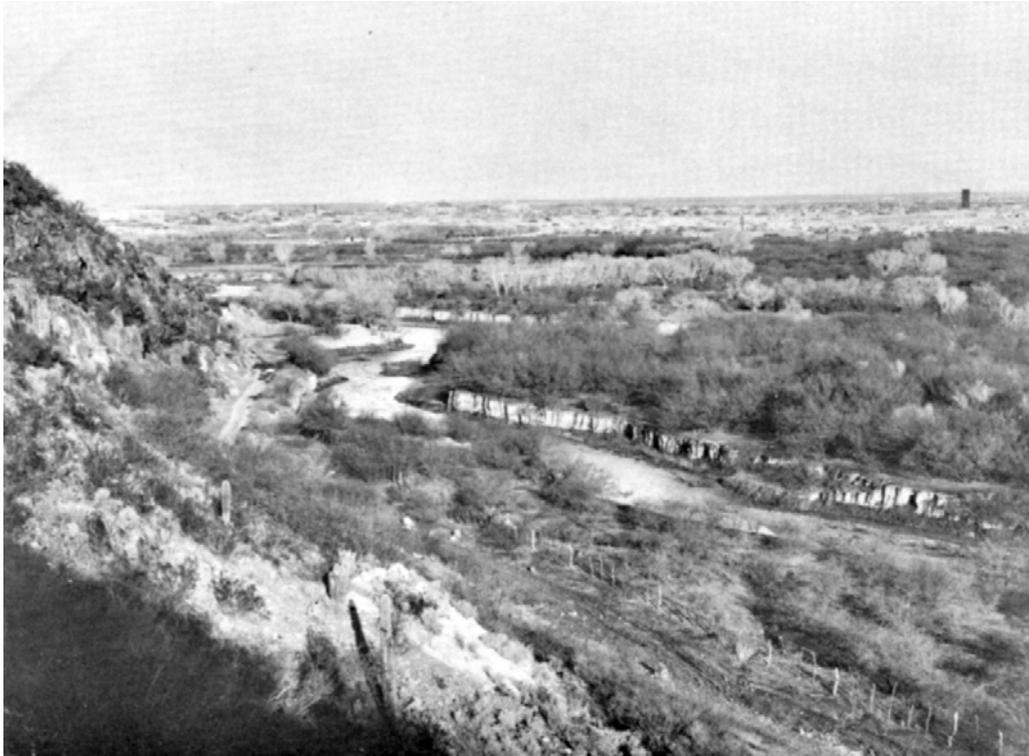
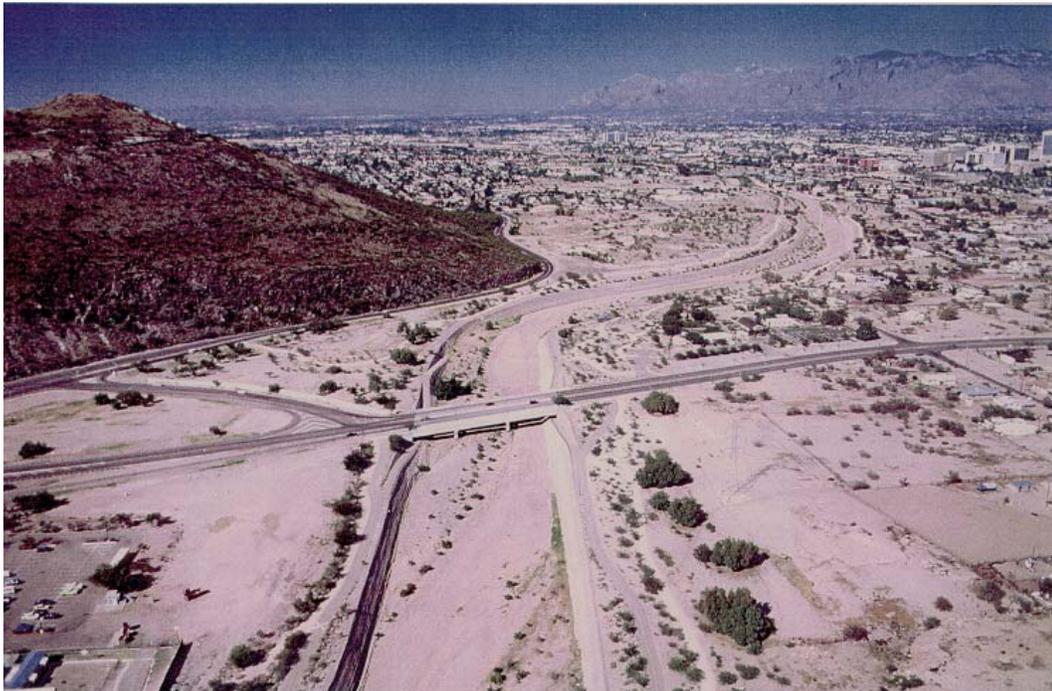
***FIGURE 4.1 Comparison of Historic and Present Conditions***

Confluence of the West Branch and the Santa Cruz River from Sentinel Peak, 1904  
(Arizona Historical Society, Tucson)

The same area as it appears in a contemporary photograph

Discontinuous arroyos existed 6 to 12 miles upstream of Tucson as early as 1849 but photos of the Santa Cruz River near Sentinel Peak from the early and late 20<sup>th</sup> Century provide an illustration of how historic habitat conditions have changed (Figure 4.1). As the end of the 19<sup>th</sup> century approached, a series of occurrences in Tucson dramatically accelerated the transition of the Santa Cruz River valley, particularly in the study area, into an arid landscape. In 1887, entrepreneur Sam Hughes excavated a ditch to tap near-surface flows in the vicinity of the St. Mary's Road crossing of the Santa Cruz River to provide water for irrigation of cultivated lands north of St. Mary's Road. Severe flooding occurred along the Santa Cruz River in July and August of 1890, following a period of severe drought. The flood breached the dams and eroded lakes. During one of the August floods, Sam Hughes' new ditch served as the starting point for an upstream erosion (head cut) that retreated for a time at the rate of about 100 feet per hour toward Congress Street. Subsequent events extended the erosion. By 1910, the resulting arroyo had coalesced with a gully at Valencia Road that continued to Martinez Hill. During the 1914-1915 floods, the arroyo eroded to a point several kilometers south of Martinez Hill on the Indian Reservation (Betancourt and Turner 1985).

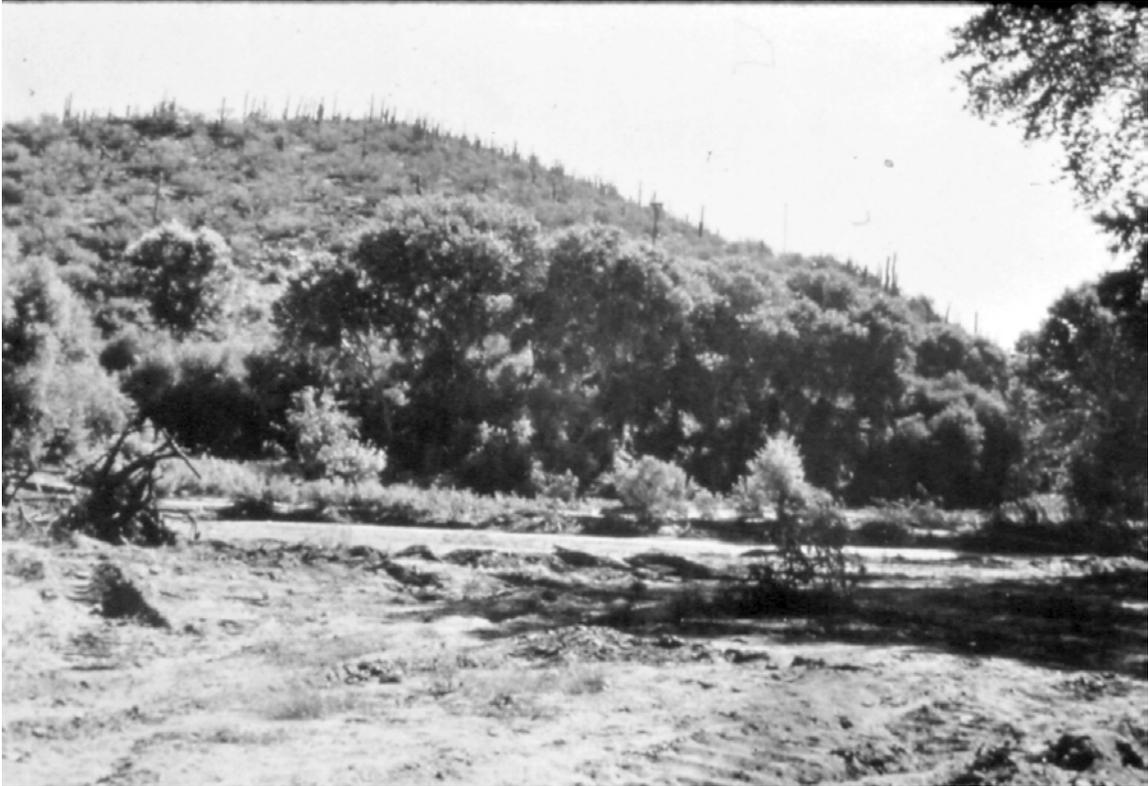
***FIGURE 4.2 Historic Conditions***

Cottonwoods persisted at the base of Martinez Hill near San Xavier in the 1940s  
(Arizona Historical Society, Tucson)

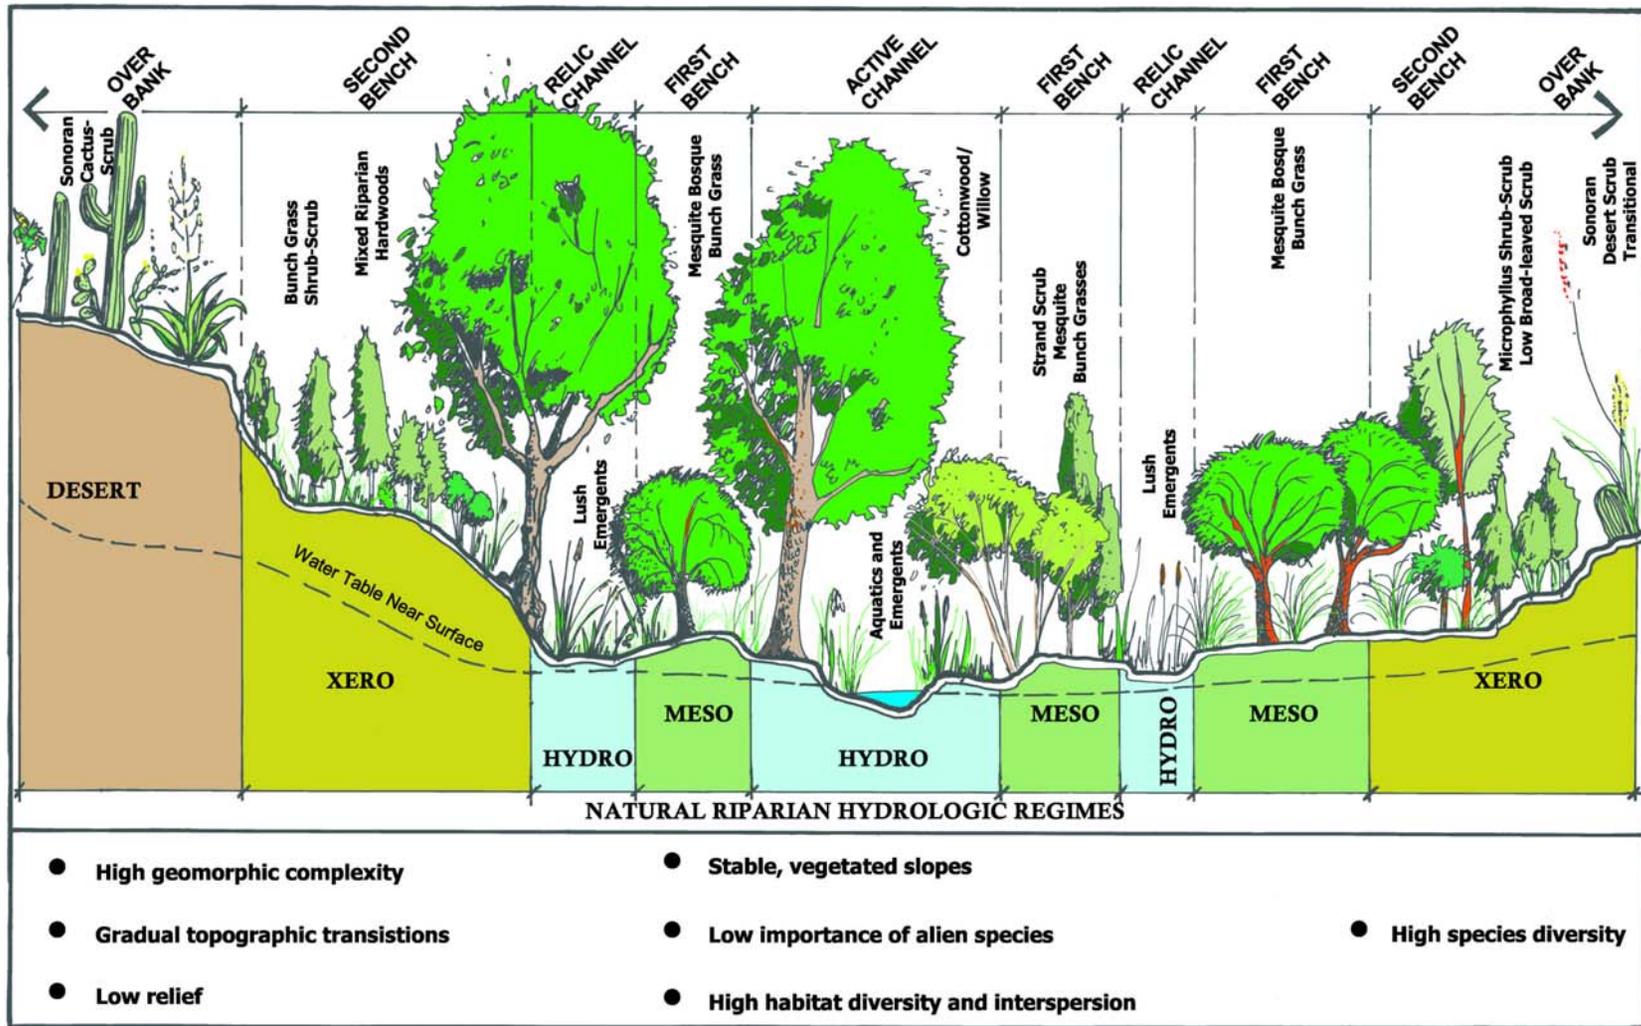
*FIGURE 4.3 Natural Sonoran Riparian System*

Mesoriparian regime. This portion of the channel cross-section occurs on first benches and terraces located above ordinary channel flow levels, to as much as 1-4 feet above, depending on soil grain size and local drainage patterns. Water is provided by direct precipitation, local runoff and relatively frequent flooding. These areas are not exposed to normal channel flow waters but may be inundated or saturated several times each year to as much as every two years by flood events. Groundwater contributes to water presence in this zone by way of soil capillarity and deep roots. Dominant plants occurring include cottonwood-willow mixtures, mesquite, perennial bunchgrasses, such as sacaton, and medium shrubs adapted to floodway disruption, such as burrobrush. Overall, vegetation density is moderate to high. Species diversity is typically high due to the relatively steep gradient in available moisture across this zone. Soil evaporation is typically low due to relatively dense shading.

Xeroriparian regime. This zone is found on secondary terraces, generally above the elevation of the two-year recurrence interval storm, extending upward to the periphery of the ten-year storm floodway (and higher). Available moisture in this zone always exceeds surrounding desert and includes sources of direct precipitation, lateral overland flow from uplands and occasional flood inundation. Groundwater may be important to only the more deep-rooted trees and shrubs. Vegetation density may range from high to low depending on position relative to actual water concentration potential, but is lowest on average for all the riparian zones. Species diversity is moderate to high. Typical vegetation is the mesquite bosque habitat; although various brush or cactus-dominated communities may temporarily prevail due to flood or fire disruptions.

Natural riparian systems will display a high geomorphic complexity, relatively low absolute topographic relief (each rising zone being broader and flatter than the previous) and high soil stability due to higher maintained vegetation densities. In a relatively undisturbed landscape, riparian change occurs gradually, almost imperceptibly in human temporal references, and at a scale amenable to biological processes. A point bar will change its orientation, a bank will slough or a back channel will fill with sediment. These newly altered areas, exposed to a continual rain of propagules (seeds) from surrounding vigorous populations, will be quickly re-colonized by species adapted for the conditions. The catastrophic changes that have occurred in the riparian zone and particularly in the landscape surrounding the Paseo de las Iglesias reach of the Santa Cruz River have resulted in a very different riparian condition than that occurring under the natural circumstances.

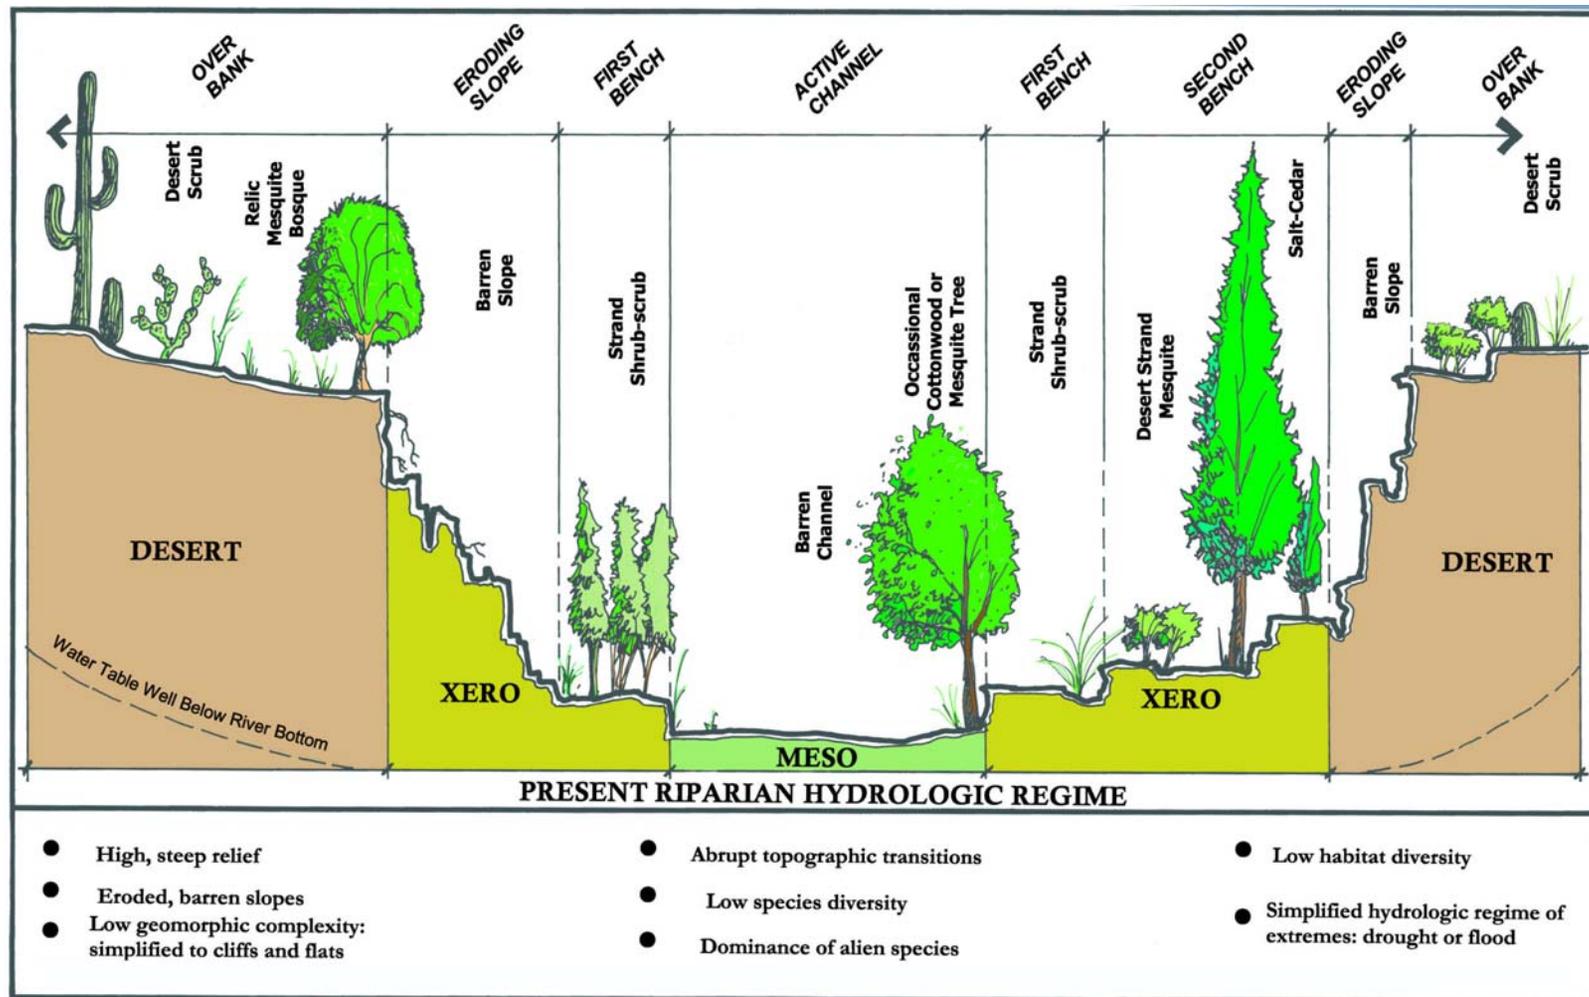
**FIGURE 4.4 Degraded Santa Cruz Riparian System**

The Santa Cruz channel is now a 10 to 40 foot deep, usually desiccated erosional scar, with frequently steep, near vertical and unstable banks through much of the Paseo de las Iglesias reach. Figure 4.4 entitled, "Degraded Santa Cruz River Riparian System", is designed to both depict present typical conditions and contrast with Figure 4.3. Natural geomorphic complexity has been replaced by a simplified set of parallel flat terraces separated by steep banks. The highest flat, formerly the xeroriparian mesquite bosque that was topographically disconnected from the Santa Cruz flooding regime by progressive head-cutting events, is a highly disrupted, nearly barren plain with a desert hydrogeomorphic regime. First and second terraces, formed since the occurrence of the major channel erosion events, may support a xeroriparian regime in many places, with occasional stands of the alien buffelgrass, invasive salt-cedars and native burro-brush. The channel bottom may support a mesoriparian regime; however, occasional flood flows tend to sweep out all vegetation, leaving only a dry sand bed that is highly suitable for off-road vehicle traffic. Biological resources within the study area are severely degraded. Continuous groundwater mining has dramatically lowered the area's groundwater table; the water table is over 100 feet below the riverbed. Surface water is rare, and occurs only following rainfall events or because of release of water by people.

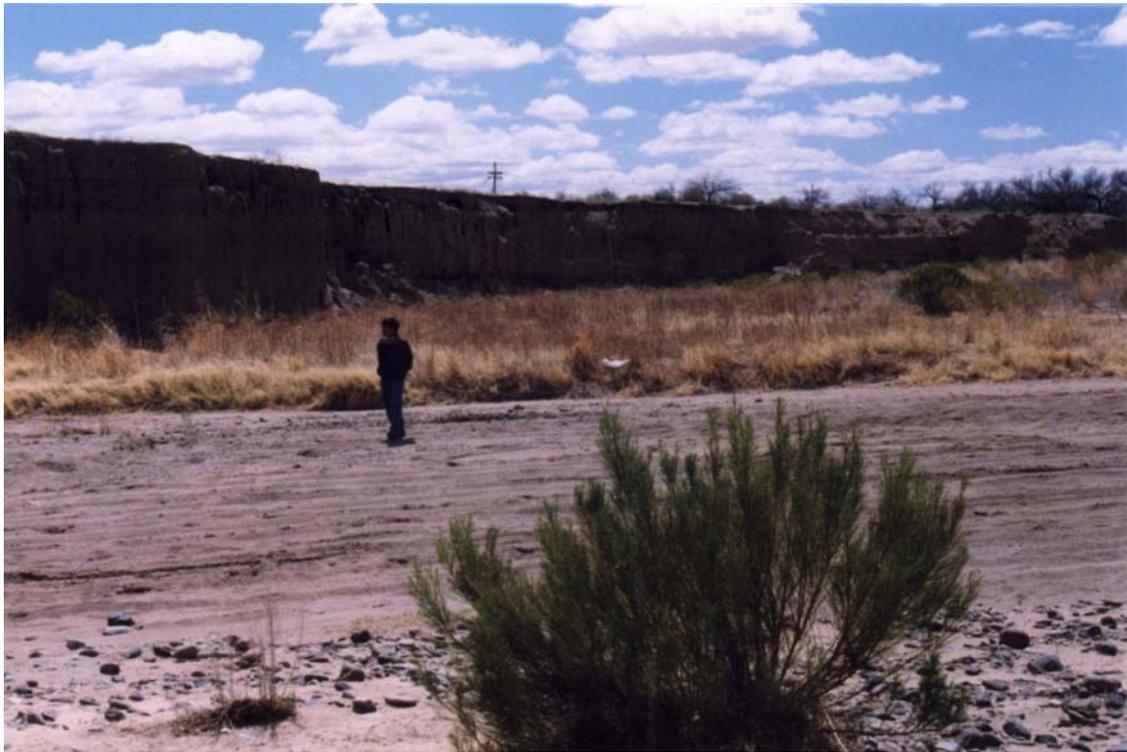
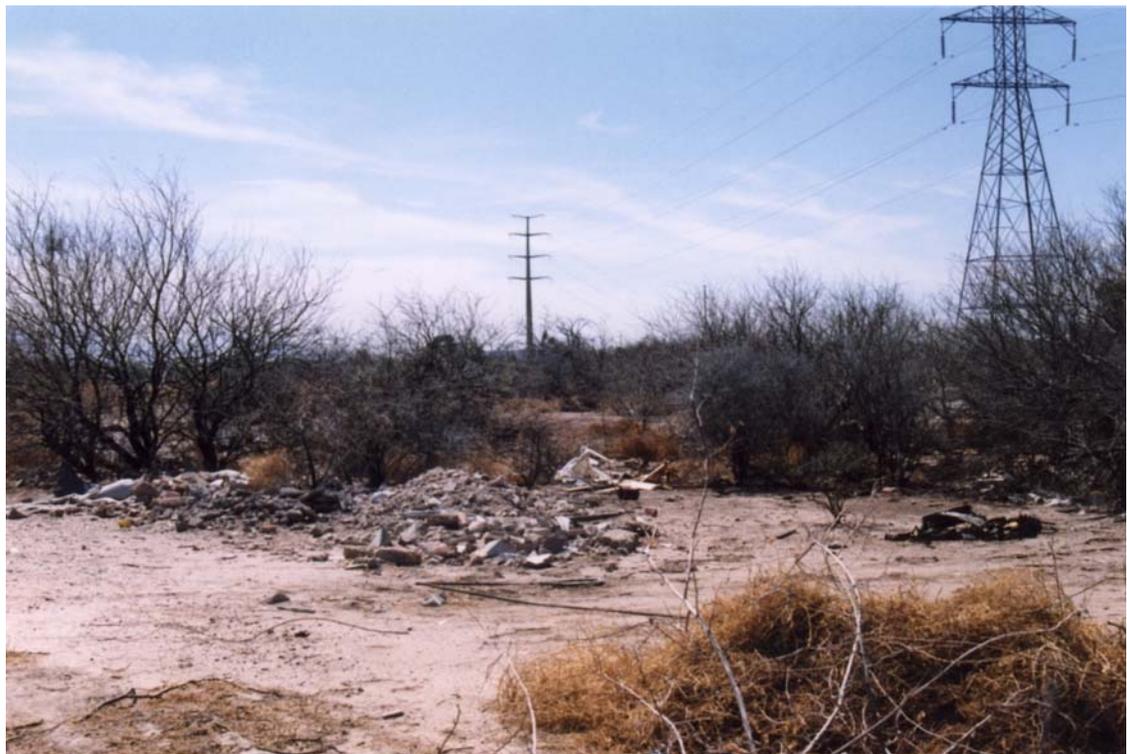
***FIGURE 4.5 Existing Conditions***

Note the nearly vertical banks in this unprotected reach south of Drexel

Debris left in channel north of Irvington

Currently, the study area consists primarily of urban and disturbed land on both sides of a frequently disturbed, deeply entrenched ephemeral riverbed (Figure 4.5 & 4.6). It is almost entirely isolated from natural vegetative communities by urban development and barren lands. Continuing disruptions in the former floodplain include chronic channel and overbank erosion, ongoing development, relict agricultural operations and landfills, off-road vehicle use, construction of soil cement lined banks, illegal dumping, and transient camps. The aquatic and riparian communities have vanished, and the mesquite bosques are represented only in diminished, isolated pockets of stunted trees sprouting from cut or burned stumps. Exotic plant species, including salt cedar (*Tamarix ramosissima*) and Athel tamarisk (*Tamarix aphylla*), have replaced most of the native cottonwood and willow.

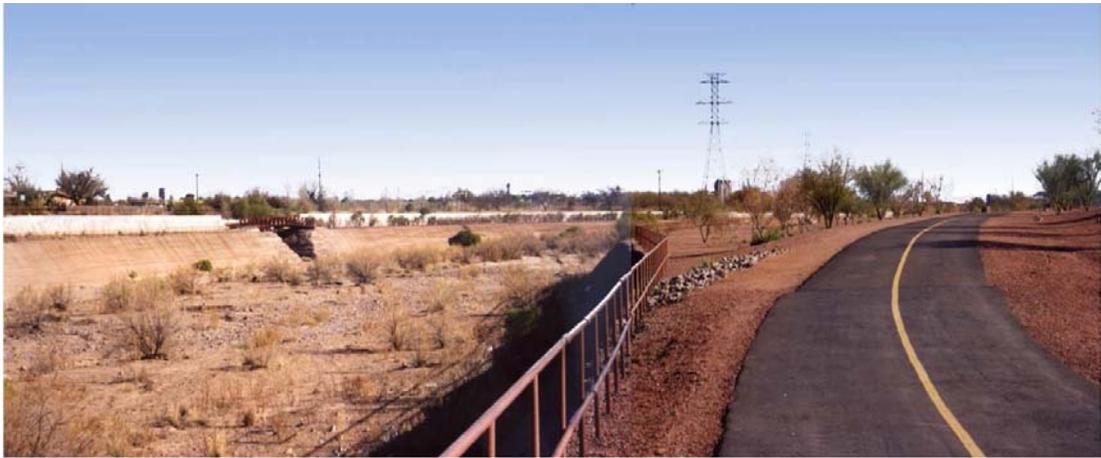
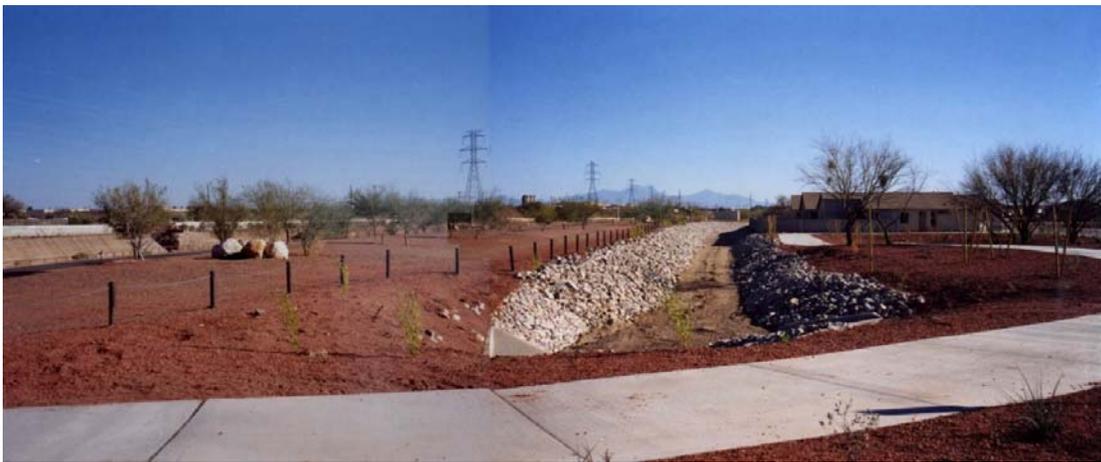
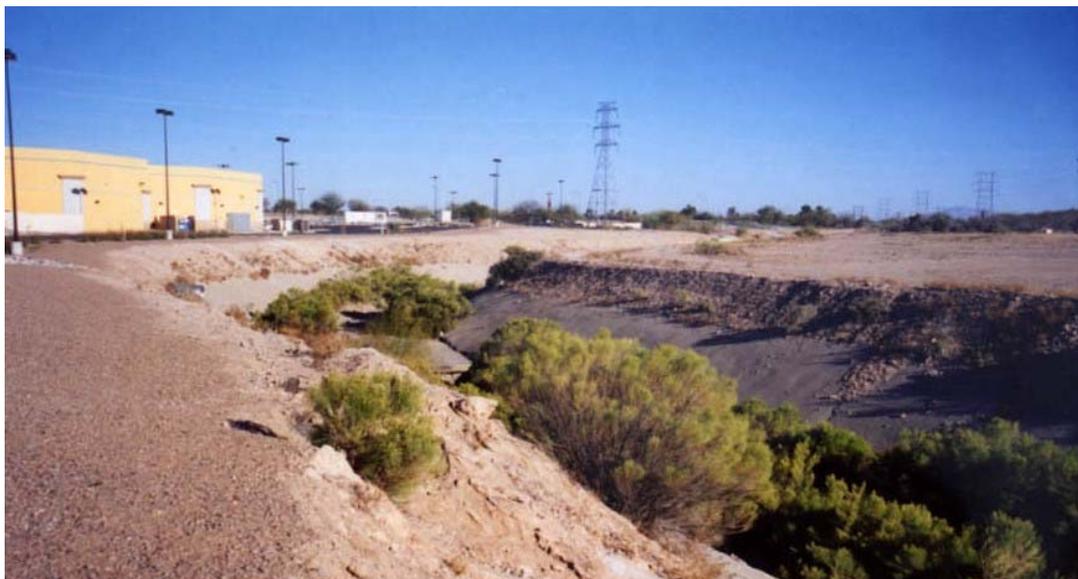
***FIGURE 4.6 Existing Conditions***

Bank and River Park trail south of Ajo Way

New housing and drainage structures on the Santa Cruz west bank south of Ajo Way

Condition of tributary wash upstream of its confluence with the Santa Cruz River

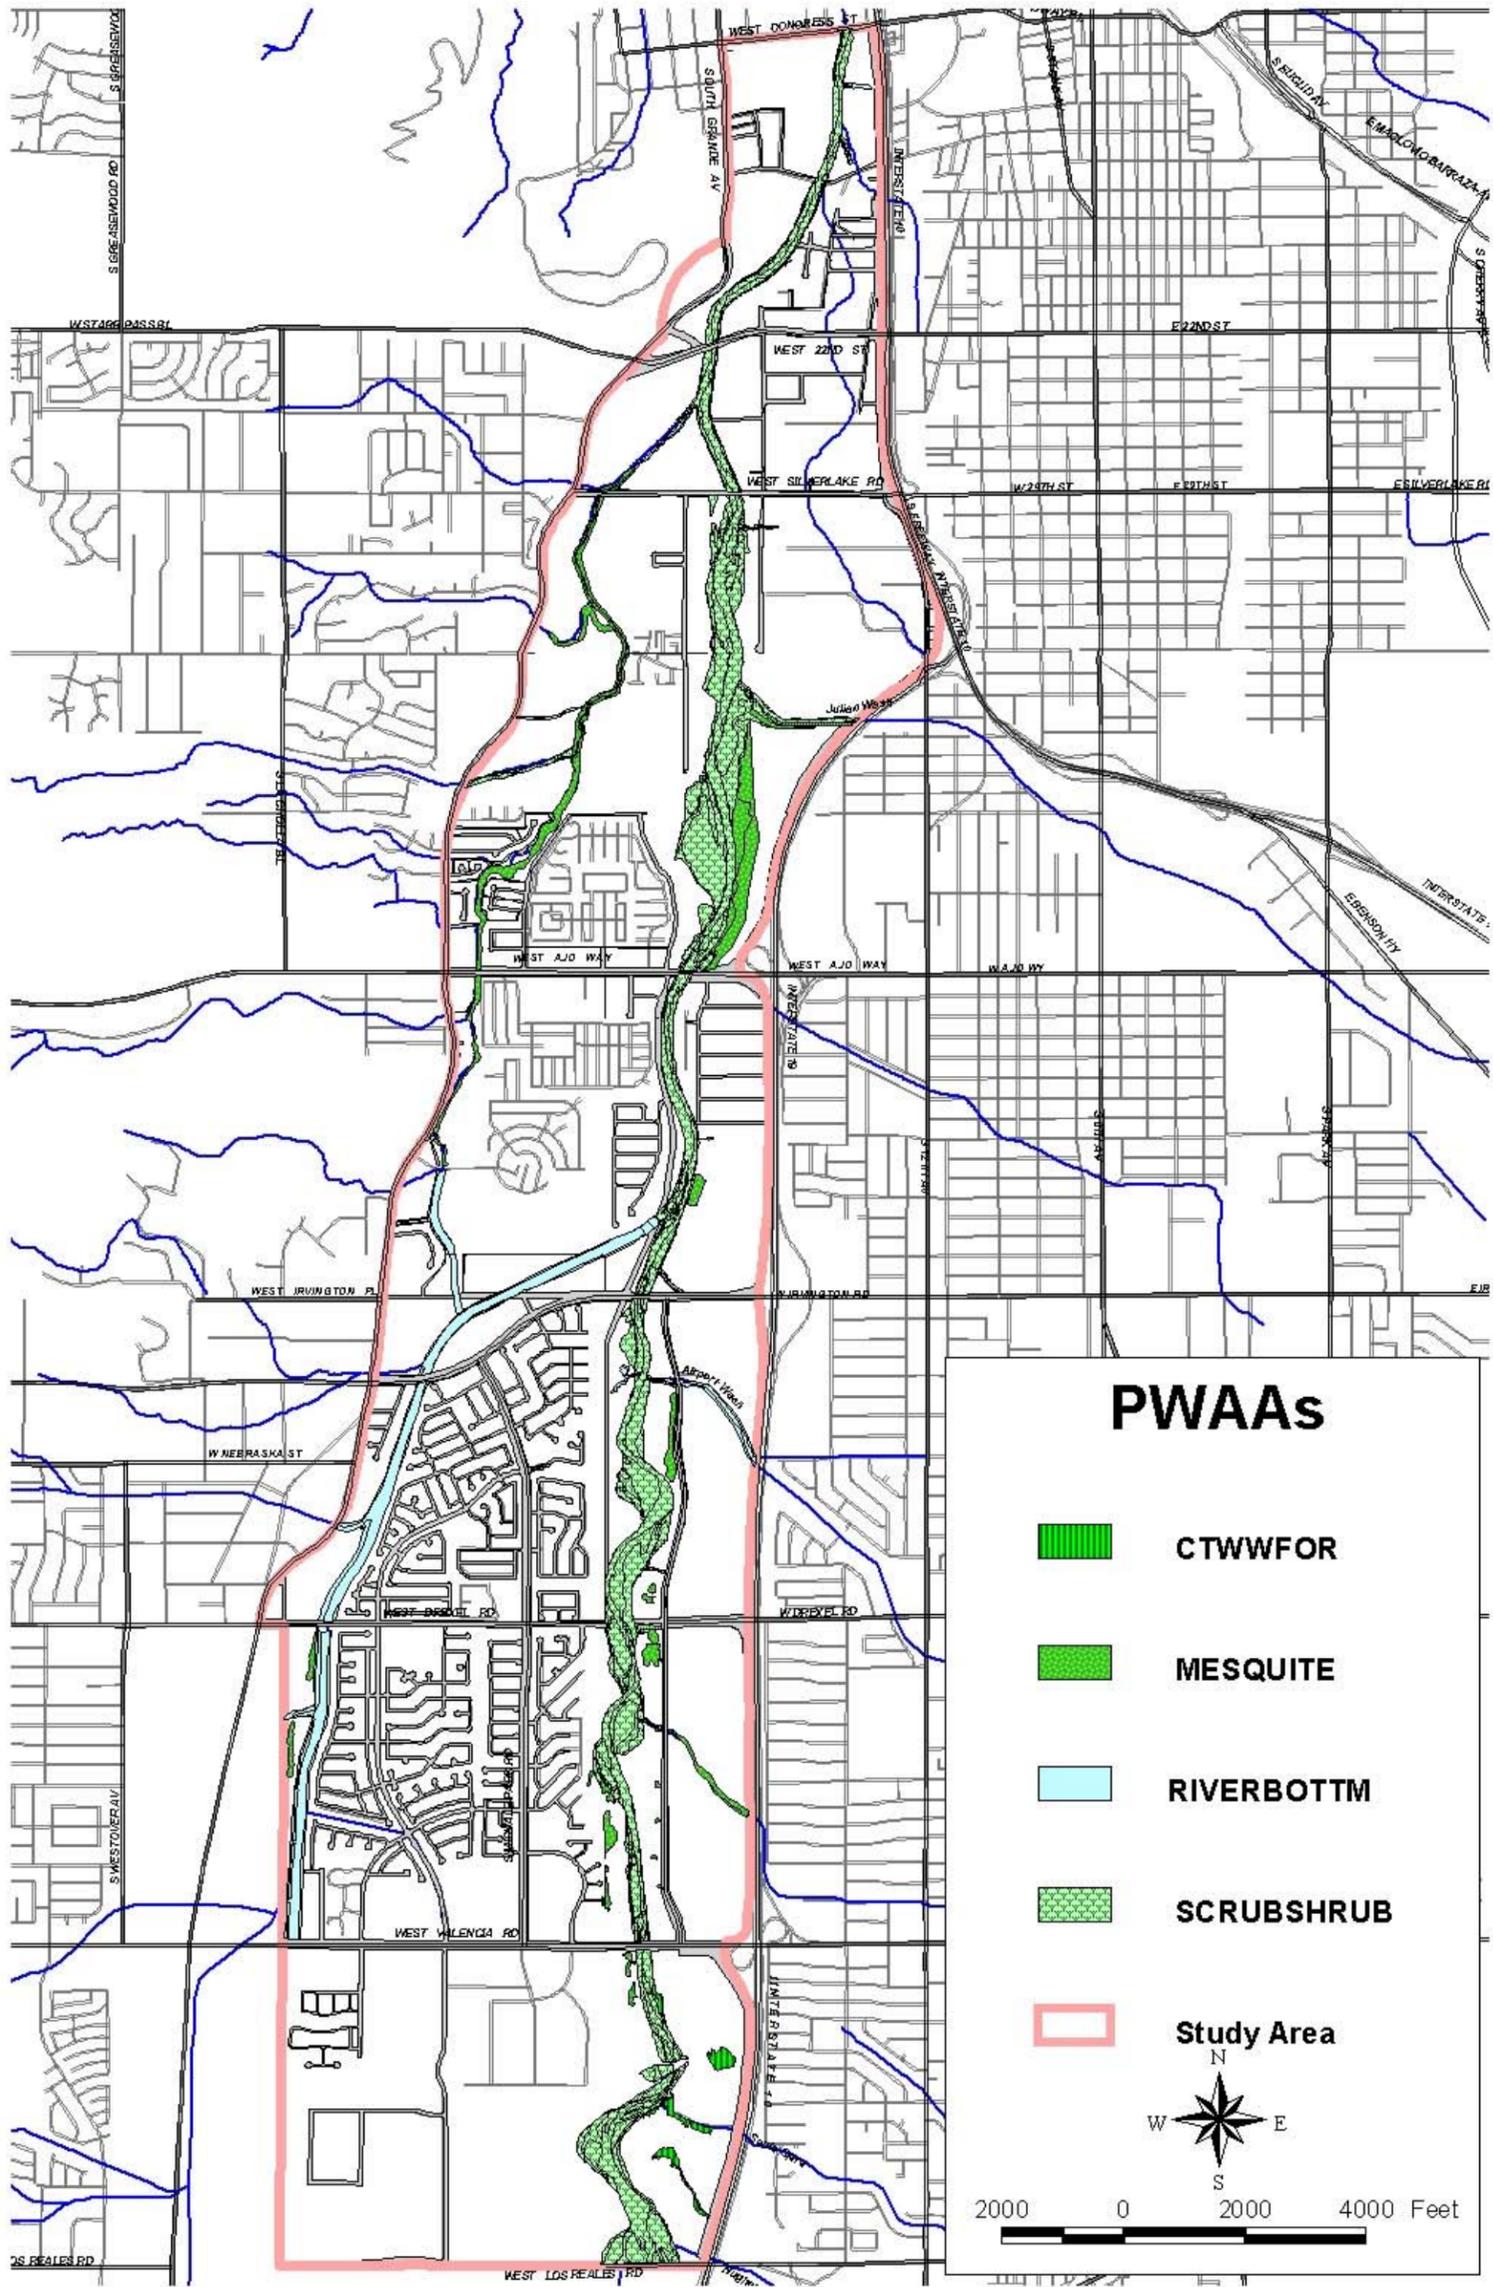
FIGURE 4.7 Distribution of Cover Types

Mesquite woodlands or bosques historically thrived over large areas within the river floodplain and on higher terraces of the river and were common into the 1940s. These communities have been nearly eliminated from the river ecosystem by a combination of anthropogenic activities (e.g. cutting for firewood) and an ever lowering aquifer combined with an altered flood regime. Significant contiguous stands currently exist along the Old West Branch of the Santa Cruz River. Several smaller patches are scattered throughout the historic floodplain of the Santa Cruz. These small bosques generally consist of struggling trees that have been isolated from the river by soil cement banks and are threatened by urbanization. Together, these areas of mesquite-dominated woodlands total 160 acres.

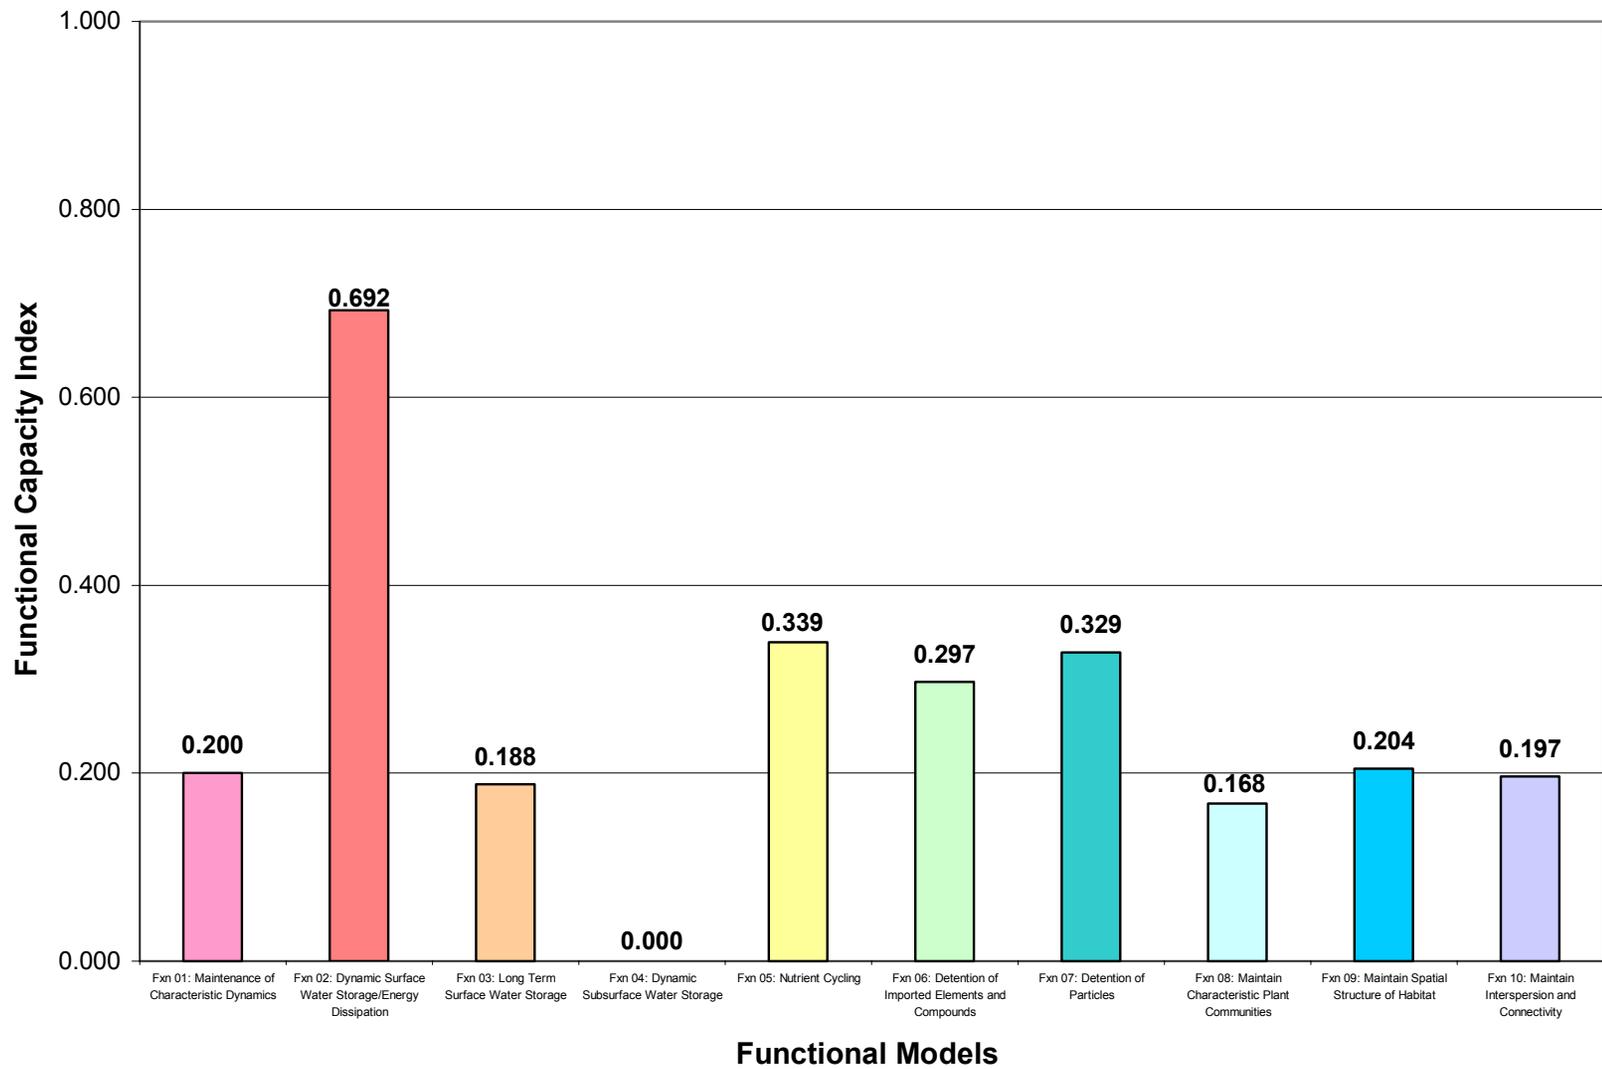
**FIGURE 4.8 Baseline Functional Capacity Index Results**

is poorly functioning. The average FCI is 0.26 for Paseo de las Iglesias. The lowest rated reference site, the Salt River, was rated at 0.57.

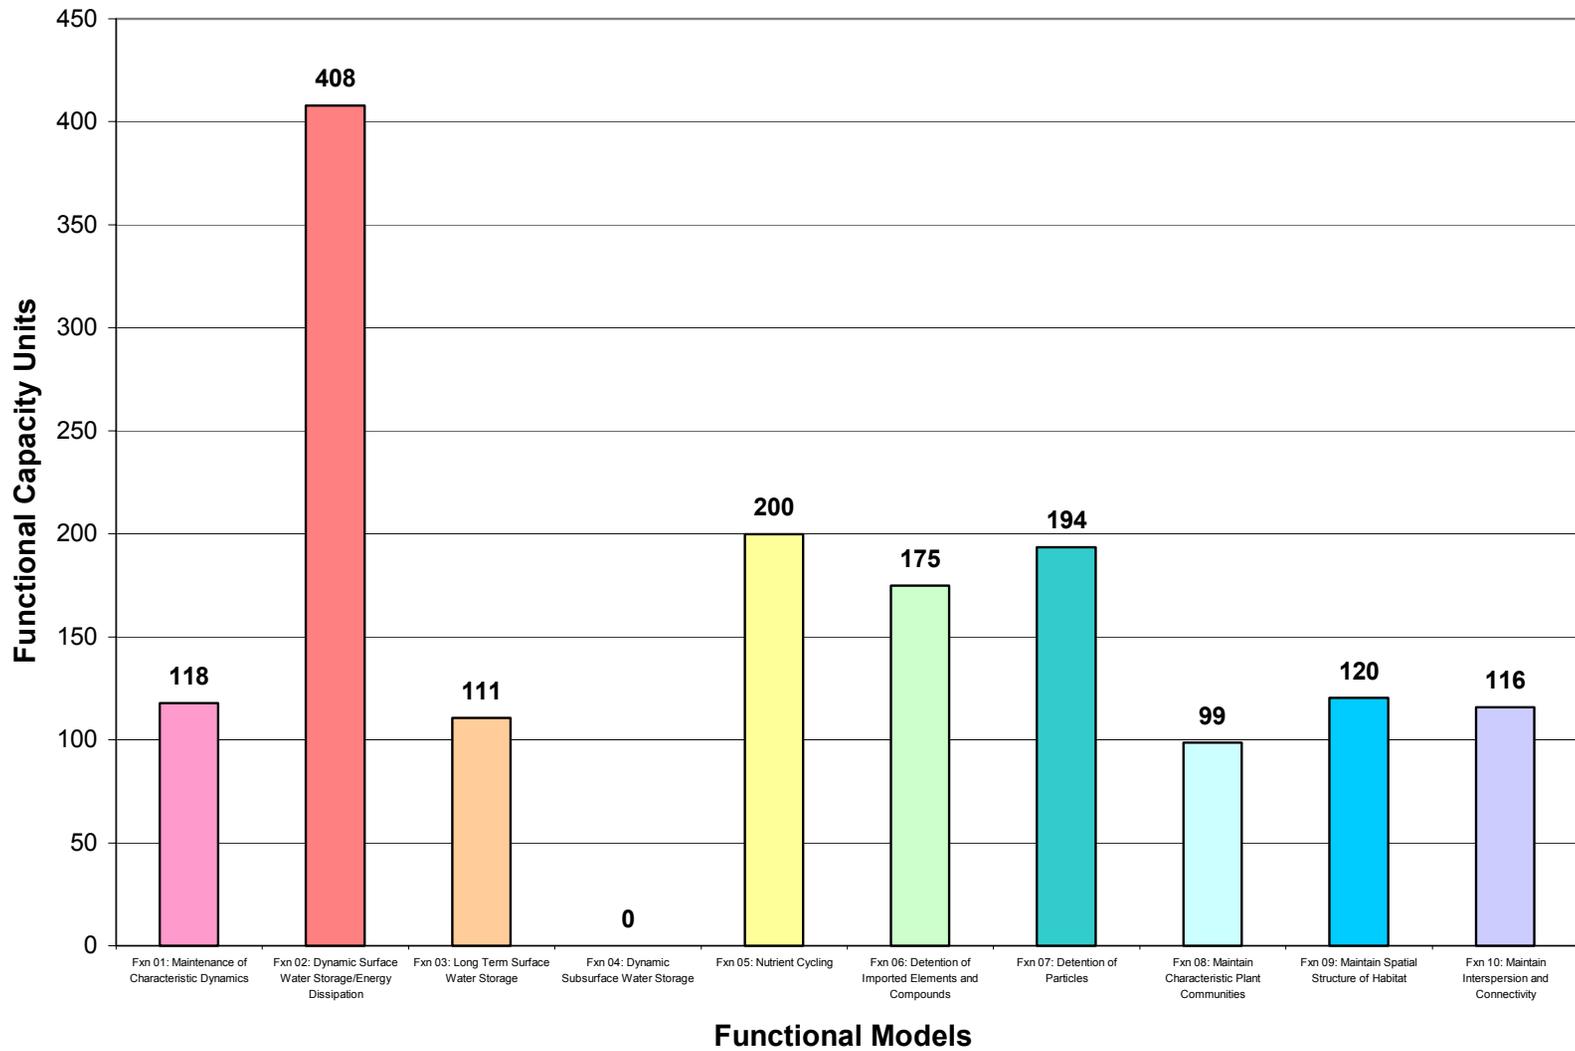
**FIGURE 4.9** *Baseline Functional Capacity Unit Results*

To compare Functional Capacity Units between the reference site(s) and the study area, the FCI for each reference site was multiplied times the same acreage per PWAA that exists in the Paseo de las Iglesias study area. When the Paseo de las Iglesias site is compared to the Arizona reference sites, the area has a much lower functional capacity index for desirable cover types. This illustrates the inability of the habitat within this reach to sustain itself. The average across the ten functions for the existing conditions in the study area is 154 AAFCUs, compared to the results for the Salt River reference site (the least productive of the five reference sites), which was 333 AAFCUs.

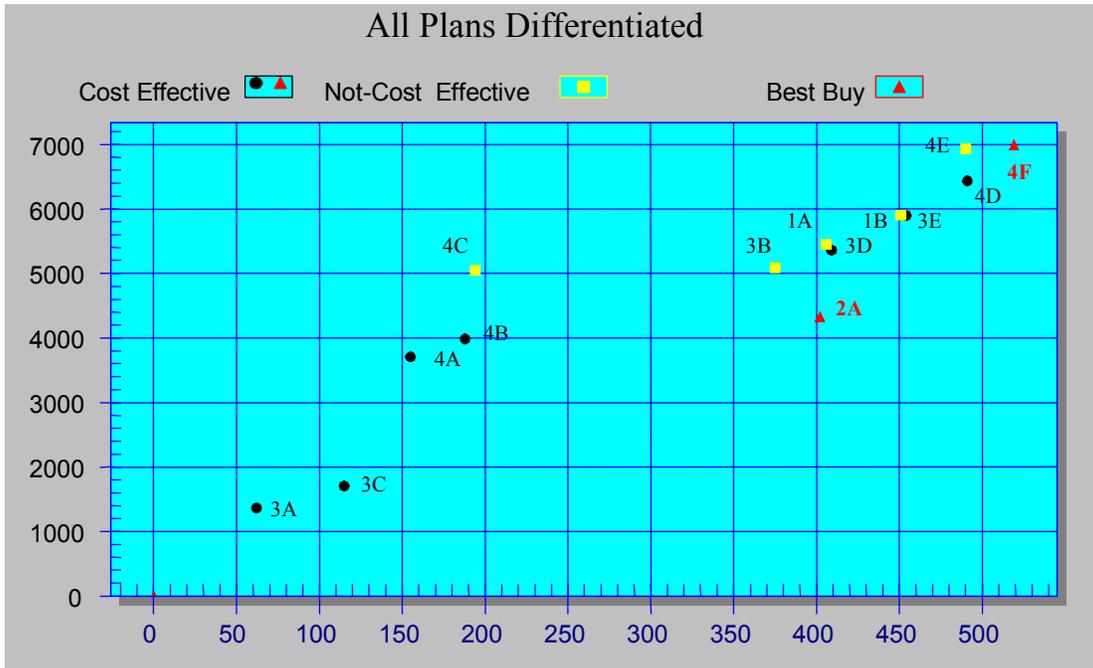
**FIGURE 5.2 All Plans Differentiated**  
(CEA Plans and Best Buy Plans Labeled)

cheapest unit cost is also the alternative with the highest total output. The alternative with the lowest cost per unit of output is Alternative 2A, which produces a net increase of 402 average annual FCU at a cost of \$10,433 dollars per unit. The alternative with the next cheapest cost per unit of output is Alternative 4F, which produces an additional 117 average annual FCU at an incremental cost of \$22,162 dollars per unit. Thus the final array of alternatives, from which the recommended plan is to be selected, consists of these two alternatives. The results of these analyses are represented in Figures 5.2 and 5.3.
