**US Army Corps  
of Engineers  
Los Angeles District**

**Santa Cruz River, Paseo de las Iglesias  
Pima County, Arizona  
Draft Feasibility Report**

**July 2004**

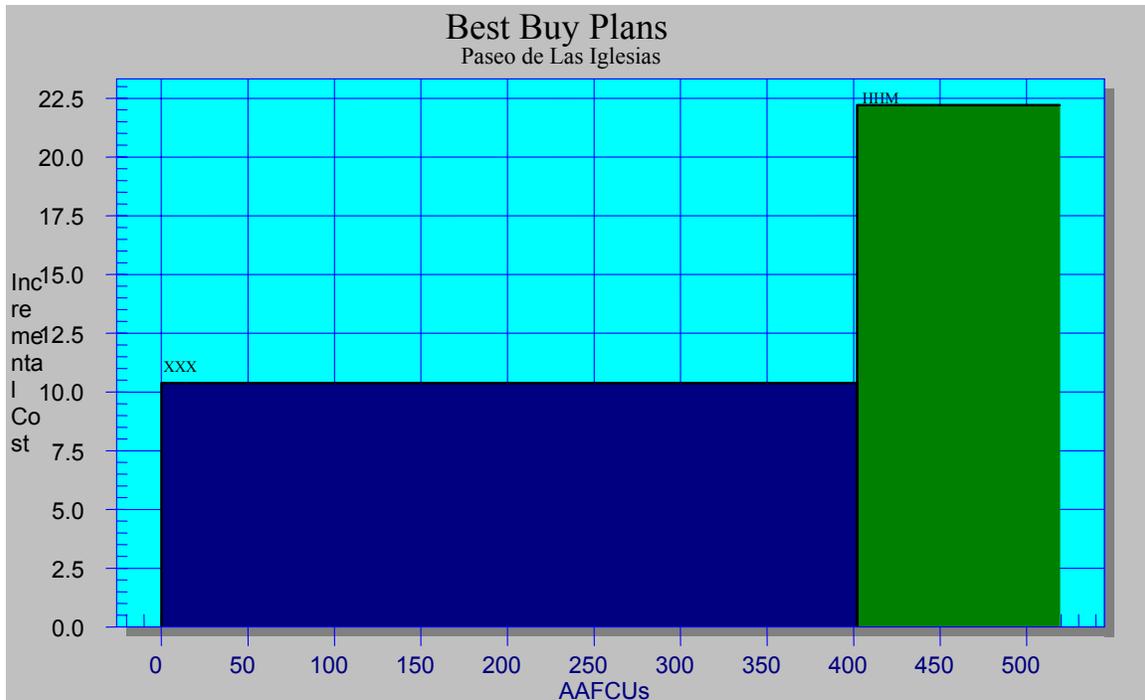
**FIGURE 5.3 Final Incremental Cost Results  
(Incremental Average Cost by Incremental Output)**

cheapest unit cost is also the alternative with the highest total output. The alternative with the lowest cost per unit of output is Alternative 2A, which produces a net increase of 402 average annual FCU at a cost of \$10,433 dollars per unit. The alternative with the next cheapest cost per unit of output is Alternative 4F, which produces an additional 117 average annual FCU at an incremental cost of \$22,162 dollars per unit. Thus the final array of alternatives, from which the recommended plan is to be selected, consists of these two alternatives. The results of these analyses are represented in Figures 5.2 and 5.3.

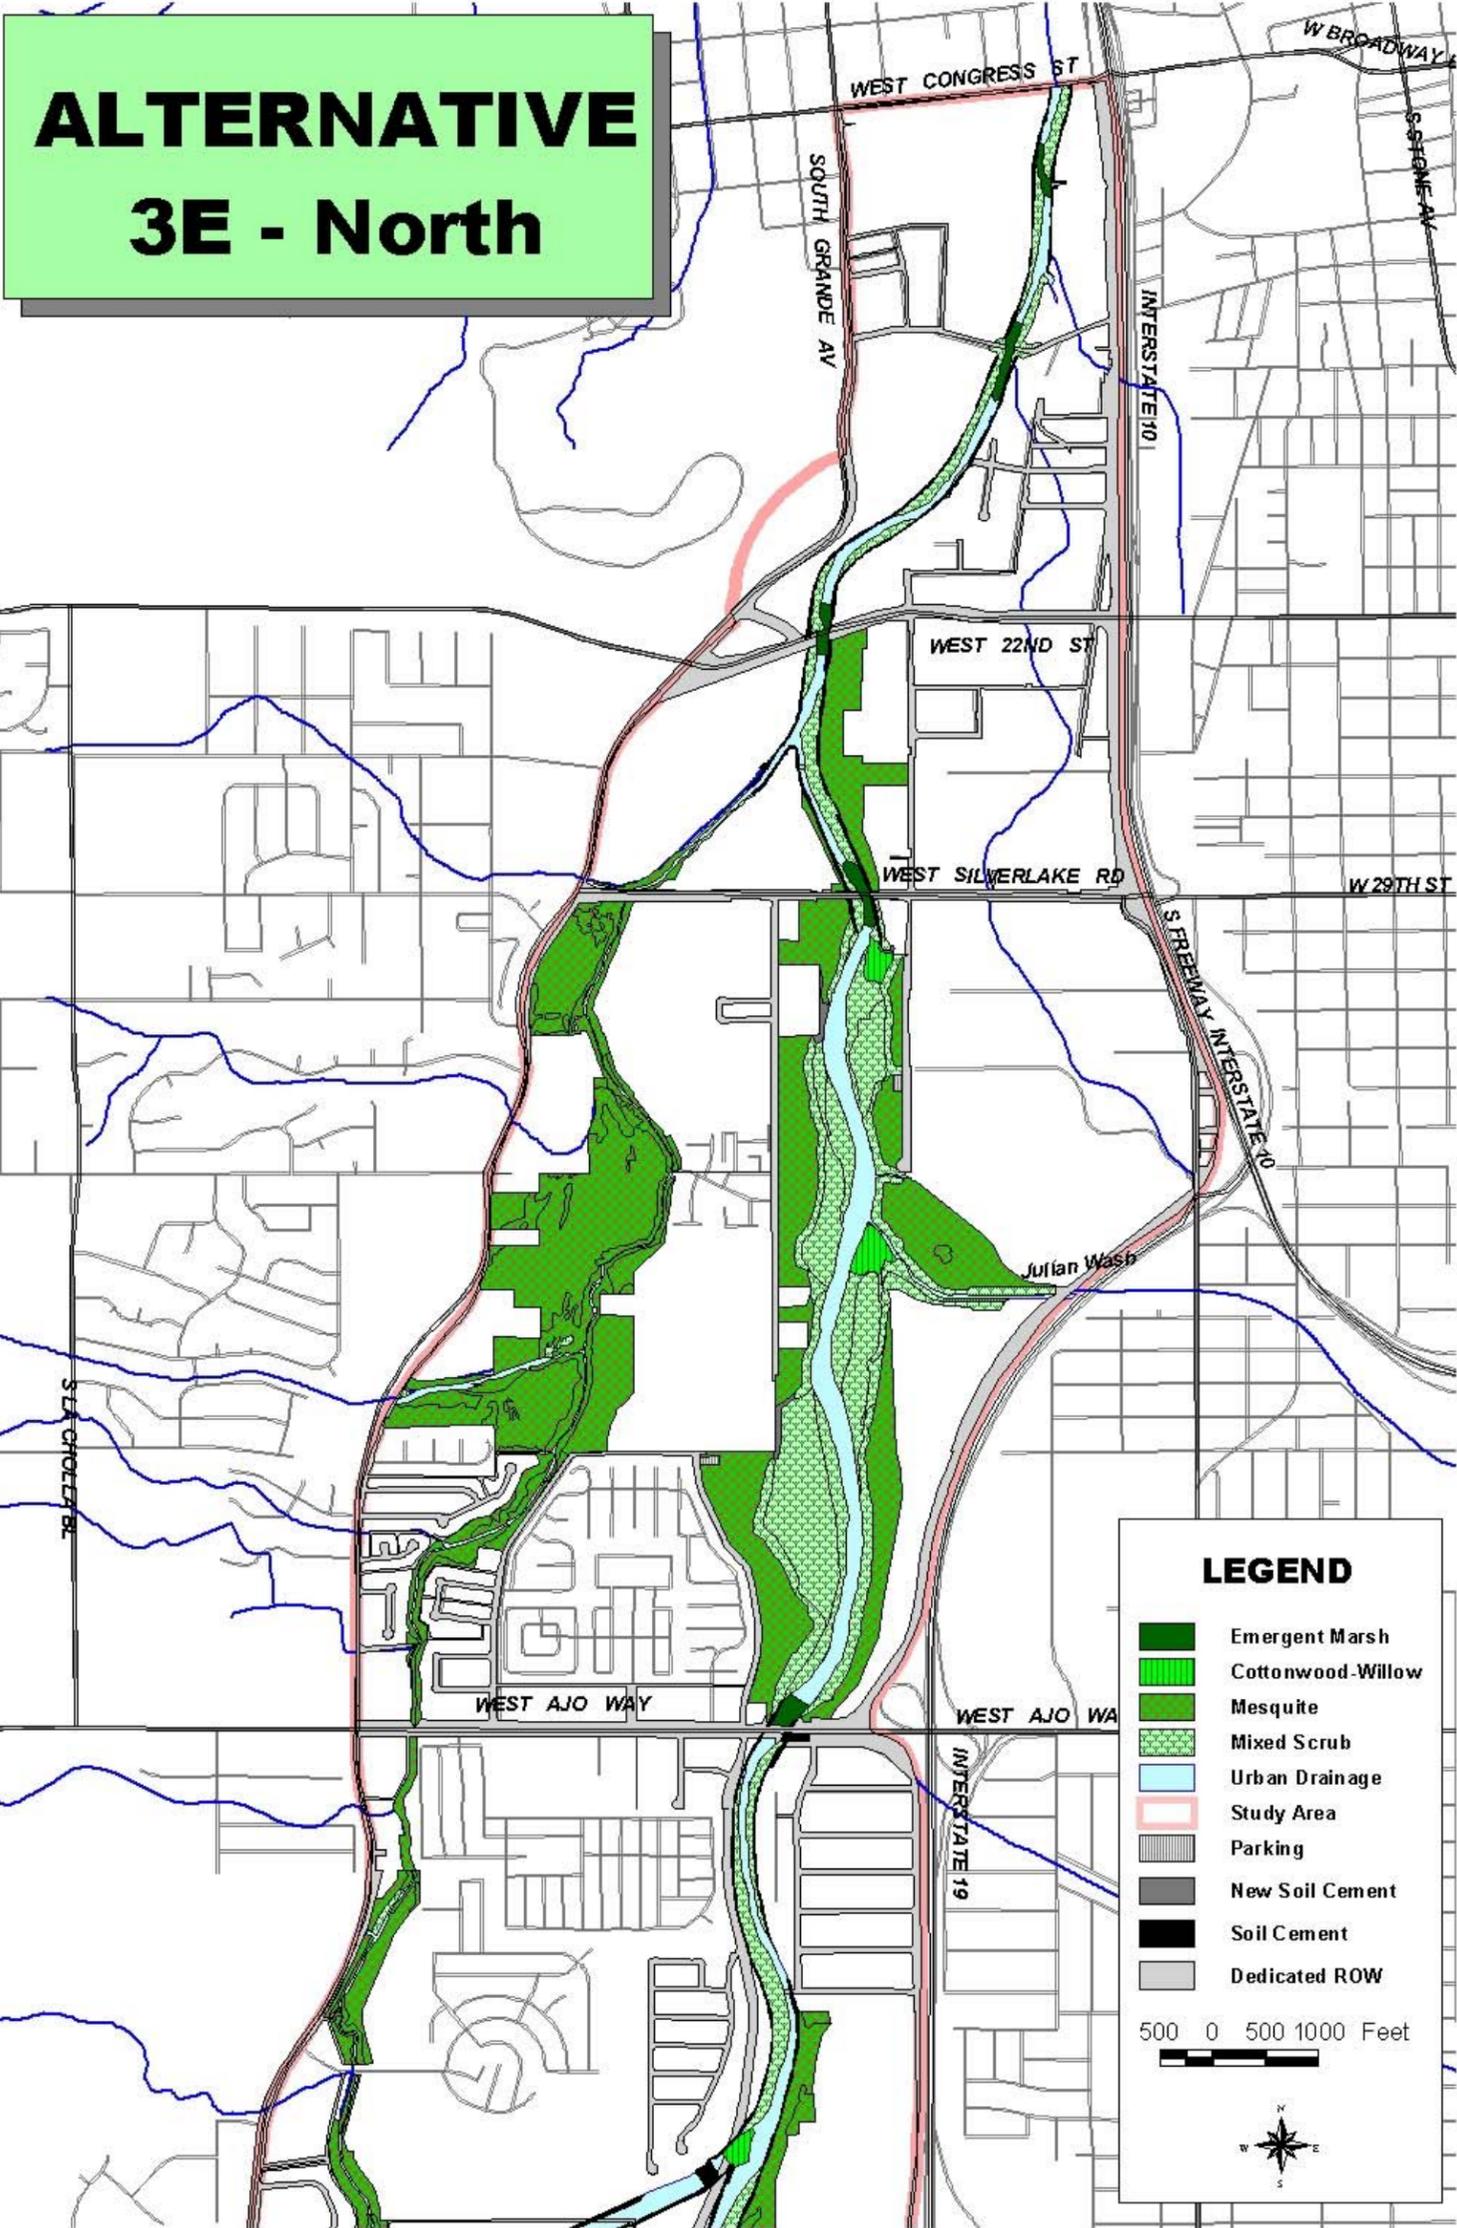
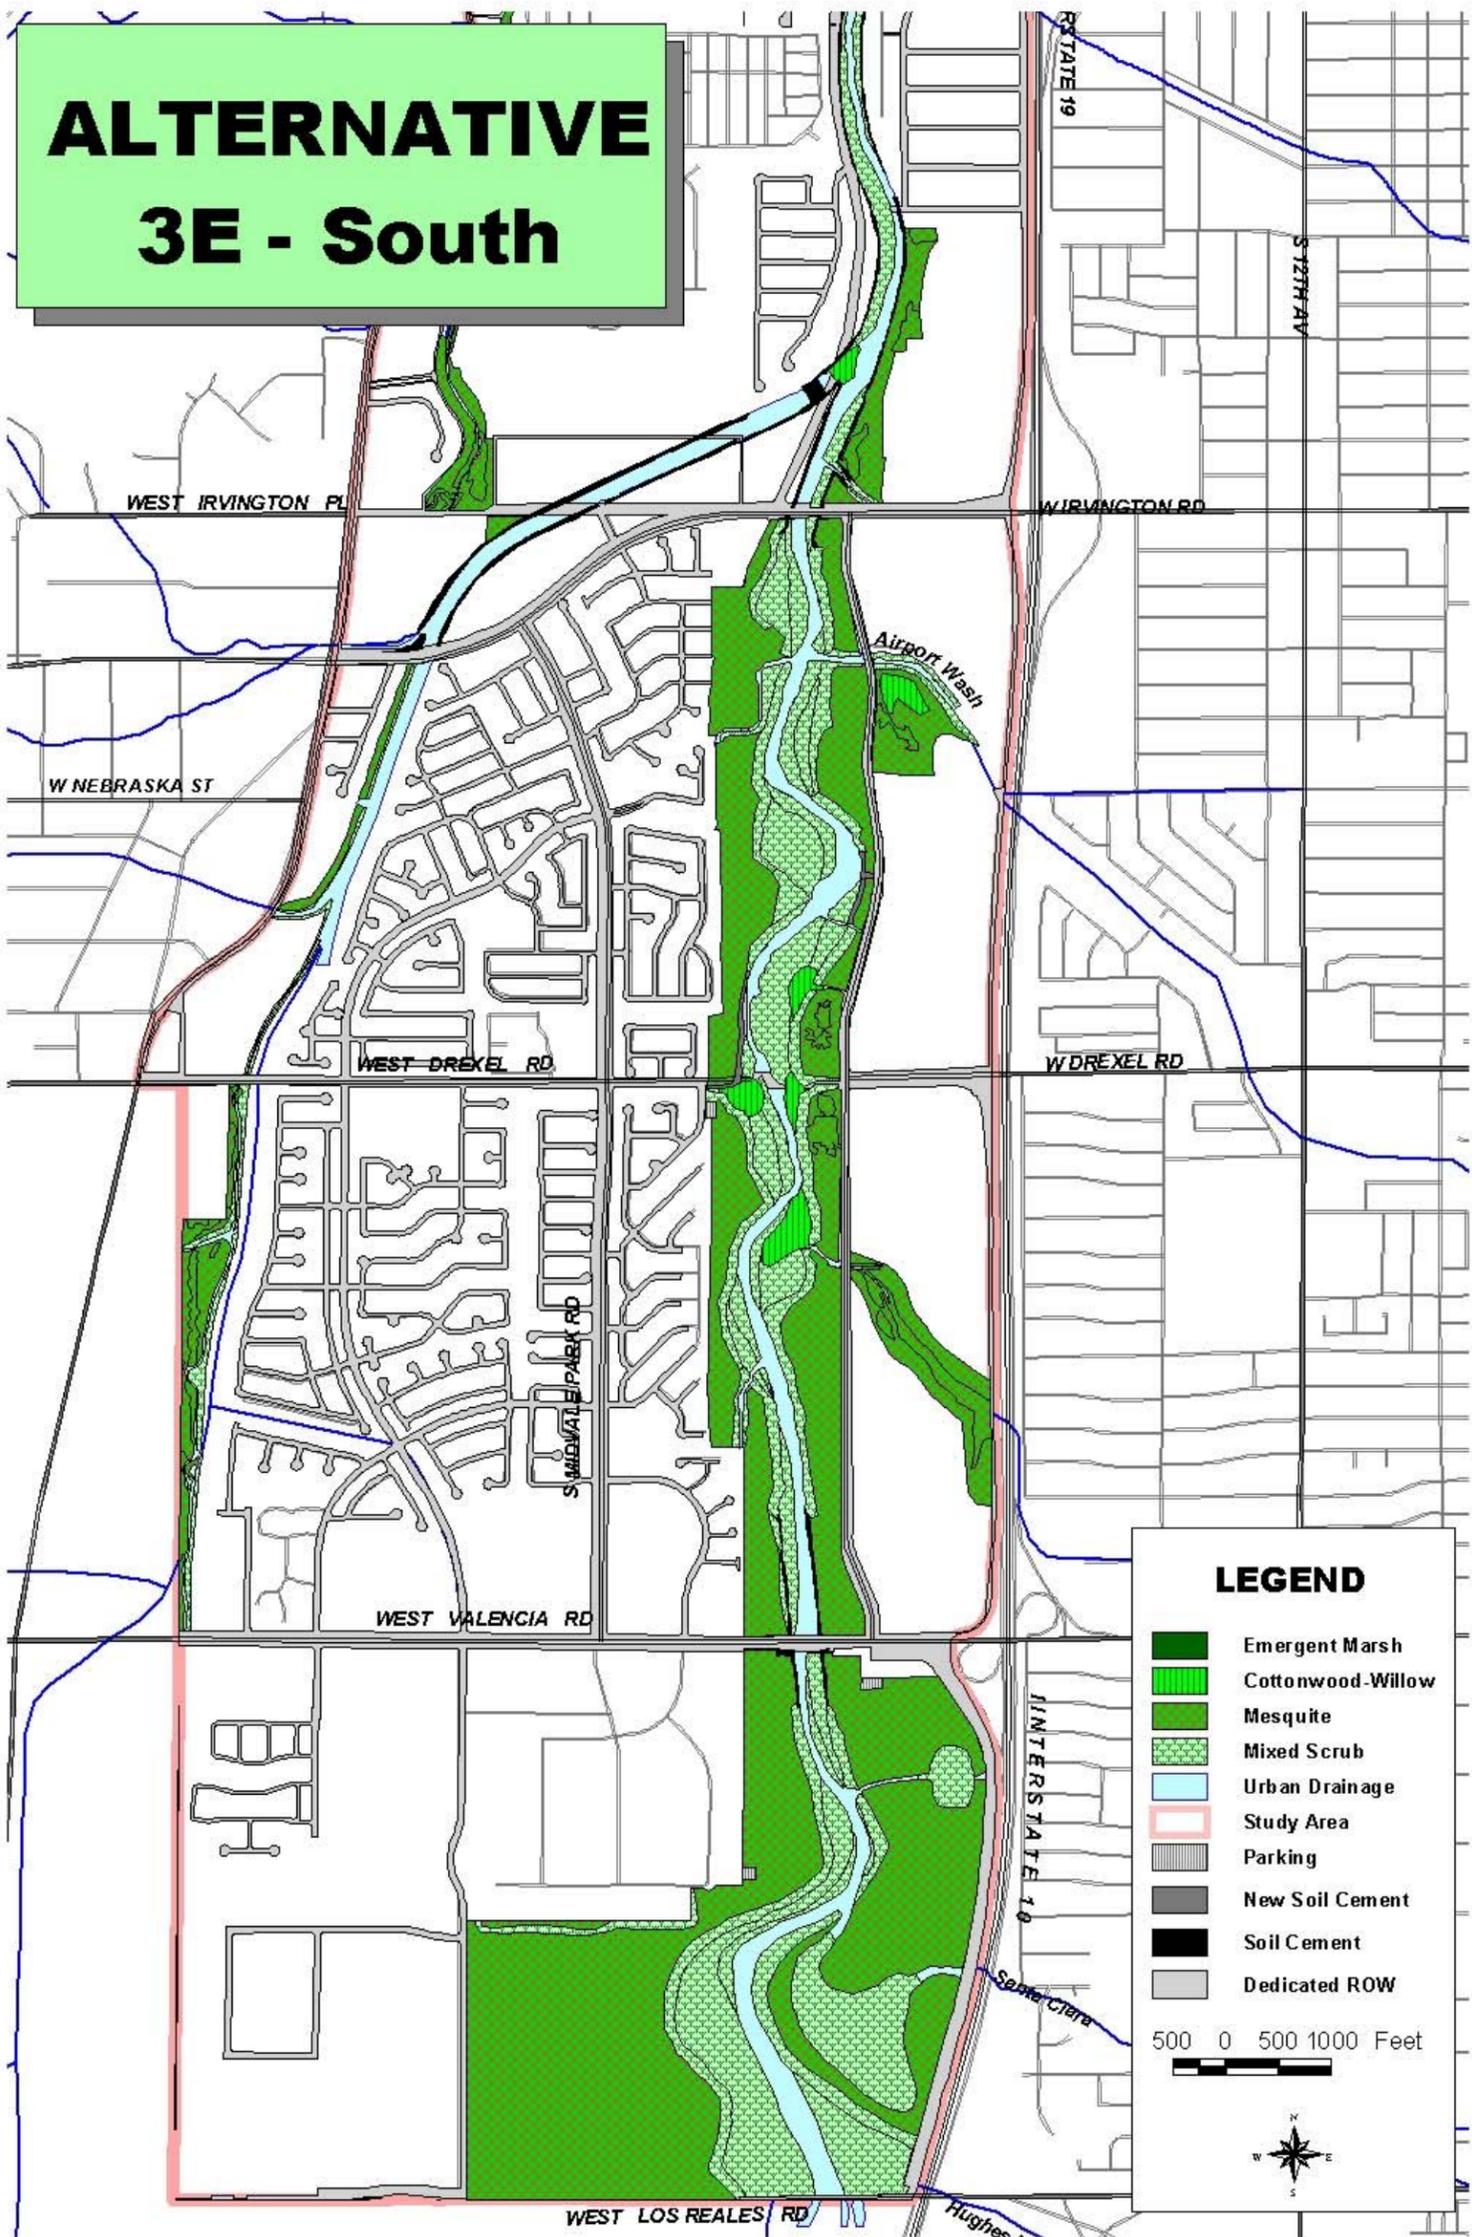
FIGURE 5.5a Alternative 3E

*Alternative 3E:* This alternative builds on 2A by providing irrigation to the subsurface water harvesting basins in addition to water harvesting, soil amendment, surface grading, irrigation of the lower reaches of the Old West Branch. Implementation of these measures will allow creation of new PWAAS as well as enhancement of existing PWAAS with plantings in Cottonwood-Willow, Mesquite, Scrubshrub, and Riverbottom. These planted areas will be irrigated (Figure 5.5).

for selecting Alternative 3E is that it comes closest to presenting a mid-point in water demand between Alternatives 2A and 4F. Alternative 3E restores mesoriparian habitat to the project area with pockets of hydroriparian plantings. Alternative 3E, with an annual water budget of just under 2,000 acre-feet, provides a substantial reduction from Alternative 4F while still committing enough water to sustain mesoriparian plant communities. In addition, although Alternative 3E is incrementally more expensive than Alternative 4F, it ranks second for cost effectiveness with a cost of \$12,598 per average annual functional capacity unit.

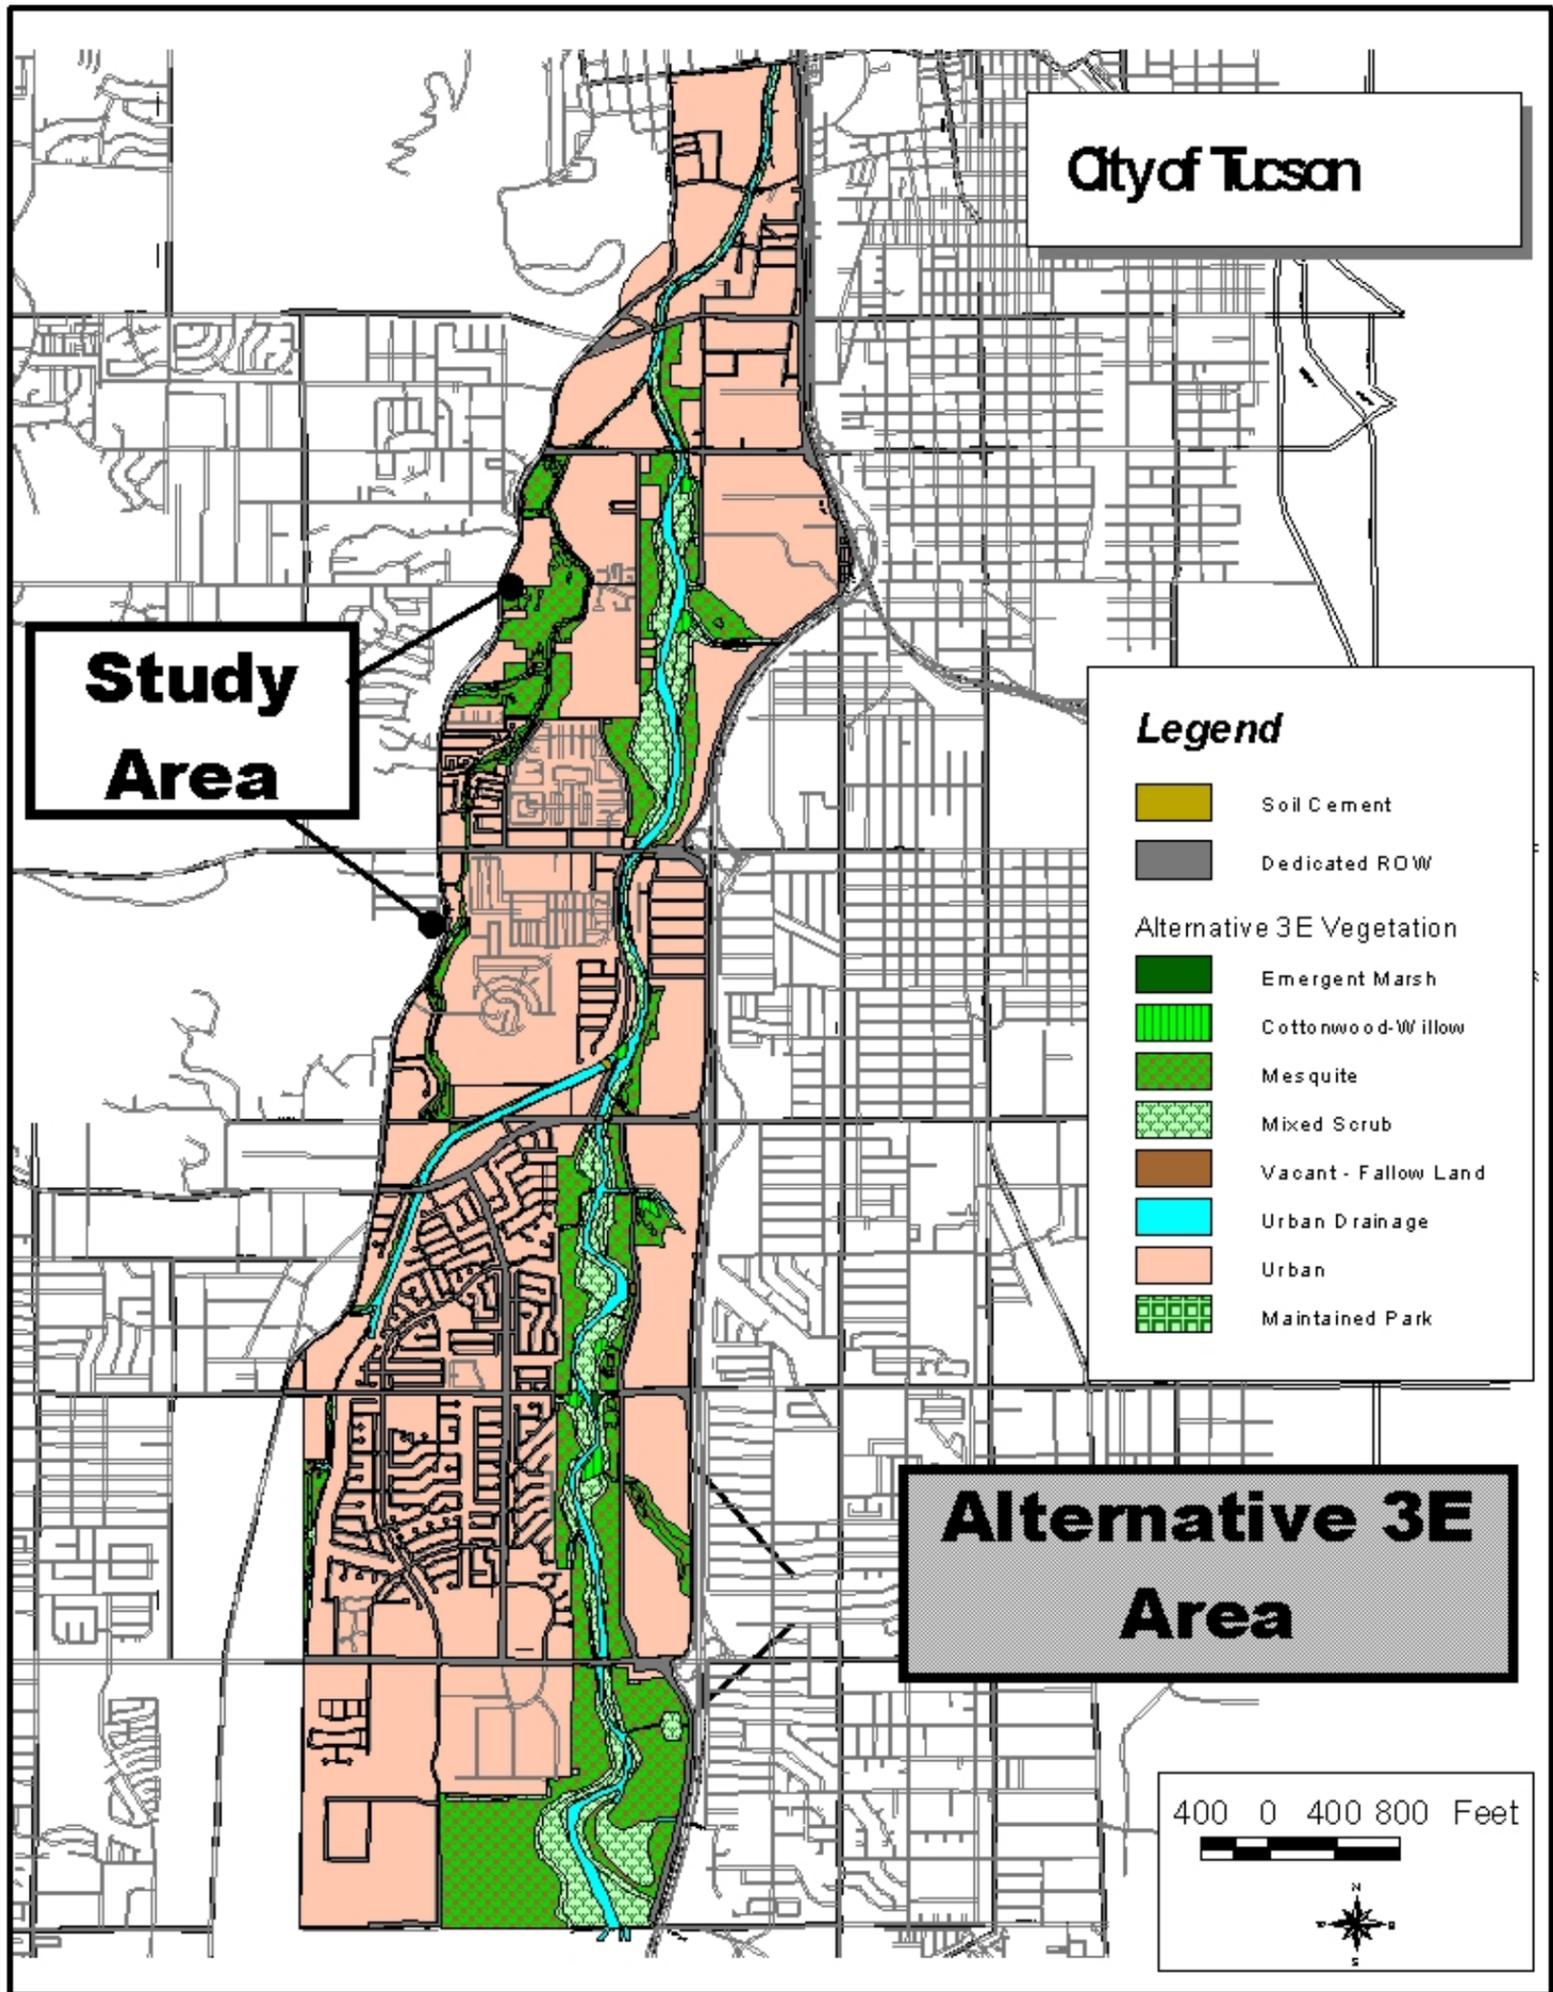
**FIGURE 6.1 Recommended Plan**

The excess material generated by cutting back these banks will be trucked down the channel to southernmost reach of the project. The material will be placed into abandoned gravel pits located in the historic floodplain to the west of the Santa Cruz River. In addition to eliminating the need for off-site disposal of the cut material this placement will make the area more suitable for restoration by reducing extreme variation in elevation created by past mining.

There are five short reaches of eroded bank where insufficient space exists to accommodate 5:1 slopes. These areas, totaling approximately 4,700 linear feet of bank cannot be regarded however; in their current state they pose a threat of increased erosion and consequent destruction of plantings in adjacent areas. In order to preclude these risks the areas will be stabilized using soil cement.

The reaches of steep eroded banks would be modified by cutting back into the historic floodplain to create gentler and more stable slopes graded at a 5 foot horizontal to 1 foot vertical slope and planted. This treatment is not intended to prevent lateral channel migration during catastrophic events. However, it will reestablish a hydrologic connection to the river, reduce the frequency of bank failure during intermediate events and should reduce the need to reestablish habitat due to washout.

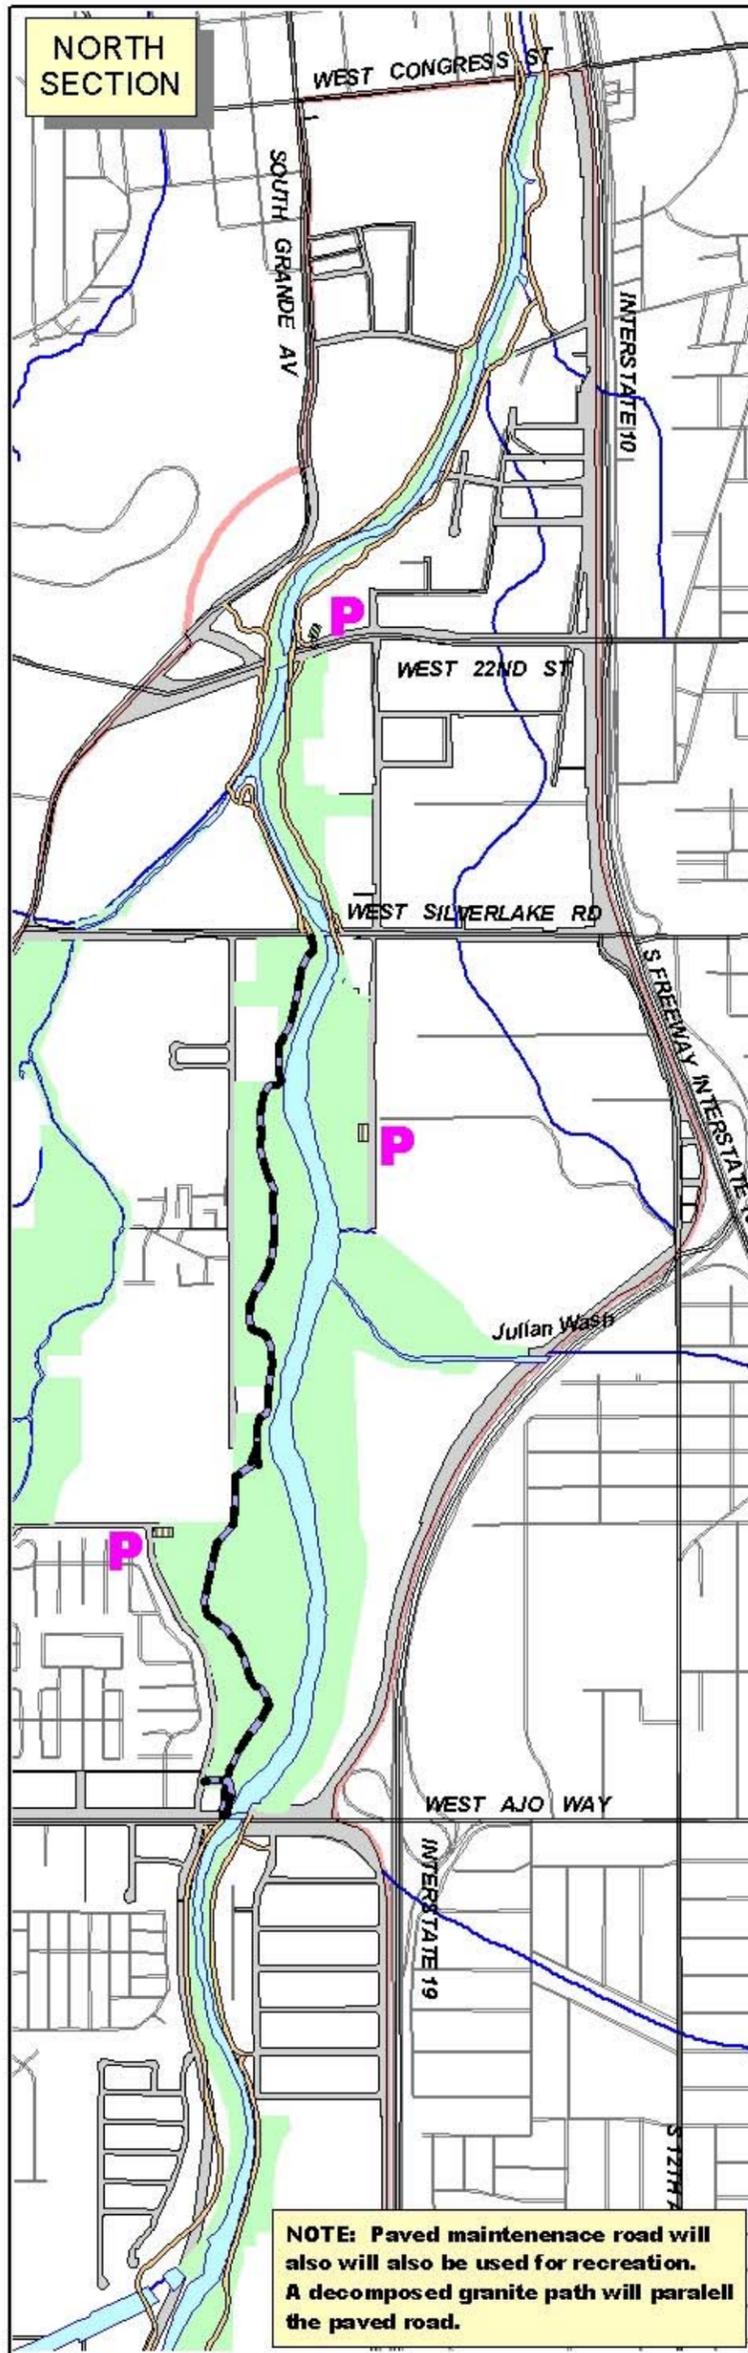
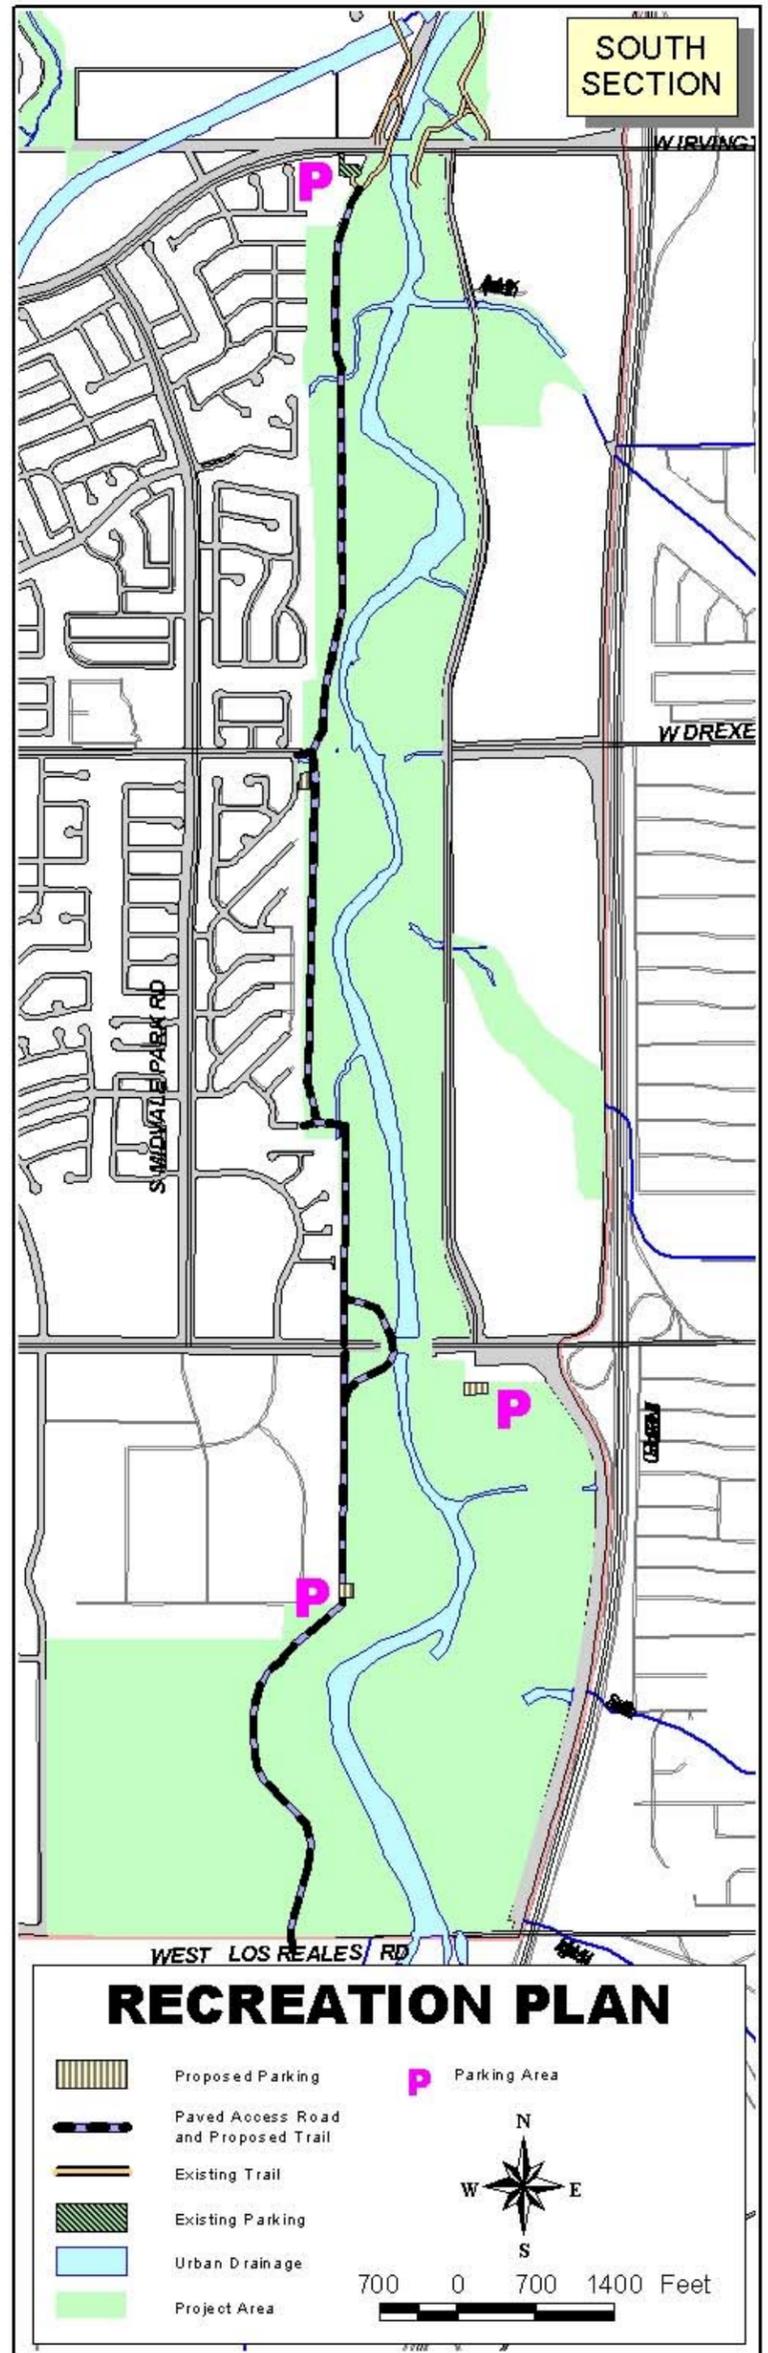
FIGURE 6.2 Recreation Plan

The Recreation Plan proposed in conjunction with the recommended restoration plan consists of decomposed granite (DG) multipurpose trails, parking, and trail links that serve a recreation purpose by connecting existing unlinked trail segments and providing opportunities to a variety of recreational users. Comfort stations will serve the basic safety needs of the recreational user. All road segments designated as maintenance provide access to areas in case of emergencies such as flooding and fire. Access will also provide a means to maintain vegetation in the newly restored area and park facilities. Warning signs are also added to direct pedestrians off the newly restored area and guide pedestrians away from any potential danger. These changes will provide a unique opportunity for resource-based recreation and environmental education. Trail alignments and parking locations are shown on Figure 6.2. Placement of comfort stations will be determined during detailed design.
