Groundwater Level Changes in the Tanque Verde Valley UPDATE

Sonoran Desert Conservation Plan

GROUNDWATER LEVEL CHANGES IN THE TANQUE VERDE VALLEY

Groundwater Level Changes in the Tanque Verde Valley
November, 2001
by Elizabeth Hill and Julia Fonseca

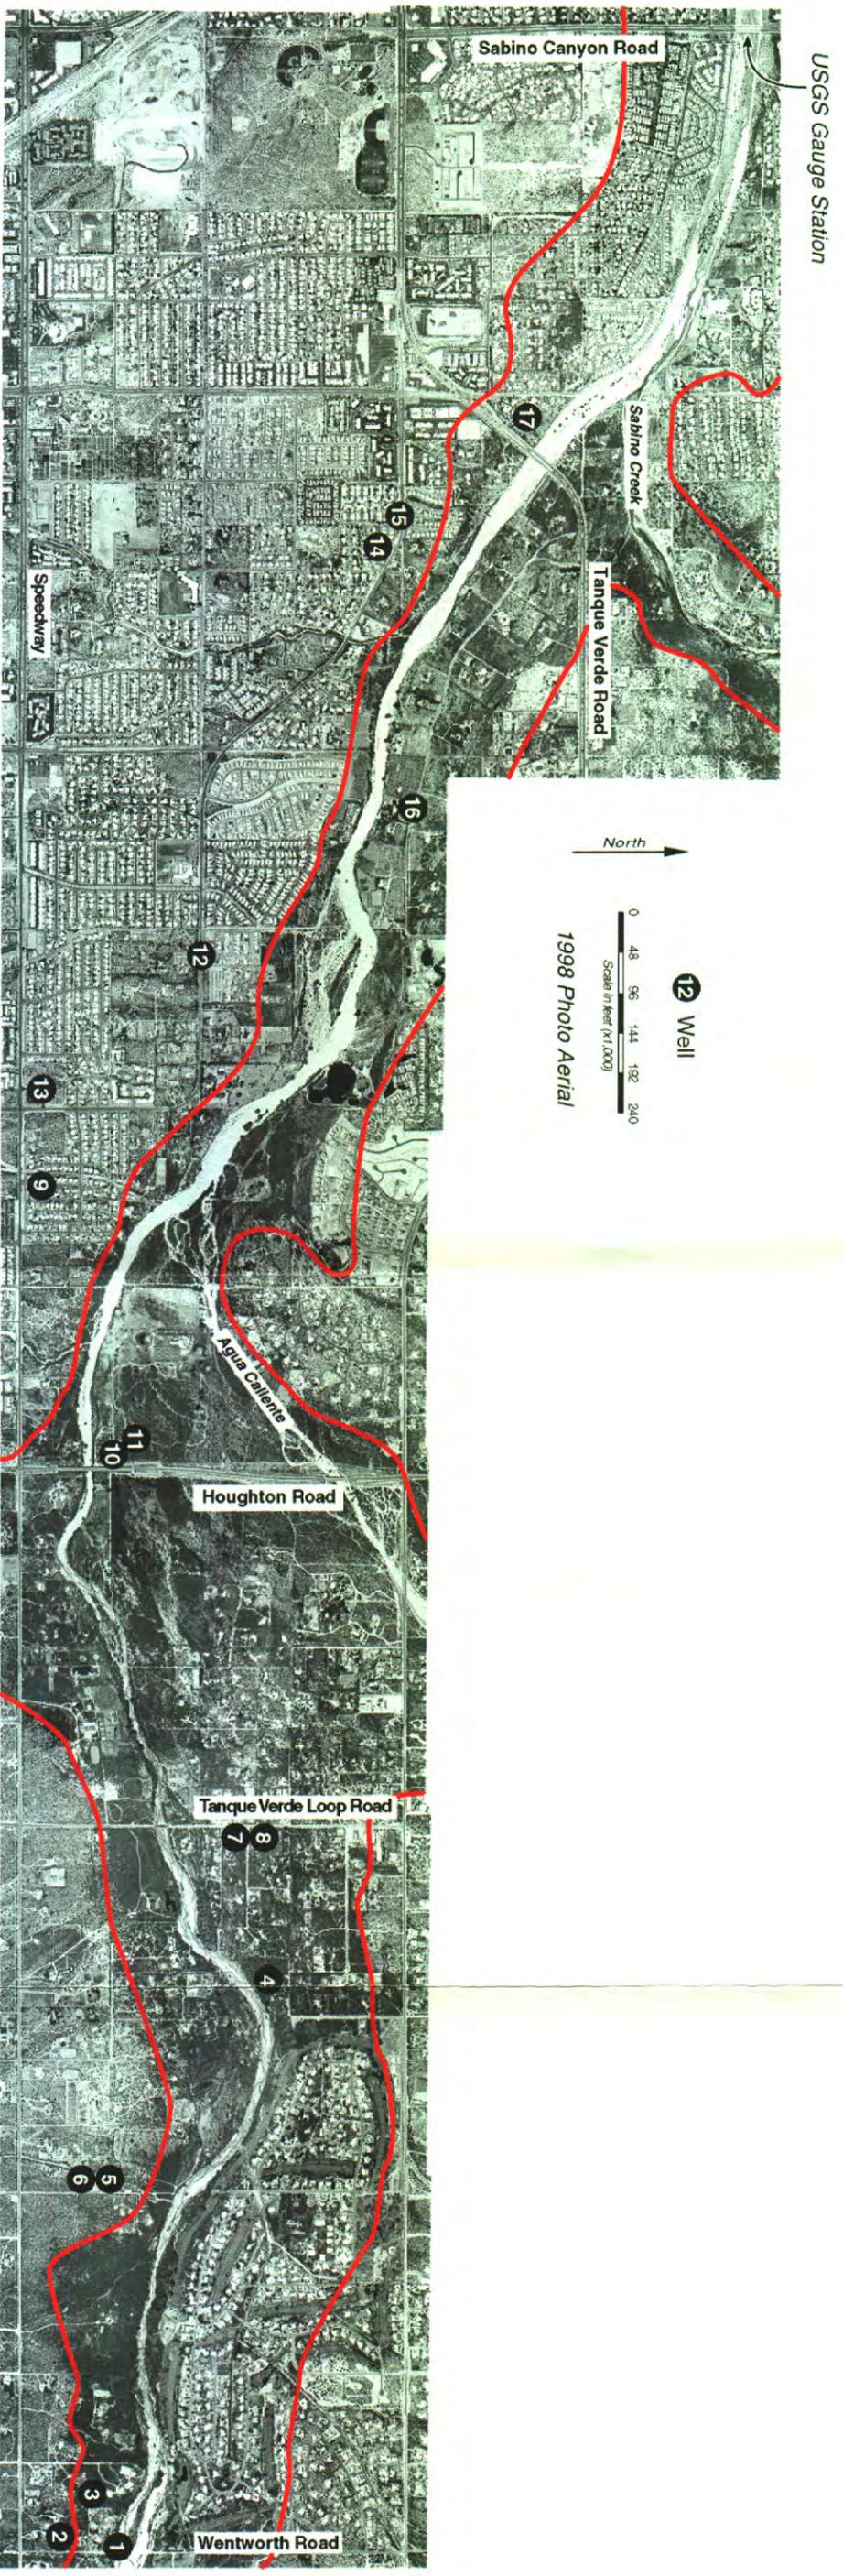
Figure 2. Location of wells used in this study

Approximate boundary of riparian corridor as inferred from 1941 aerial photography.

Figure 2 shows an aerial photo of the study area (1998). Tanque Verde Creek has natural earthen banks upstream of Houghton Road, except for a few isolated locations where bank stabilization has been constructed by individual property owners. Hydro-mesoriparian habitat has been mapped across much of the floodplain from Wentworth Road to Houghton Road. The presence of a significant stand of continuous riparian vegetation is one of Tanque Verde Creek's most distinguishing characteristics (Pima County Flood Control, 2001).

The 17 well locations are shown on Figure 2 and the wells are described in Appendix B. For ease of reference, Tucson Water well names have been numbered simply from 1 to 17, beginning at Wentworth Road and proceeding downstream. Water surface elevations in wells located upstream of Houghton Road are generally higher; the direction of groundwater movement is generally westerly.

The United States Geological Survey operates a gauging station at Site #09484500 located at the intersection of Sabino Canyon Road and Tanque Verde Creek (Figure 2). The Tanque Verde Creek streamflow data shown in Figure 8 are for Water Years (October 1 to September 30).

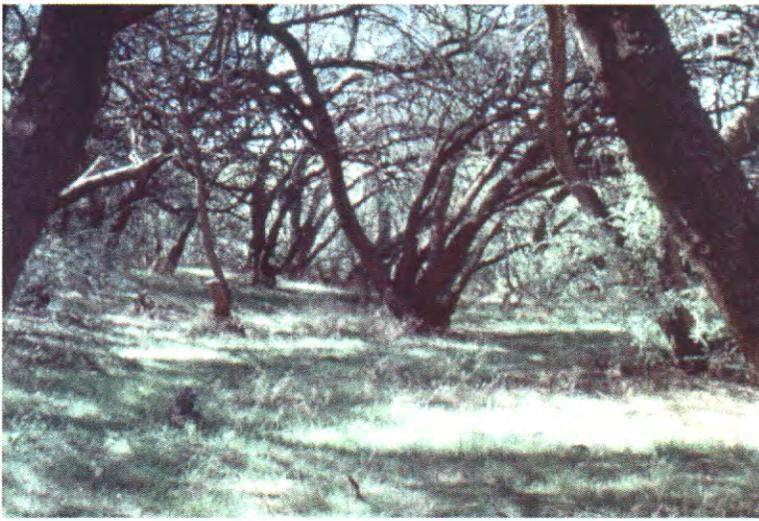
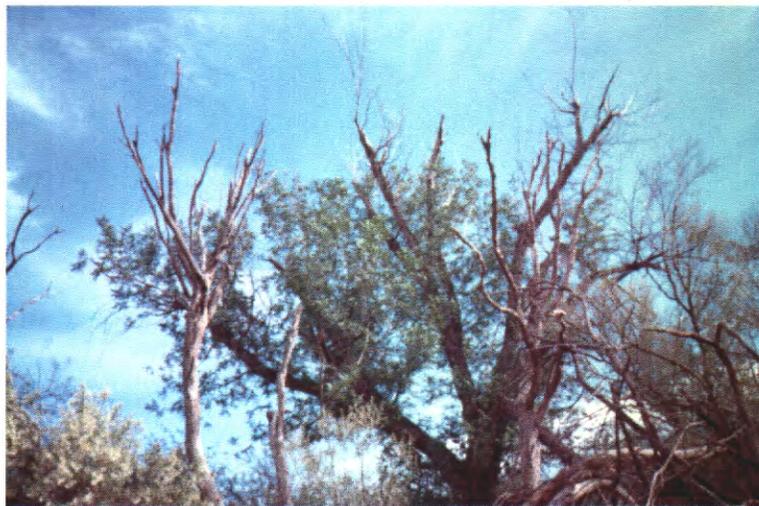
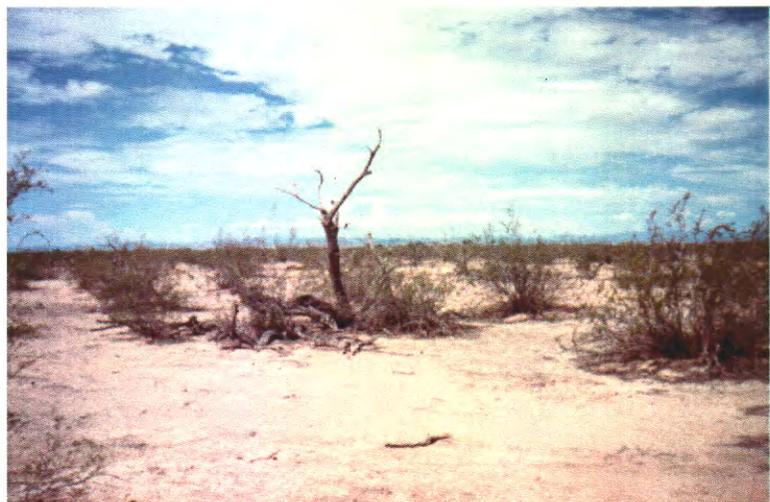
Figure 3. Decline of Mesquite Bosques

Healthy mesquite bosque, Cienega Creek (groundwater level at approximately 20 feet).

Canopy dieback, Tanque Verde Creek at Pantano Wash
November 1999 (groundwater level at approximately 50 feet).

Former mesquite bosque, Casa Grande (groundwater level at approximately 100 feet).

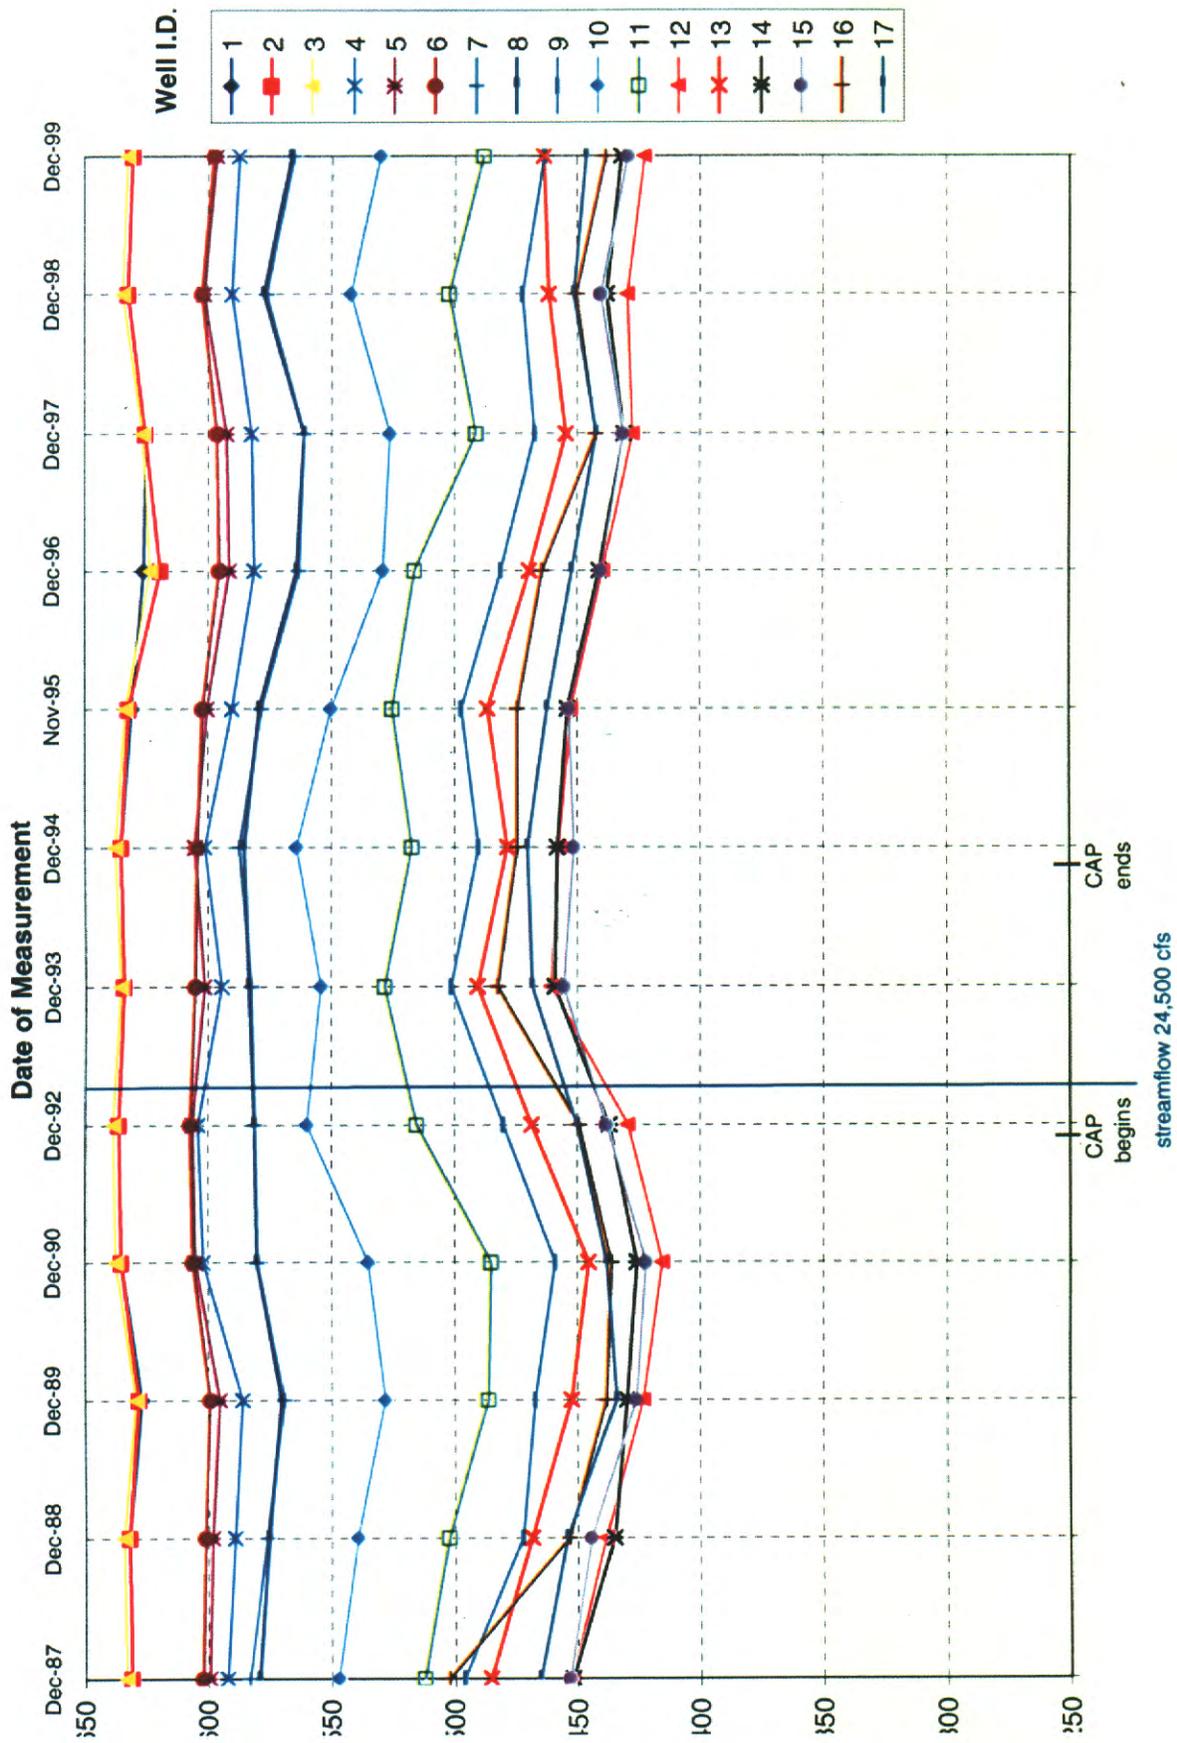
Figure 4. Water surface elevations

Groundwater profiles in Figure 4 show the water surface elevations generated for the 12 year period. Groundwater profiles in Figure 5 show the depth-to-water below land surface. The depth-to-water ranges from 6 to 161 feet. According to the Stromberg study, mesquites are stressed when water depths are between 16 and 59 feet, while near-lethal and lethal stress occurs in mesquites at water levels greater than 59 feet. As shown on Figure 5, only water levels in wells 1-3 are

Two significant dates of Central Arizona Project (CAP) water delivery are noted on Figures 4 and 5, with delivery beginning in November 1992, and phasing out approximately two years later in October 1994. As CAP water was introduced to the potable water delivery system, Tucson Water began taking water supply wells out of production, notably in their Central Wellfield.

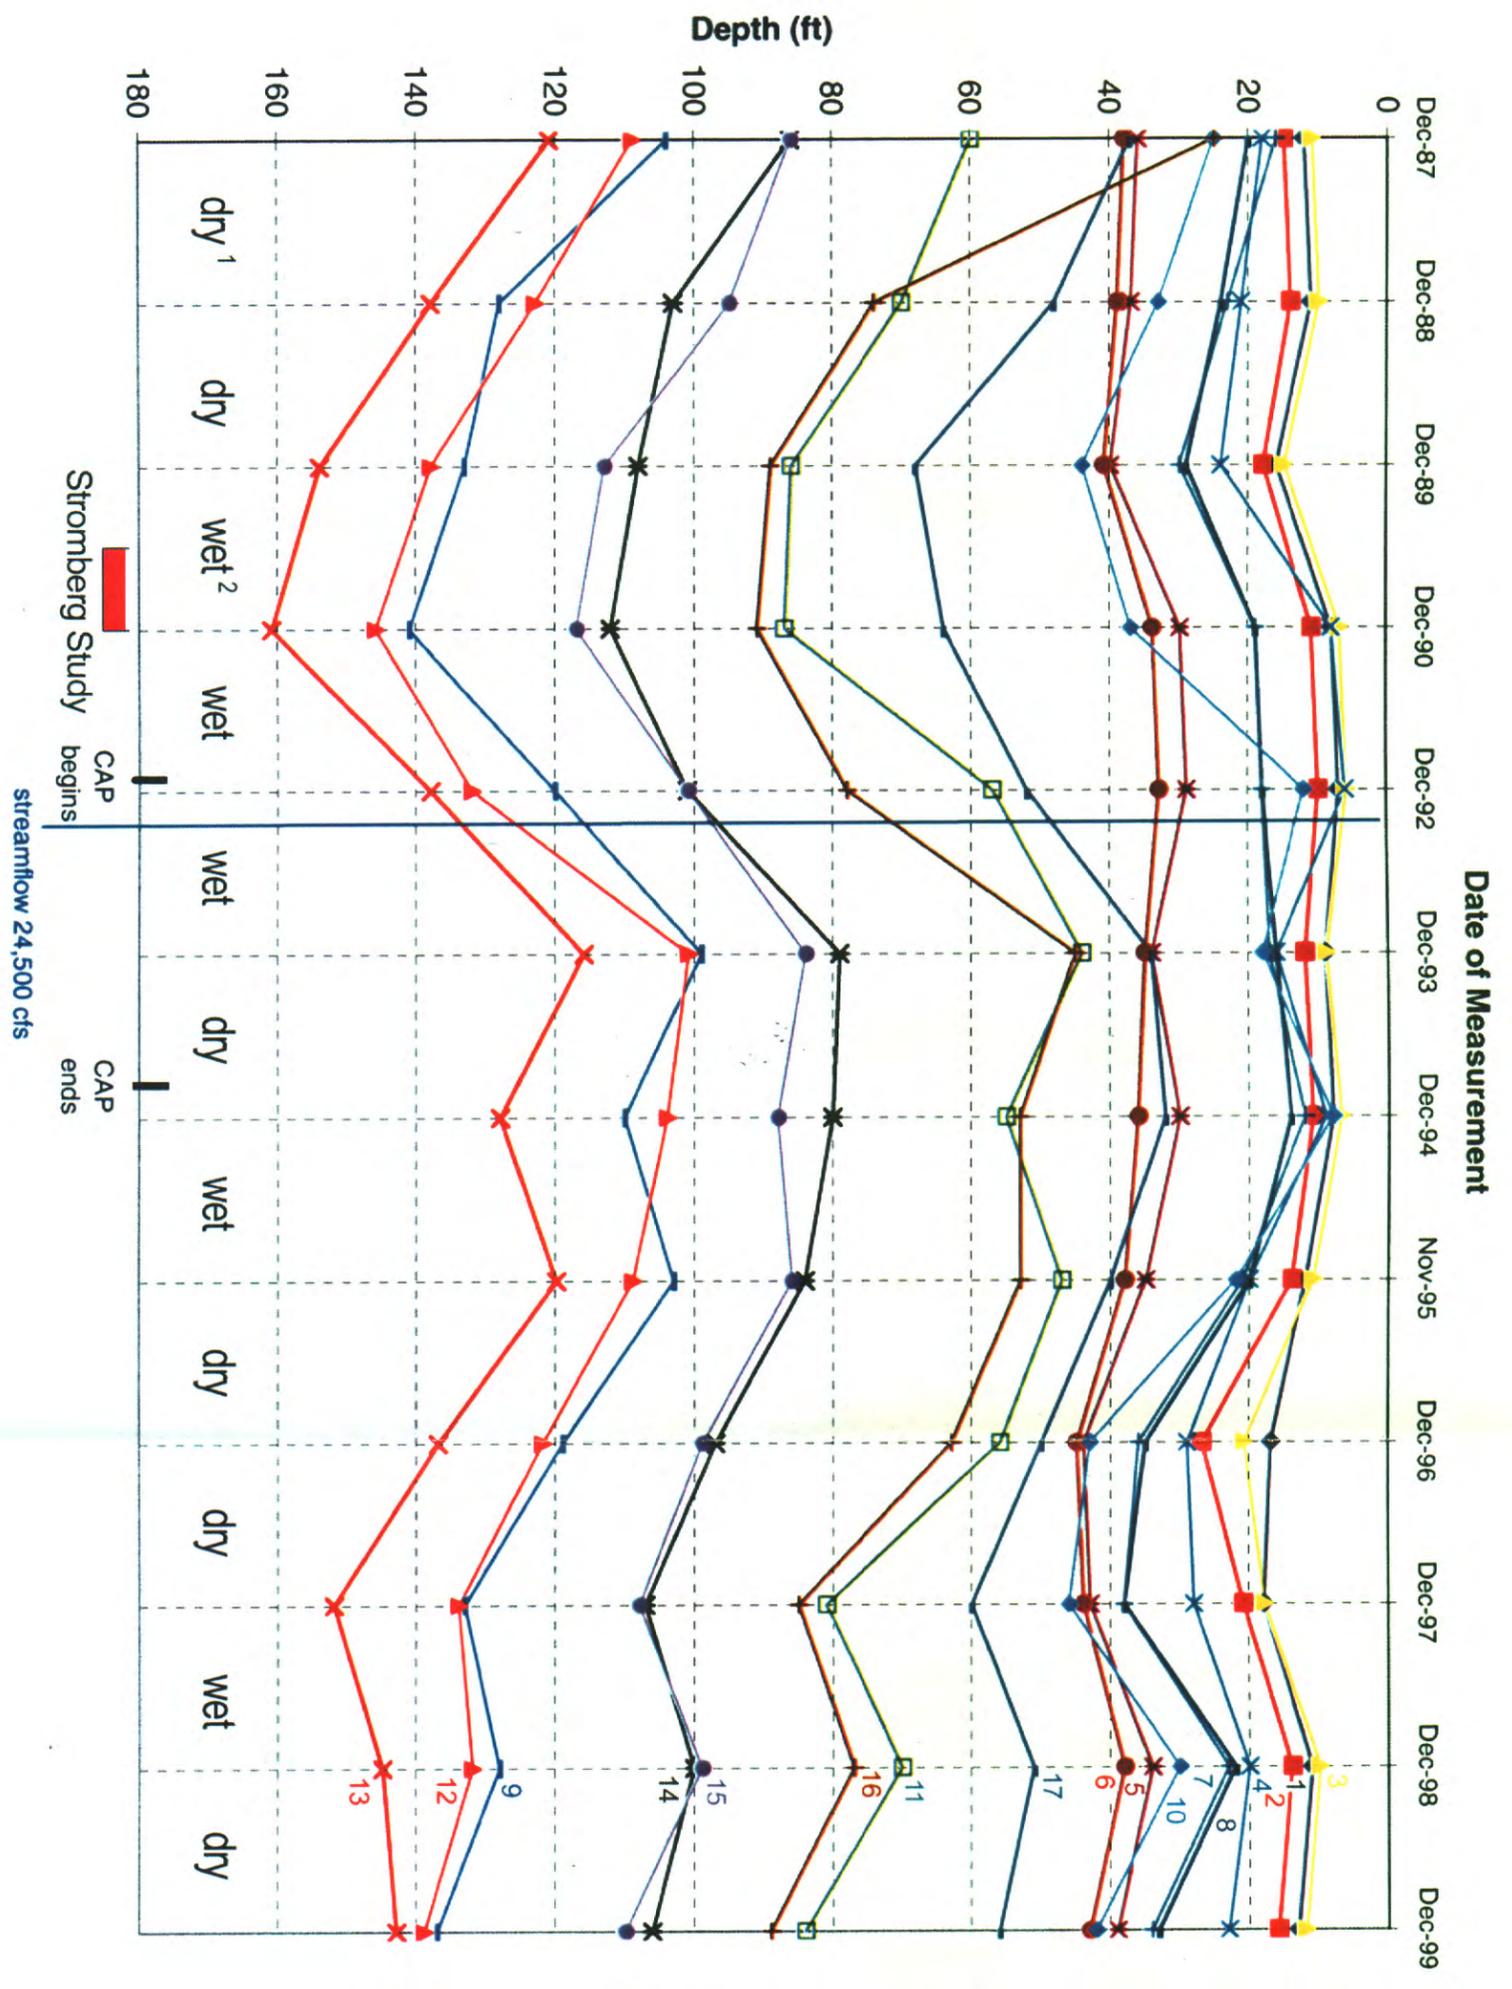
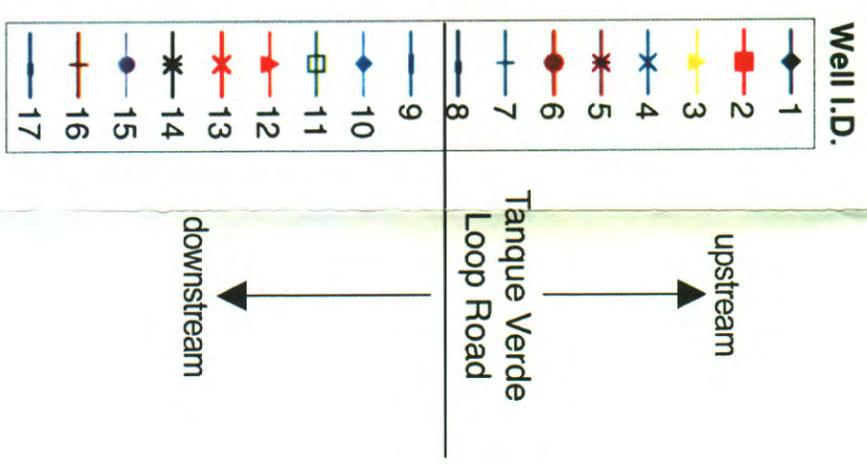
Figure 5. Depth - to - Water below land surface

generally less than 16 feet; in wells 4-10, levels are between 16 and 59 feet; and in wells 11-17, levels are generally greater than 59 feet. Wells 1,3,4,7,8,10,11,16 and 17 are at or close to the elevation of the mesquite bosque. Areas of former mesquite bosque were interpreted from 1941 aerial photographs.

TANQUE VERDE CREEK
 dry¹ year < 18,000 AF / annual stream flow
 wet² year > 18,000 AF / annual stream flow

"Wet" and "dry" years are labeled on Figure 5 and refer to an average annual discharge of approximately 18,000 AF (calculated from the 18 year period of record at the gauging station). A "dry" year thus refers to less than 18,000 AF average annual runoff. A multi-year drought was occurring prior to and during the beginning years of the graph, 1987 to 1990. Water years 1994, 1996 and 1997 were also extremely dry.

In order to visually describe the effect of runoff on aquifer recharge, "wet" and "dry" years can be compared to the fluctuating depth-to-water profiles on Figure 5. Very generally, there appears to be a decline in water levels following "dry" water years such as 1994, 1996 and 1997, and a rise in water levels following "wet" water years such as 1993 and 1995, suggesting that streambed recharge affects groundwater levels along the Creek. All of the wells do not exhibit this rise-and-fall

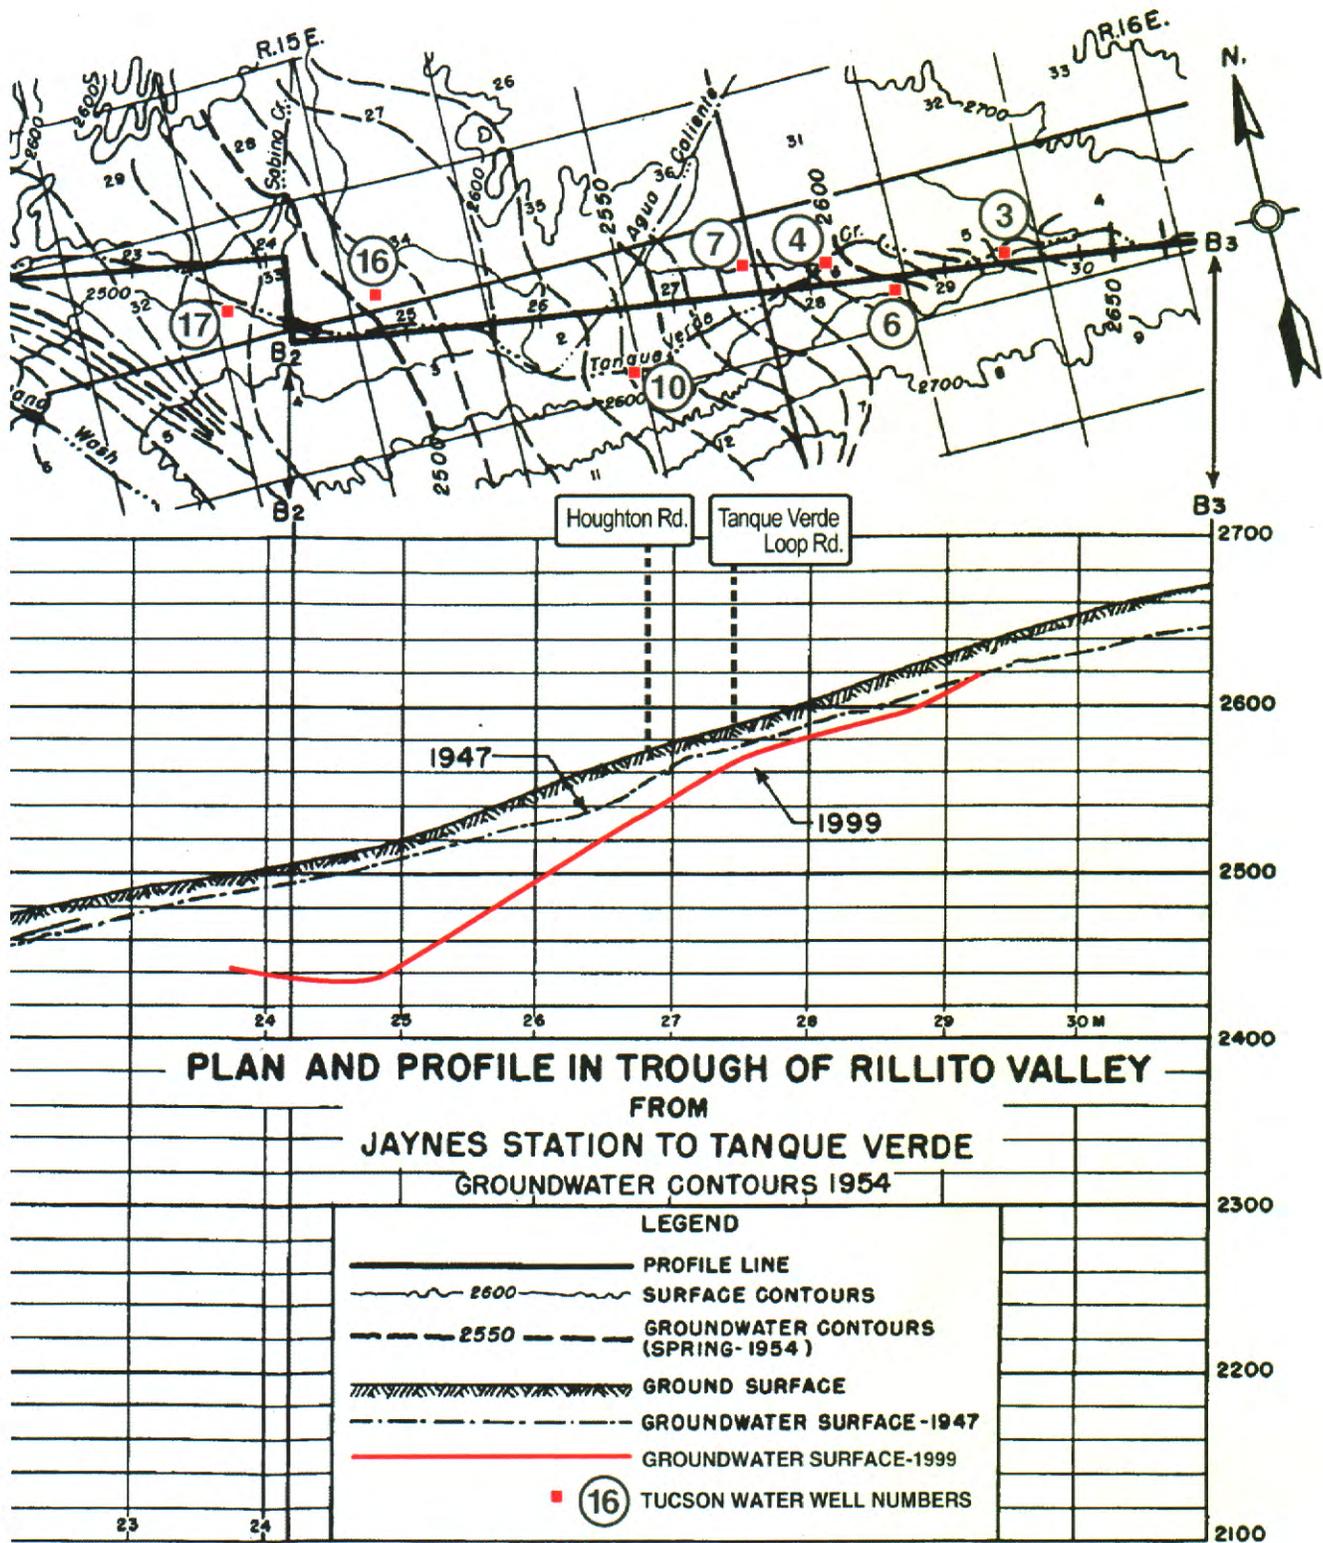
Figure 6. Water Levels in 1947 and 1999

Figure 6 is based on work by Schwalen and Shaw (1957). The top map is a plan view showing groundwater table contours in spring 1956. The authors constructed longitudinal profiles along the axis of Tanque Verde Creek for several years between 1947 and 1956 to show water level changes as a result of pumping. The 1947 groundwater surface varies between 10 and 20 feet below ground surface. We have superimposed 1999 water levels on the Figure 6 profile to compare with 1947 water levels. As Schwalen and Shaw state, the 1947 water levels reflect groundwater depletions. Our review of 1941 aerial photographs shows much of the Tanque Verde corridor was used for irrigated agriculture at that time.

Inspection of Figure 6 water levels shows that 1999 water levels in wells upstream of Tanque Verde Loop Road are similar to 1947 conditions, while downstream of Houghton Road the 1999 water levels are lower than 1947 by up to 60 feet.

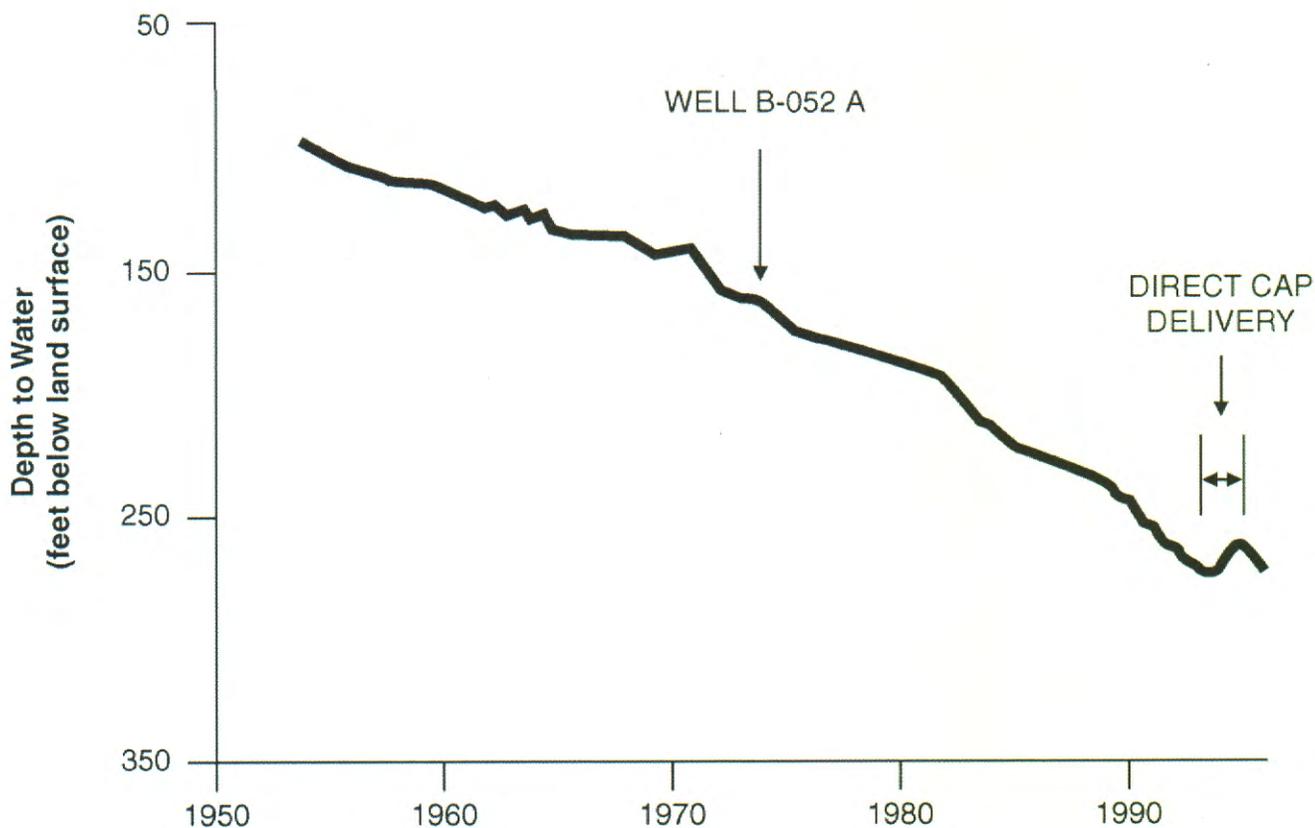
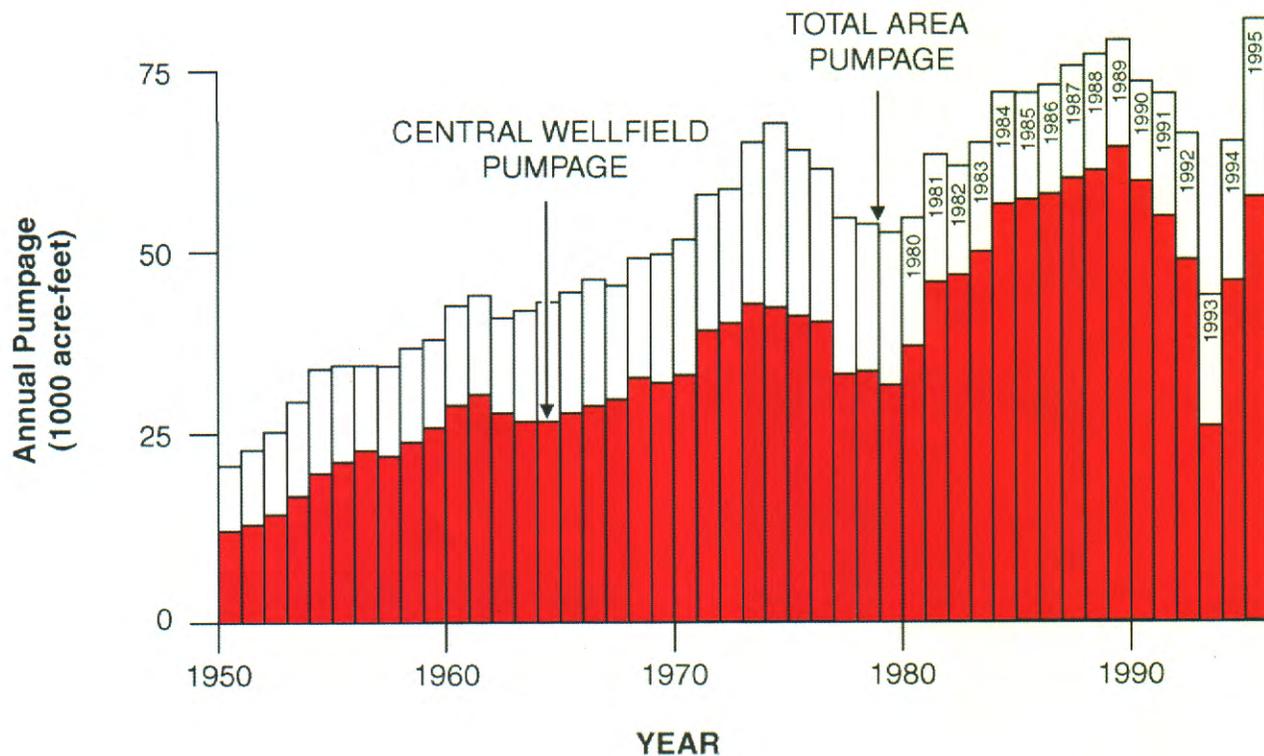
Figure 7. Tucson Water Central Wellfield Pumpage and Hydrographs of Well B-052 A

The graphs in Figure 7, extracted from a City of Tucson report (1996), illustrates the general effect CAP water delivery had on pumping in the Central Wellfield, and on total area pumping. A continuous hydrograph of Well B-052A, located in the Central Wellfield near Grant/Craycroft, shows a rise in water surface elevation during CAP delivery and supply well shutdown. In 1993, with CAP water supplementing the delivery system, there was a significant decrease in total area pumping, when compared to previous years. Inspection of Figure 5 Depth-to-Water in 1993 shows that the reduction in pumping coupled with a very wet year resulted in rising water surface levels in the deeper wells. However, in the dry year of 1994 when consumer demand increased (Figure 7) and CAP was being phased out, water levels declined in the deeper wells. (Figure 5). Shallow wells did not show consistent water level fluctuations for those years.

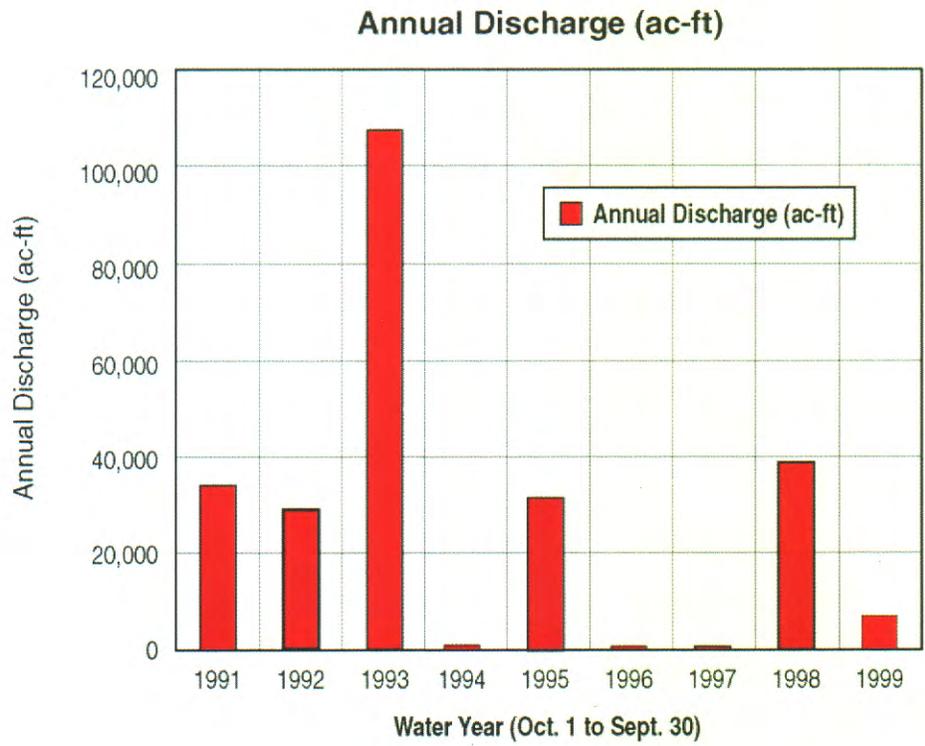
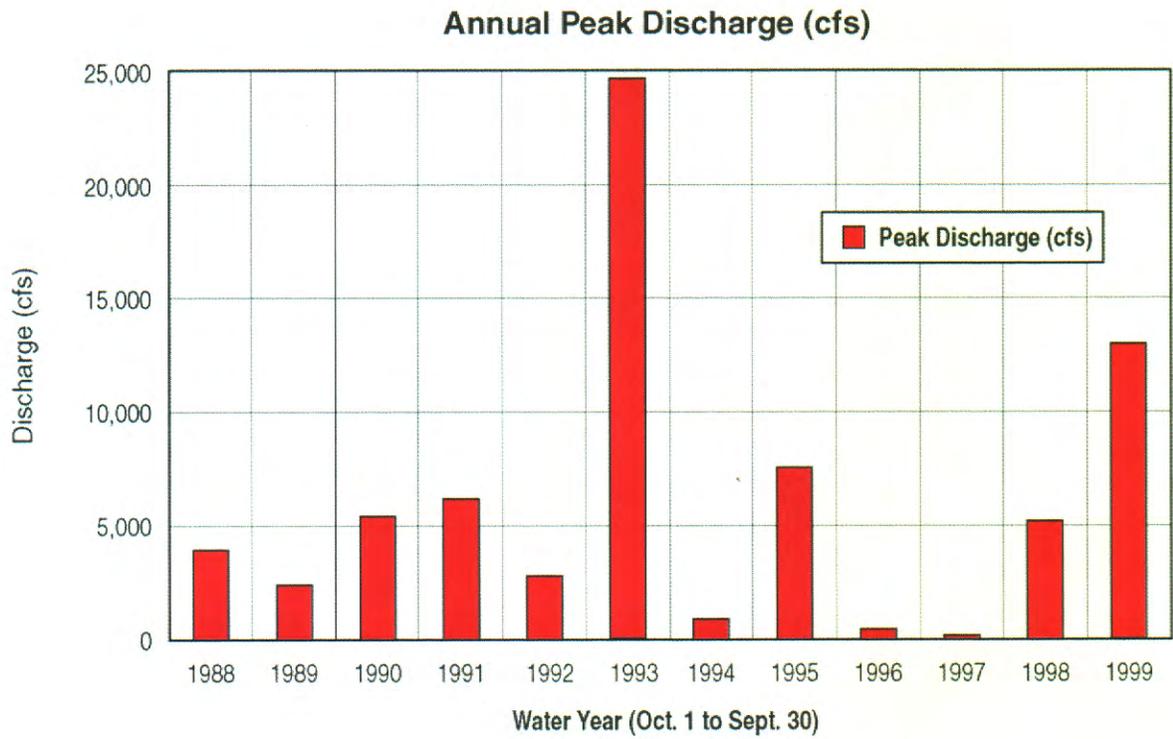
Figure 8. Tanque Verde Creek USGS Gauge #984500

Total annual streamflow in acre-feet (AF) was available for eight years, 1991 to 1999 (Figure 8, top). Water Year 1993 was significant with over 100,000 AF.

Annual peak streamflow in cubic feet per second (cfs) was available for the 12 year study period (Figure 8, bottom). Water Year 1993 was significant with a peak flow of 24,500 cfs, while the peaks in the previous years are much less than the 100 year event for the gauging station.

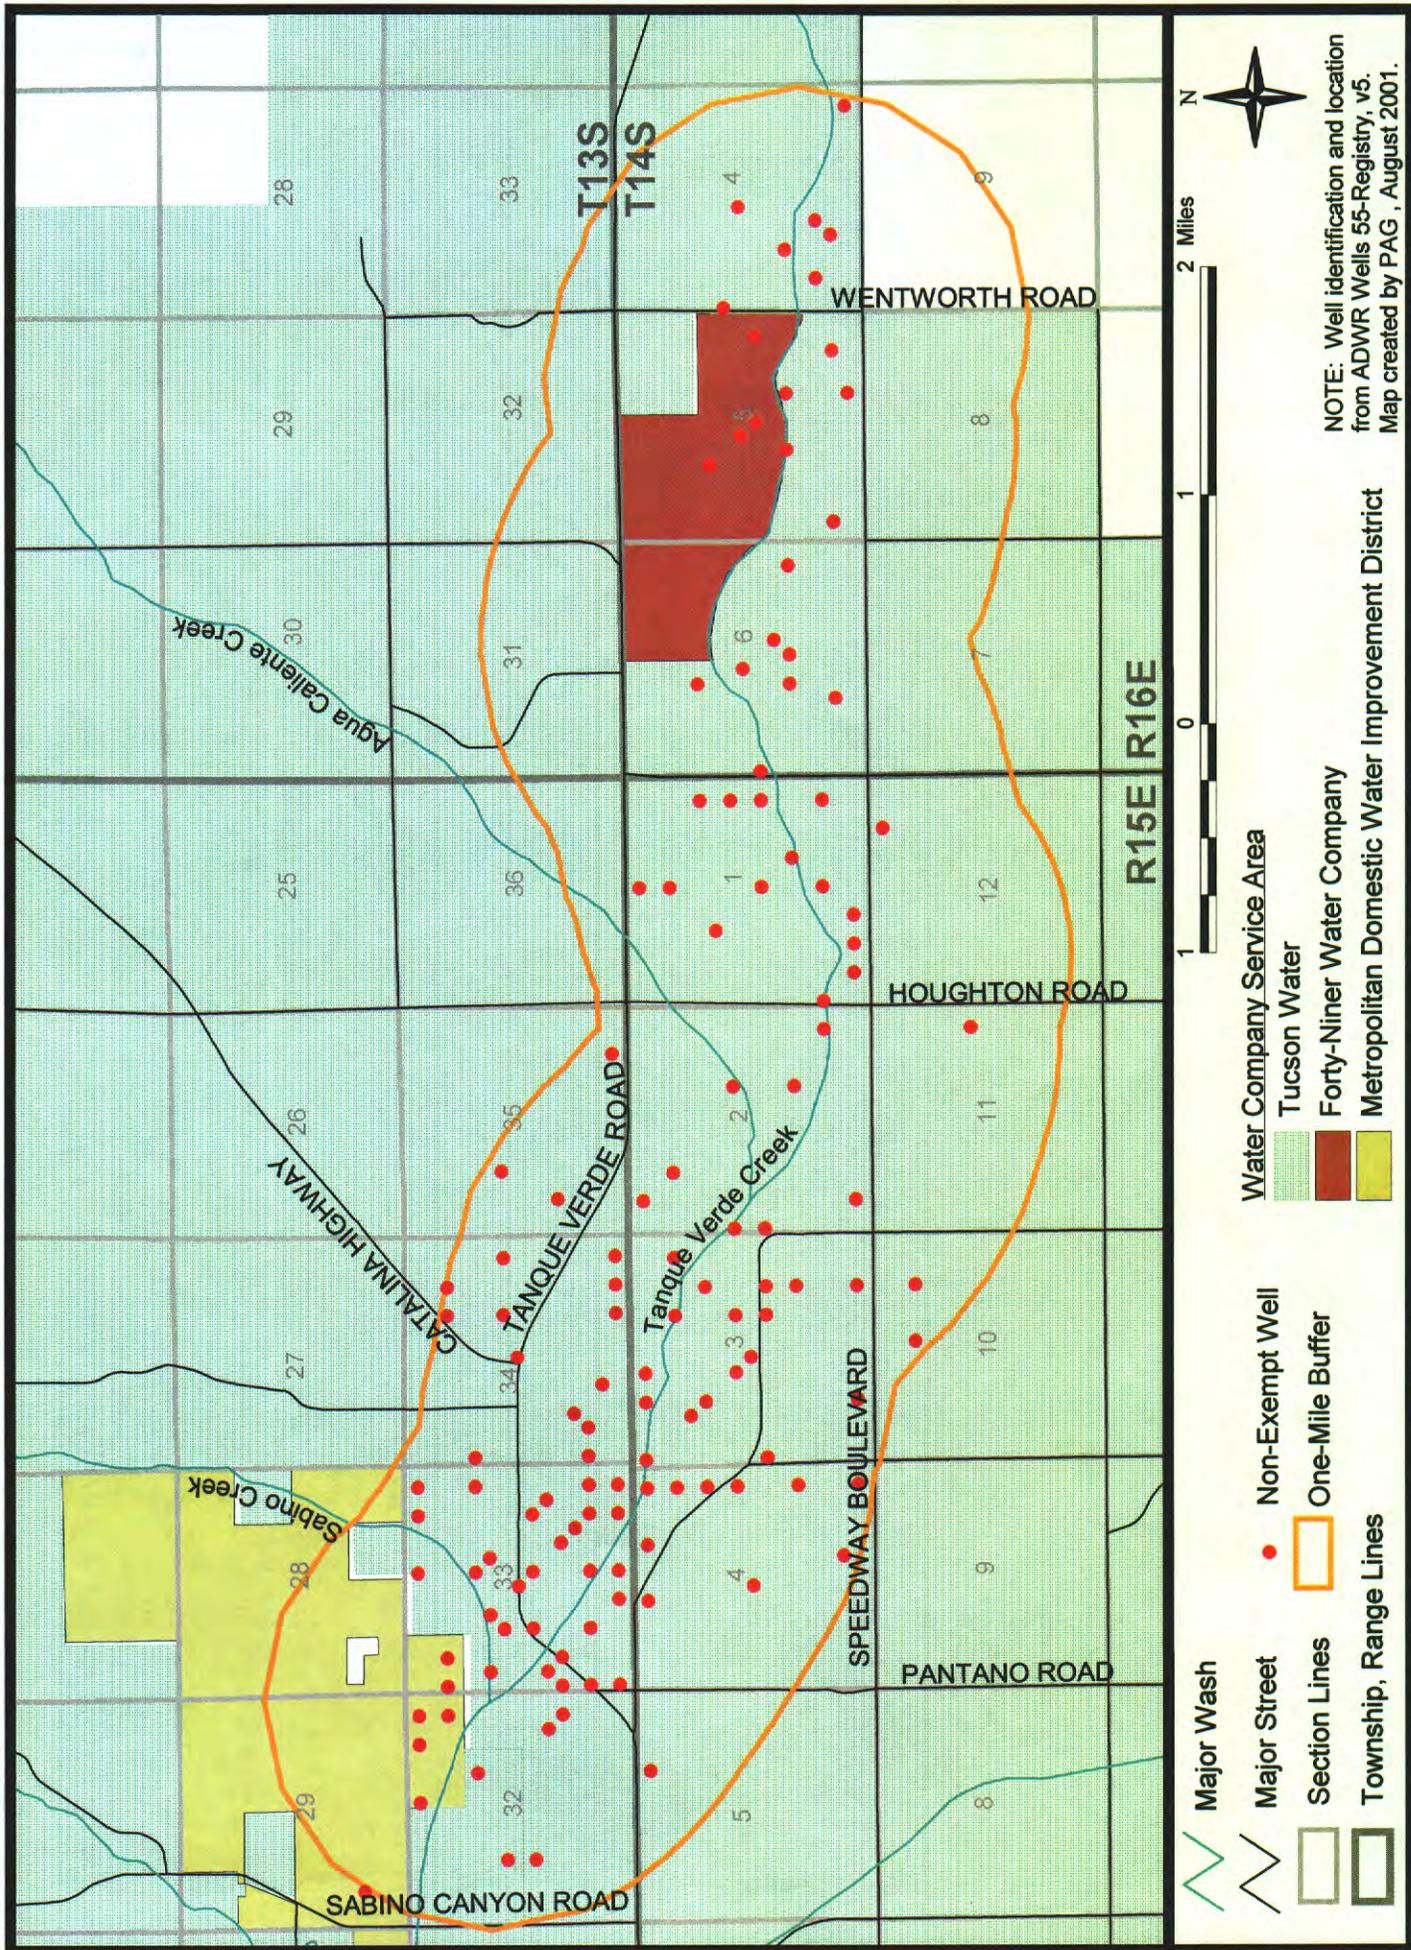
Figure 9. Non-Exempt Wells and Water Companies within One Mile of Tanque Verde Creek, Wentworth Rd to Sabino Creek

Figure 9 shows the locations of all registered non-exempt wells used for this report, along with water user jurisdictional boundaries. Exempt wells, which are pumped at a rate of less than 35 gallons per minute (gpm), are not shown on Figure 9. There are approximately 300 exempt wells in the Tanque Verde Valley, each pumping an estimated one AF per year (Pima County, 2000).
