HISTORIC PROPERTY INVENTORY FORM

Historic Name(s): Fort Lowell Officer's Quarters No. 1 (Enter the name(s), if any, that best reflects the property's historic importance.)

Address: 2951 N. Craycroft Road

name of property Fort Lowell Officers' Quarters No. 1 Continuation Sheet No. 1

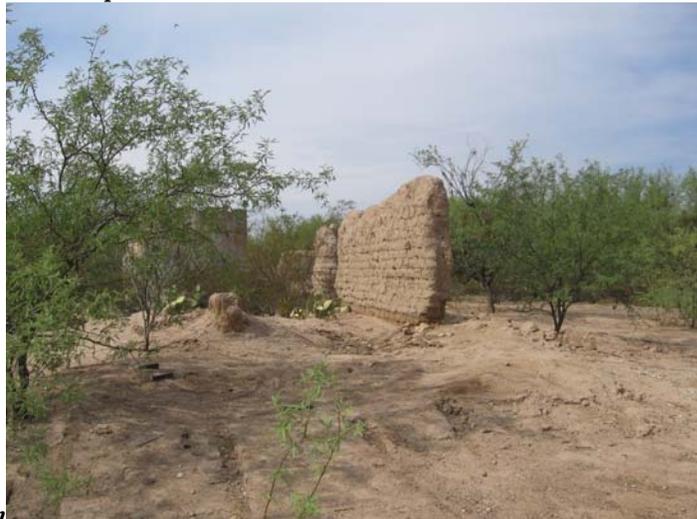
Negative No.: Jpeg Img_1527

X Ruin/Uninhabitable

All plan documents of the Fort show this to be another officer quarters with summer kitchen and this is corroborated in People of Fort Lowell, where Dolly Cates is reported to have bought the westernmost three Officer's Quarters with summer kitchens for her TB sanitarium. However the HABS drawings show a stable with a store room, and the water tank (or a silo, typical of Mormon concrete construction) between the two. Ruins confirm the HABS configuration.

Walls (structure): Unstabilized Mud Adobe Foundation: None (adobe) Roof: Wood framed with sahuaro latillas supporting an earthen roof, covered with metal in 1880's _____

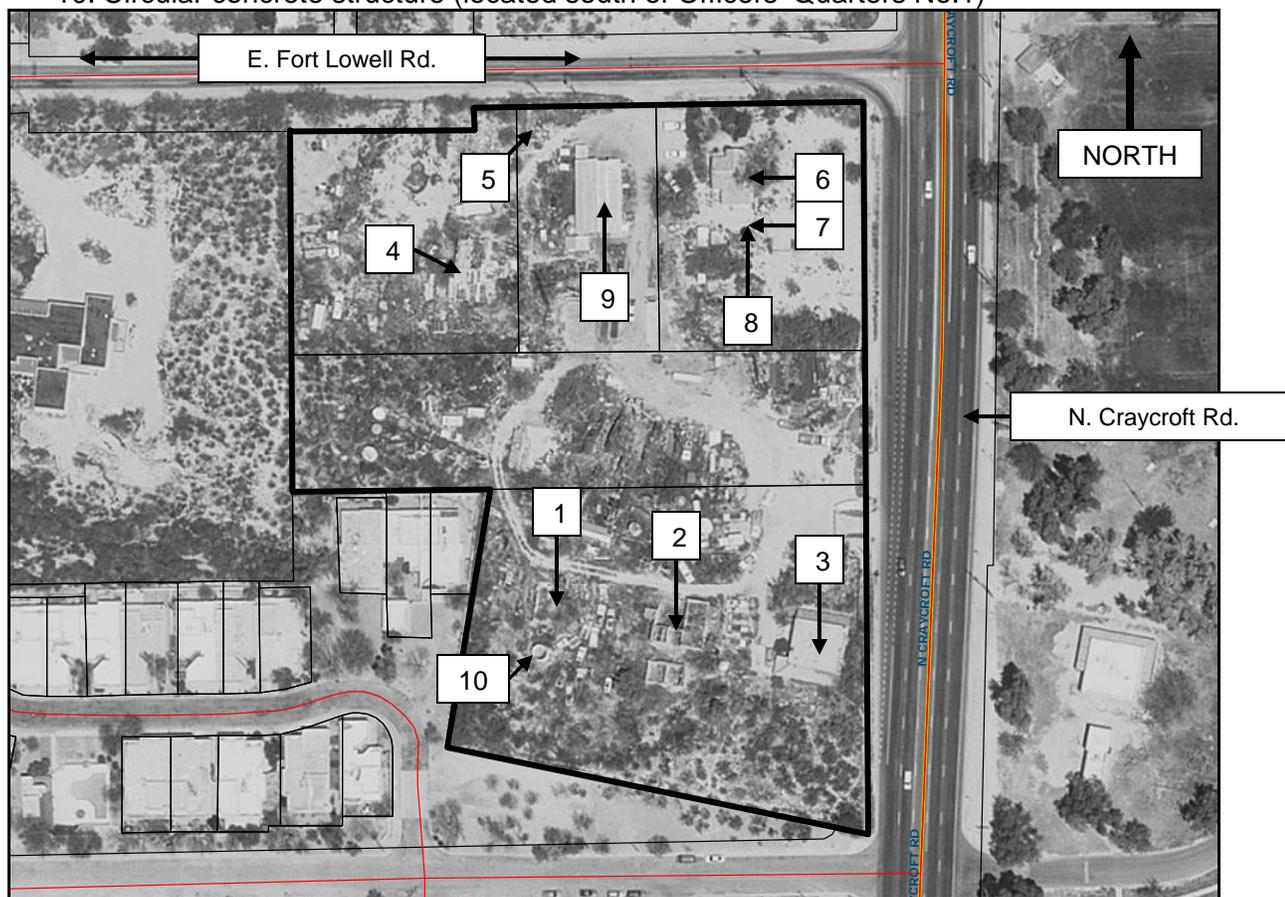
Location of Buildings and Structures

1. Officers' Quarters No. 1 (ruin, includes kitchen remains)
2. Officers' Quarters No. 2 (partial ruin, includes kitchen building)
3. Officers' Quarters No. 3 (intact)
4. Adobe Building (located west of the Steel Tank Fabrication Shed).
5. Guard House (ruin located north-west of the Steel Tank Fabrication Shed).
6. Adkins Residence (located east of the Steel Tank Fabrication Shed)
7. Water Tower
8. Windmill base
9. Steel Fabrication Shed
10. Circular concrete structure (located south of Officers' Quarters No.1)
