# HISTORIC PROPERTY INVENTORY FORM

Historic Name(s): Fort Lowell Officer's Quarters No. 2

name of property Fort Lowell Officers' Quarters No. 2 Continuation Sheet No. 1

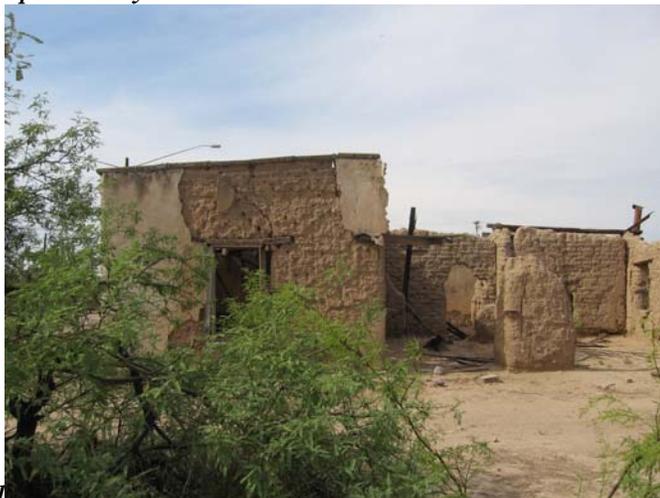
Negative No.: Jpeg Img\_1527

View Direction (*looking towards*)

south

Built with dirt floors and roof , exposed adobe walls, and saguaro latilla ceilings, we can assume Officer Quarters No. 2 was altered for livability as was Ofc. Quarters No. 3, adding interior plaster walls and ceilings, wood floors on sleepers, a metal roof over the dirt roof, and porches on the north and south sides, though the physical evidence to support these changes is not currently visible.

Walls (structure): Unstabilized Mud Adobe Foundation: None (adobe) Roof: Wood framed with sahuaro latillas supporting an earthen roof, covered with metal in late 1880's

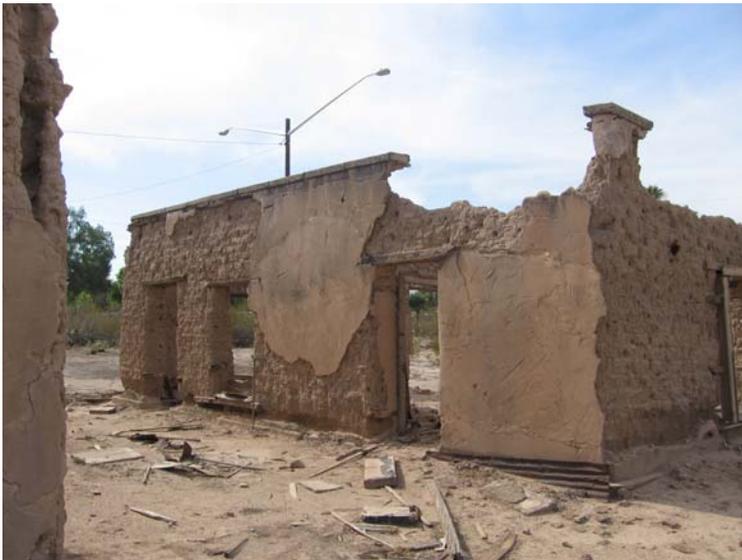
The summer kitchen exists as a ruin behind Officer's Quarters No. 2. See continuation sheets for picture.

Officer's Quarters are shown on Plan of Fort Lowell to typically have summer kitchens immediately behind and centered on the Quarters. They consisted of two rooms. The kitchen exists behind this building as a partial ruin. This is looking at the kitchen toward the southeast.

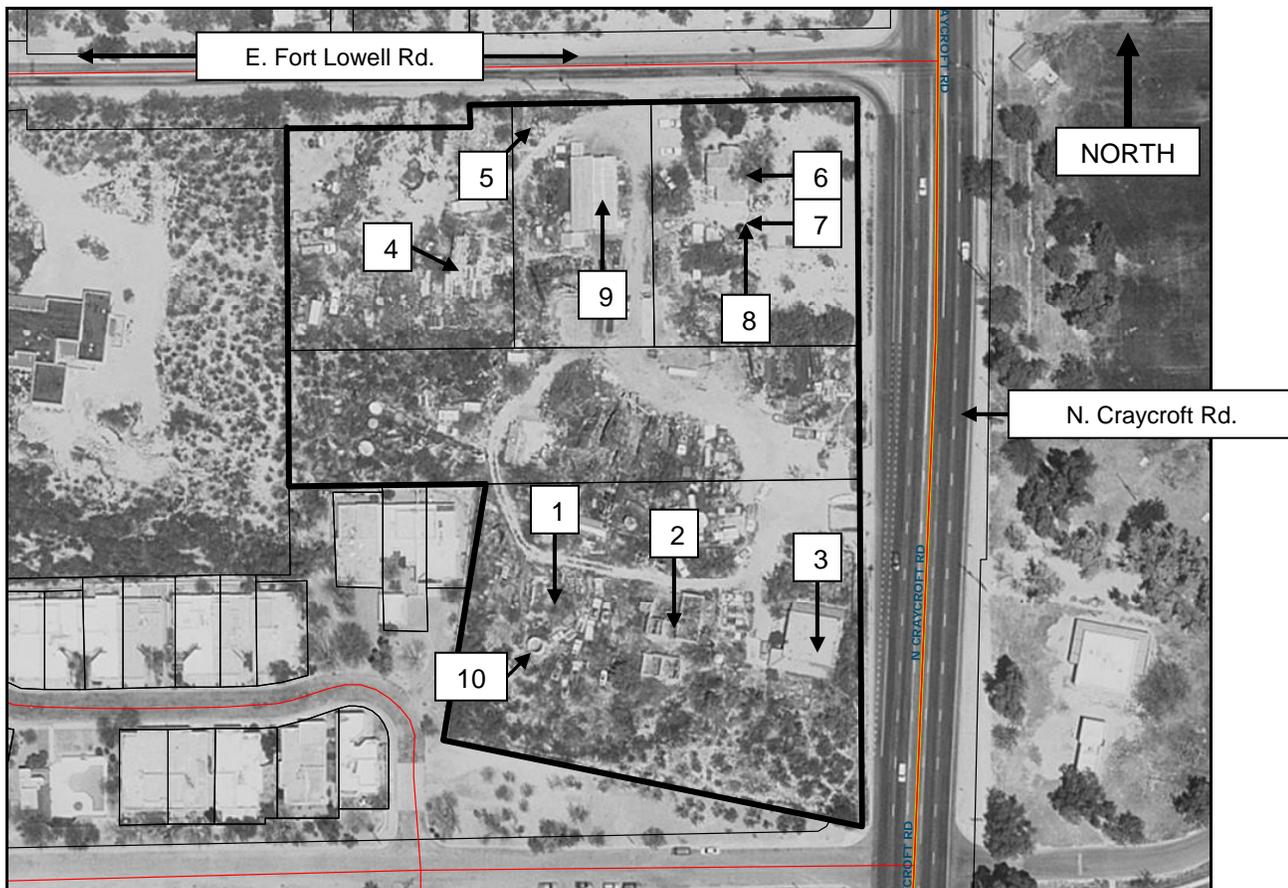
Location of Buildings and Structures

1. Officers' Quarters No. 1 (ruin, includes kitchen remains)
2. Officers' Quarters No. 2 (partial ruin, includes kitchen building)
3. Officers' Quarters No. 3 (intact)
4. Adobe Building (located west of the Steel Tank Fabrication Shed).
5. Guard House (ruin located north-west of the Steel Tank Fabrication Shed).
6. Adkins Residence (located east of the Steel Tank Fabrication Shed)
7. Water Tower
8. Windmill base
9. Steel Fabrication Shed
10. Circular concrete structure (located south of Officers' Quarters No.1)
