# HISTORIC PROPERTY INVENTORY FORM

Historic Name(s): Adkins Steel – Fabrication Shed

Address: 5444 E. Ft. Lowell Road

name of property Steel Fabrication Shed

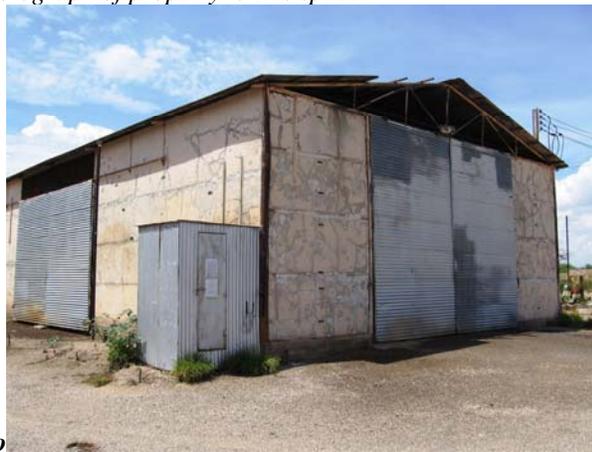
Negative No.: IMG\_1631

Erected to serve as a steel Fabrication shed. Had several Trolley cranes, welding booth, Etc. Used until property Transferred to City of Tucson.  
Sources: Harry Adkins Interview

Walls (structure): Steel wide flanges w/lightweight concrete panel infill    Foundation: Concrete

Roof: Steel with corrugated metal roof panels

Roof and wall framing were erected first. Wall panels were cast on-site, on asphaltic-building paper out of perlite-modified concrete (lightweight, insulating) and then hoisted up and into place in wide-flange beam flanges (texture of building paper still evident on interior side of panels)
